| | GROUP<br><b>Product Improvement</b> | MODEL<br><b>See Model List on Page 1</b> |
| | NUMBER<br><b>PI1802Y/Z (Rev 3, 07/01/2020)</b> | DATE<br><b>March 2020</b> |
| <b>SUBJECT: ENGINE REPLACEMENT INSTRUCTIONS<br/>FOR DTC P1326 (PI1802Y/Z)</b> | | |

This bulletin provides information related to the Technical Service Bulletin previously published in July 2018 (PI1802 Rev 10, 03/16/2020) titled "Knock Sensor Detection System - ECU Logic Improvement". Specifically, this bulletin provides instructions on which procedures to follow if, after installation of the KSDS, any one of the subject vehicles below returns to the dealer with Diagnostic Trouble Code (DTC) P1326 (Knock Signal Range/Performance).

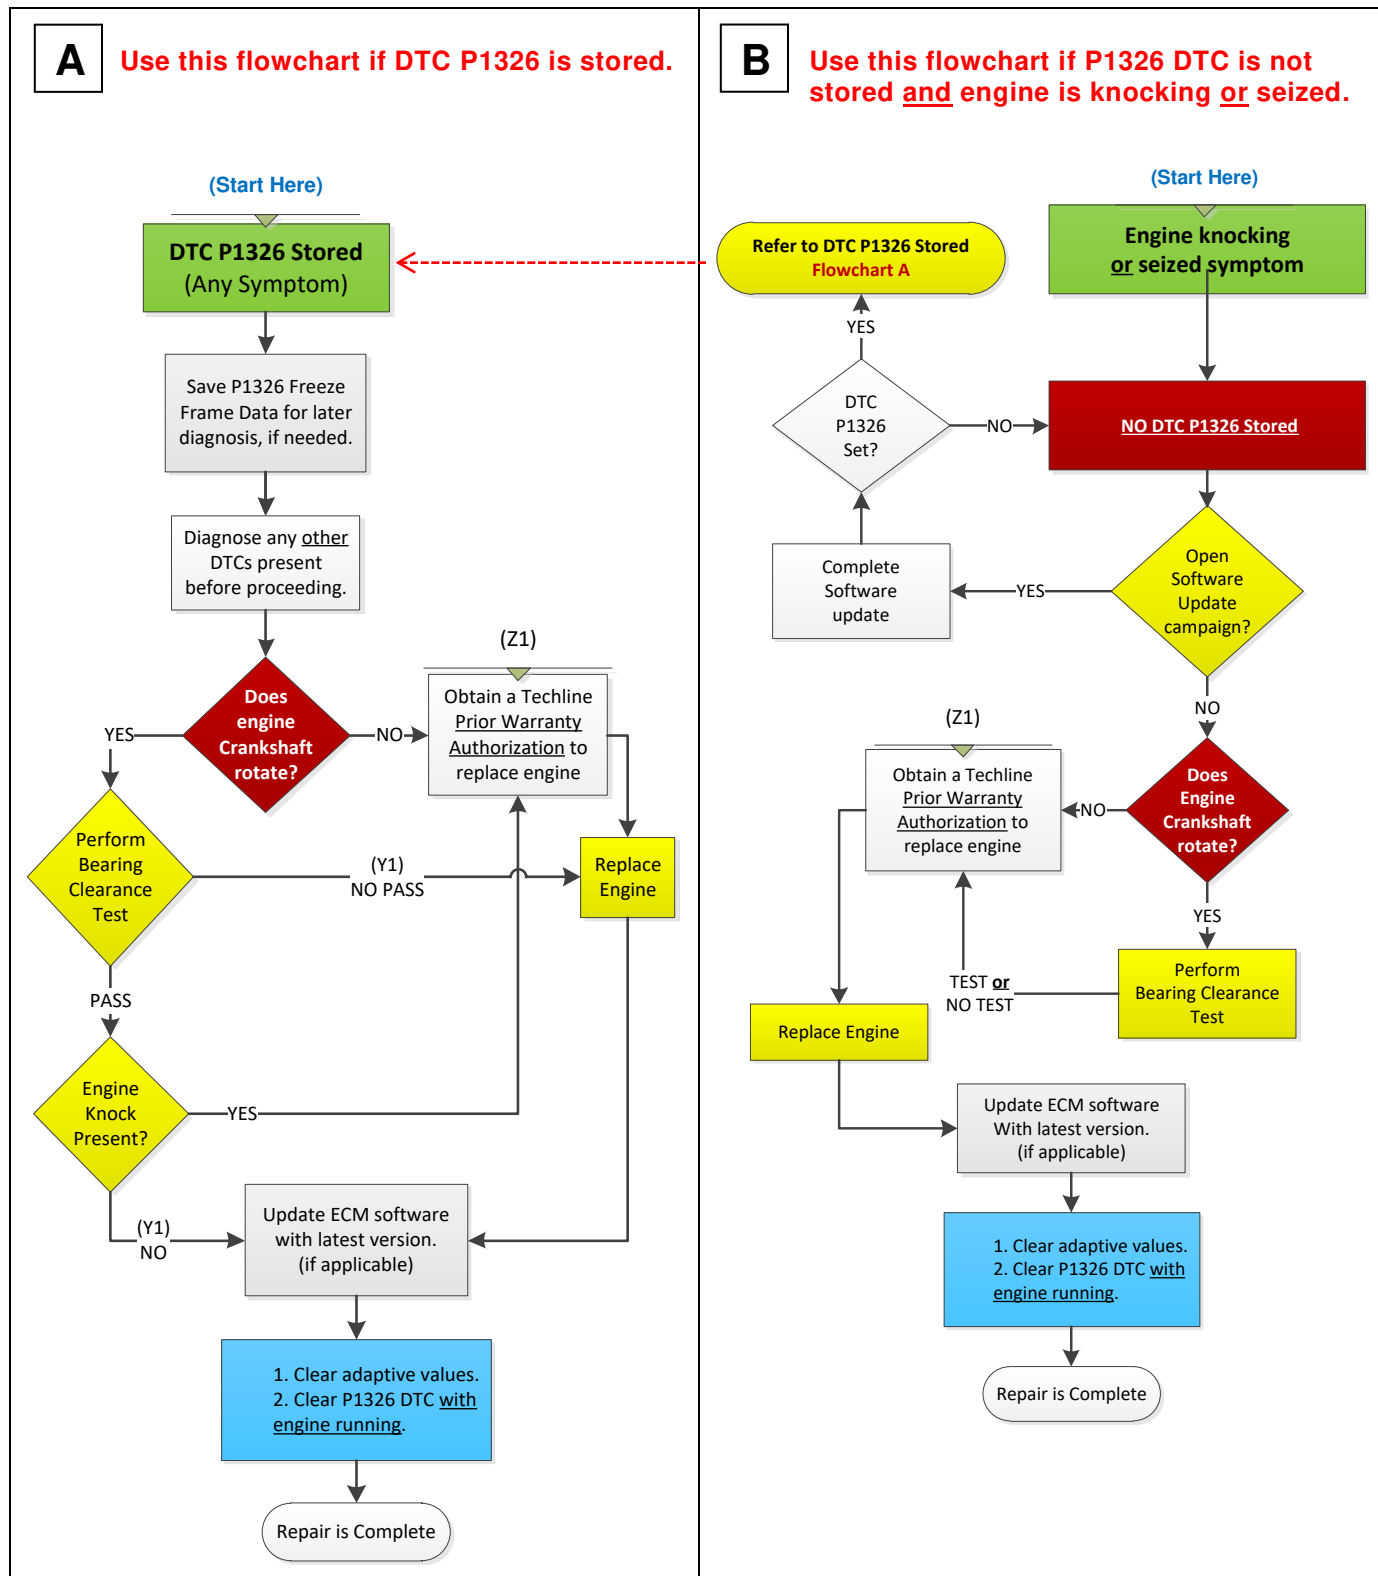
- **Scenario 1** – Vehicle is in with DTC P1326 stored (A).
- **Scenario 2** – Vehicles is in with no DTC P1326 stored but engine is knocking or seized (B).
- **Scenario 3** – Vehicle is in with DTC P1326 stored and also engine is making noise or seized (A).

**Note:** If any concerns arise after completing the flow chart, open a Techline case online.

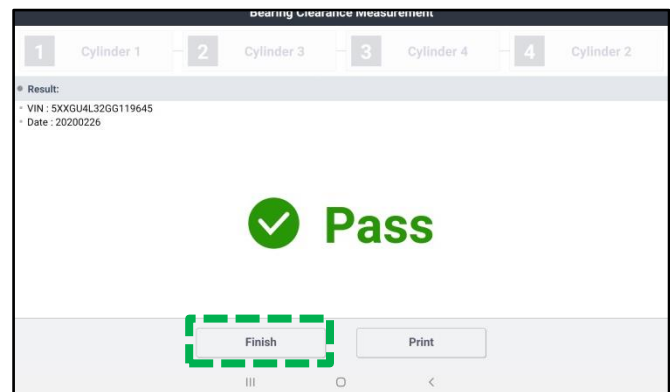
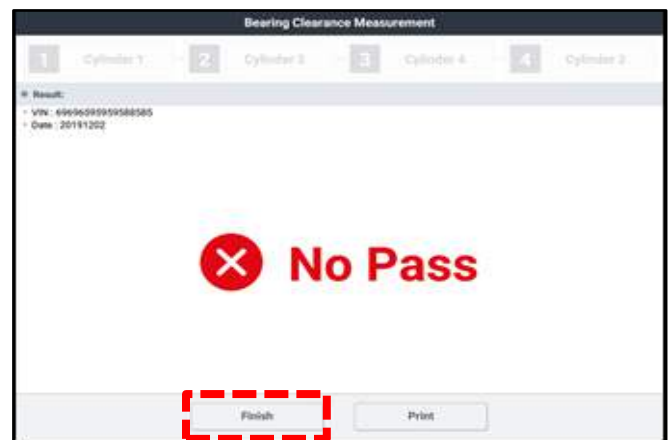
If the test result displays **"NO PASS"**, capture the screen image/screenshot for record keeping. Then proceed to replace the engine assembly per the instructions.

- Proceed to **page 11** to replace the engine assembly as outlined in this bulletin

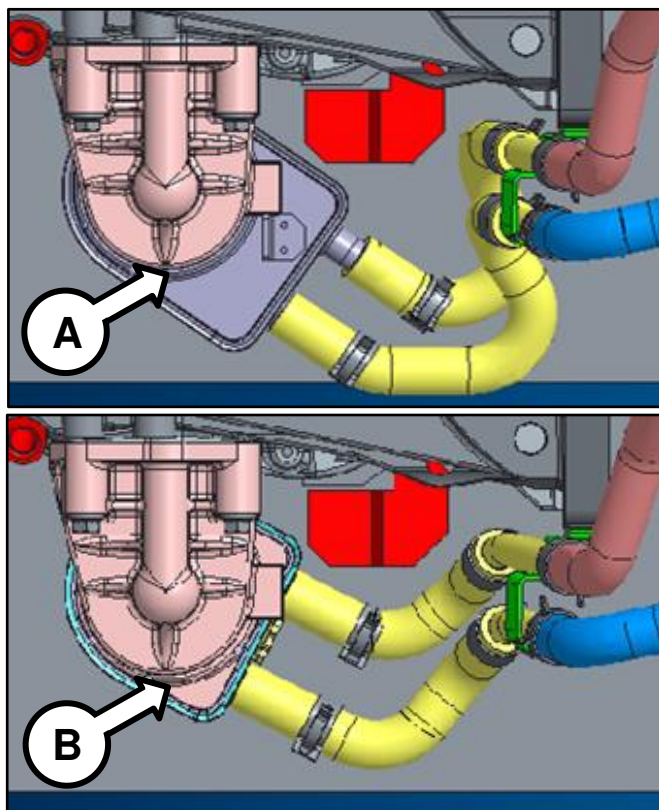
- If the new engine's (bigger) oil cooler (A) does not match the old engine's (smaller) oil cooler (B), replace the oil cooler tube assembly with the improved part. See parts table on page 24.
- If the new engine's (bigger) oil cooler (A) matches the old engine's (bigger) oil cooler (A), reuse the old engine's oil cooler tube assembly.
- If the new engine's (smaller) oil cooler (B) matches the old engine's (smaller) oil cooler (B), reuse the old engine's oil cooler tube assembly.

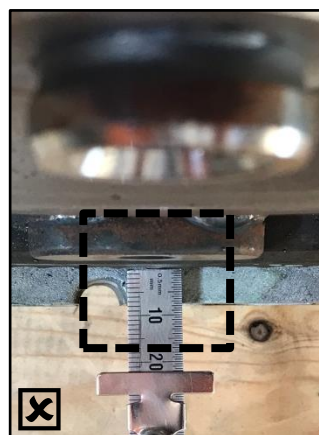
Not Fully Inserted

- If the torque converter has moved from the fully inserted position, carefully push inward while rotating the torque converter until it is recessed approximately 9/16 – 5/8" (14 – 16mm) (☑) into the transaxle case when reinstalling the automatic transaxle.
