## SERVICE BULLETIN

AT20-004a

NTB20-038a

### 2020 TITAN AND TITAN XD; DTC P288B STORED IN THE TCM

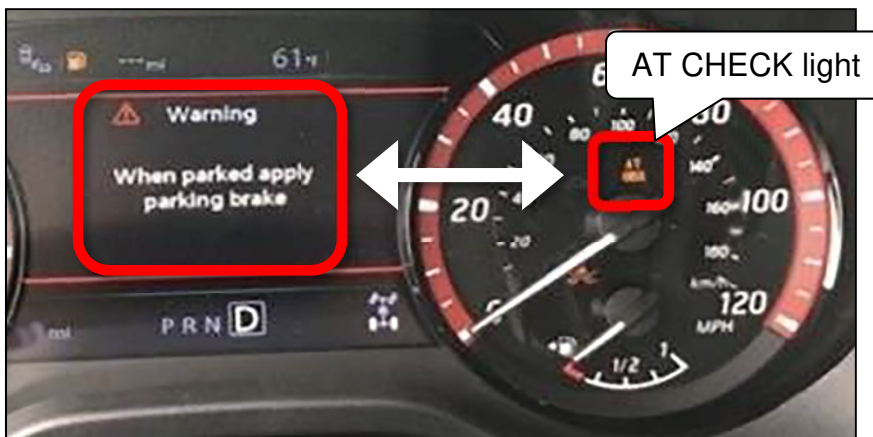
DTC P288B (PARK LOCK SOLENOID) is stored in the transmission control module (TCM).

- The warnings shown in Figure 1 turned ON in the vehicle information display and speedometer.

- Two attempts were required to shift out of Park.

- Confirm the current TCM part number.
- Reprogram the TCM, if applicable.
