# Service Bulletin

Bulletin No.: 20-NA-140

Subject: Service Front Leveling System Message - DTC U3000 SYM49 Stored

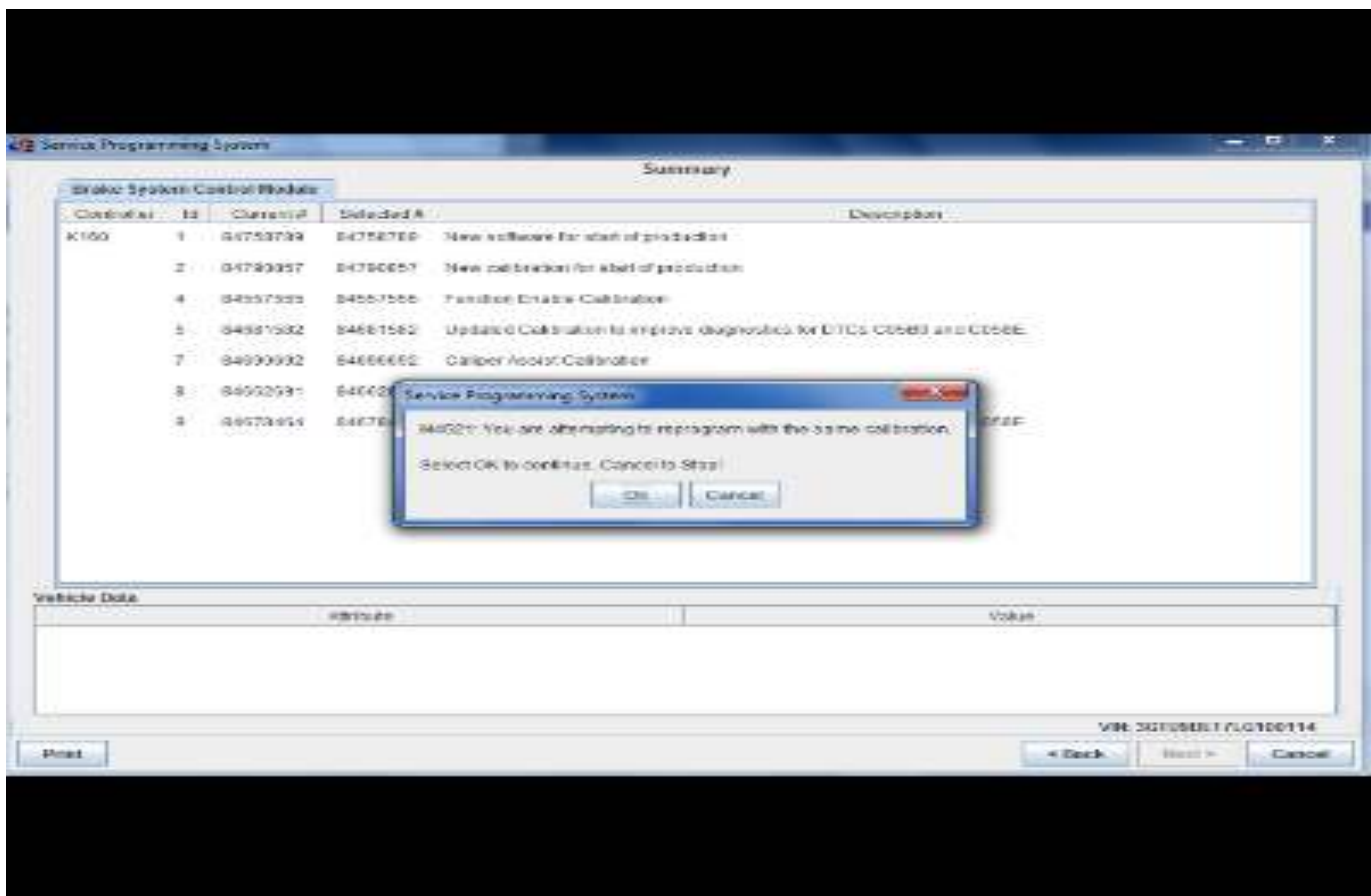
5431207

Important: TIS2WEB screen shown. Techline Connect screen is similar and will be included soon.

Important: If the Same Calibration/Software Warning is noted on the SPS screen, select OK and follow screen instructions. After a successful programming event, the WCC is located in the Service Programming

System dialogue box of the SPS Summary screen. No further action is required. Refer to the Warranty Information section of this bulletin.

1. Reprogram the Front Suspension Lifting/Lowering Hydraulic Power Pack Module. Refer to K218 Front Suspension Lifting/Lowering Hydraulic Power Pack Module: Programming and Setup in SI.
