Preliminary Information

PIC5650H Diagnostic Tip - Security Light on Intermittently / No Crank/No Start or Start Stall / Keyless Access Vehicles May Display No Remote/Fob Detected / Poor or No RKE Range / Service TPM

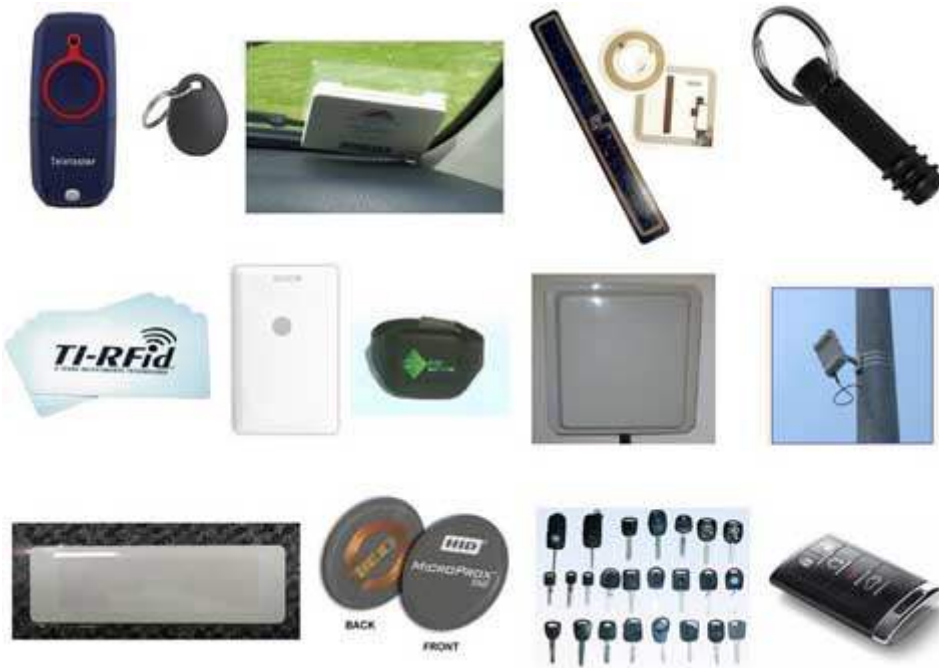
Listed below are a number of aftermarket devices that can cause RFI. In many cases, these types of devices will be attached to the customer's key ring and could be removed from the key ring or from inside the vehicle when the customer drops the vehicle off for service.

- Vehicle immobilizer keys from other vehicles
- Keyless access transmitters from other vehicles
- Interstate/bridge toll passes
- Gate/door passes to allow access to pools, driveways, entry doors, etc.
- Community/parking access cards
- Fuel station speed passes
- Building access swipe cards/ transponder devices

**Before any in depth diagnosis is performed, question the customer or inspect the vehicle for any types of aftermarket equipment, like shown above, which could cause RFI. These items need to removed and/or disconnected from the vehicle.**

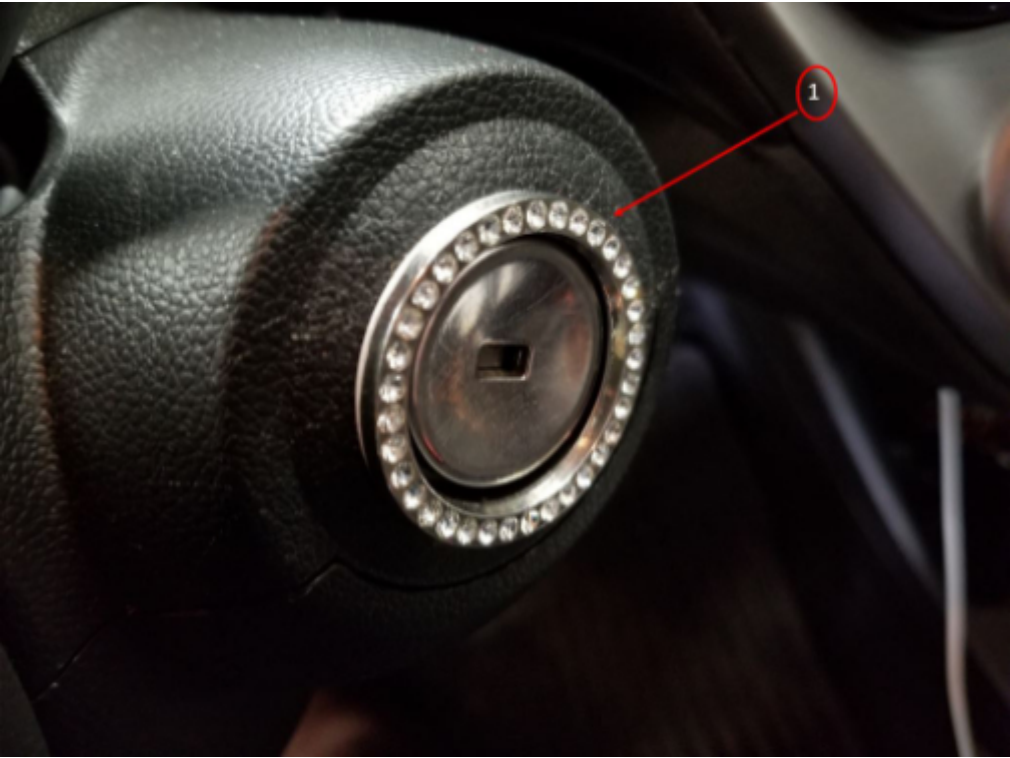
- Certain cell phone chargers
- USB power banks
- USB flash lights
- Fans (12 volt or 110 volt)
- Any type of USB, 12 volt or 110 volt chargers
- "Bedazzle Trim Ring" surrounding ignition lock cylinder, shown below (1)
