**NUMBER:** 09-010-20

**DATE:** July 2, 2020

Engine Oil Vapor Inlet Tube Modification - P2173-00 - Air Leakage In Manifold (Signal Compare Failure)

2017 - 2018 (BU) Jeep Renegade

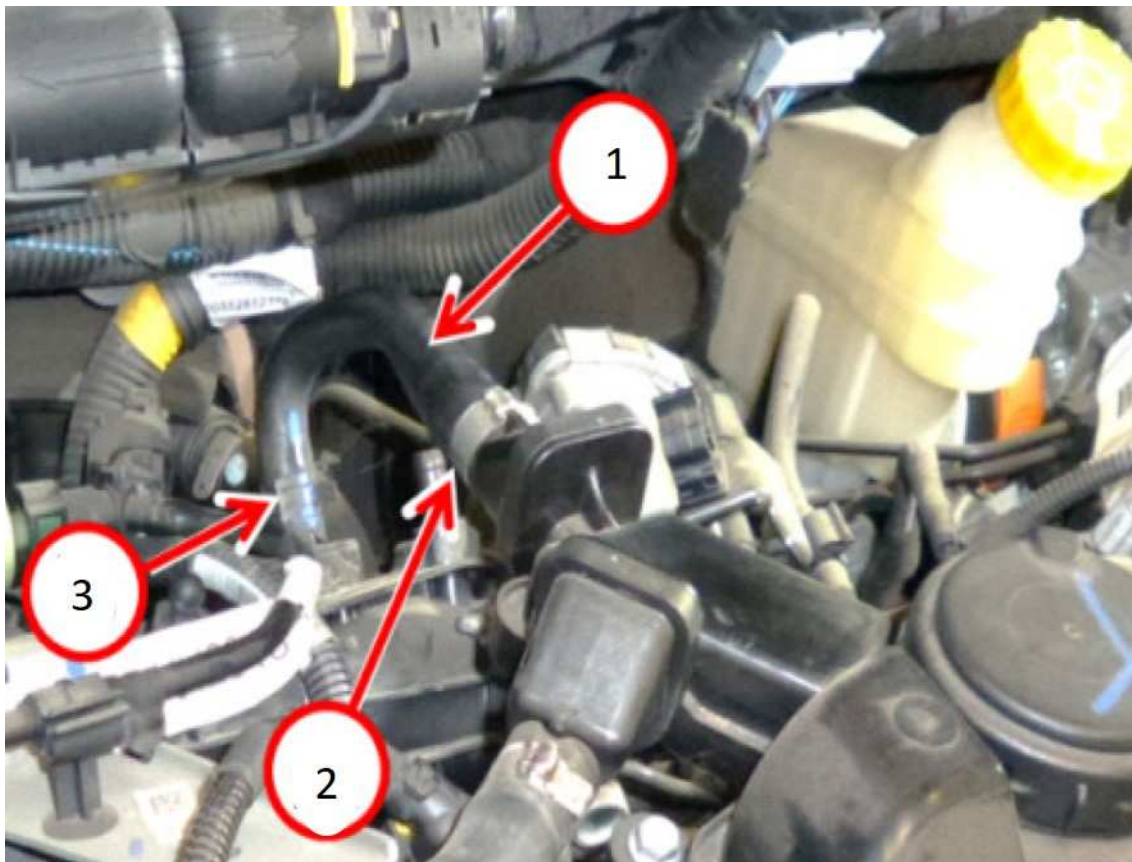
**Fig. 1**  
**Oil Vapor Inlet Tube**

- 1 - Oil Vapor Inlet Tube
- 2 - Clamp to be Discarded Do Not Reuse
- 3 - Clamp to be Reused Do Not Discard

1. Remove the engine cover. Refer to the detailed service procedures available in DealerCONNECT> Service Library under: Service Info> 09 - Engine, 1.4L I4 16V Turbo / Cover, Engine / Removal.
2. Remove the clamps, then remove the oil vapor inlet tube (Fig. 1) .

**NOTE:** The clamp at the vapor separator and tube can be discarded; the clamp at the engine must be kept and reused for reassembly (Fig. 1) .

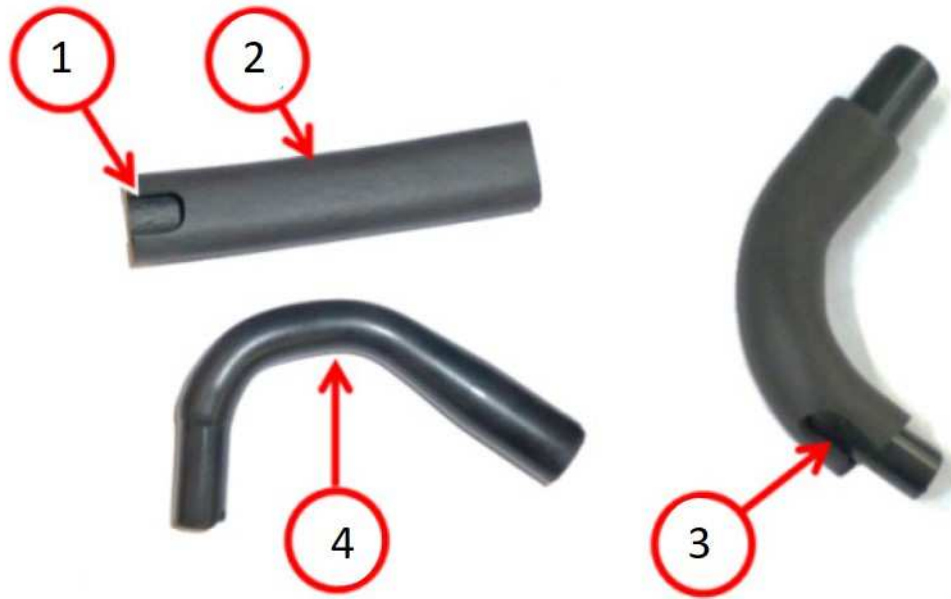
**Fig. 3**  
**Oil Vapor Sheath**

- 1 - Clamp Opening in the Sheath
  - 2 - Sheath
  - 3 - Sheath Installed with Clamp Opening Hole
  - 4 - Oil Vapor Inlet Tube
-

7. Install the insulating sheath over the tube so that the opening is at the restrictor inserted previously (Fig. 3) .

**NOTE: Use a soapy water solution to help the sheath slide.**

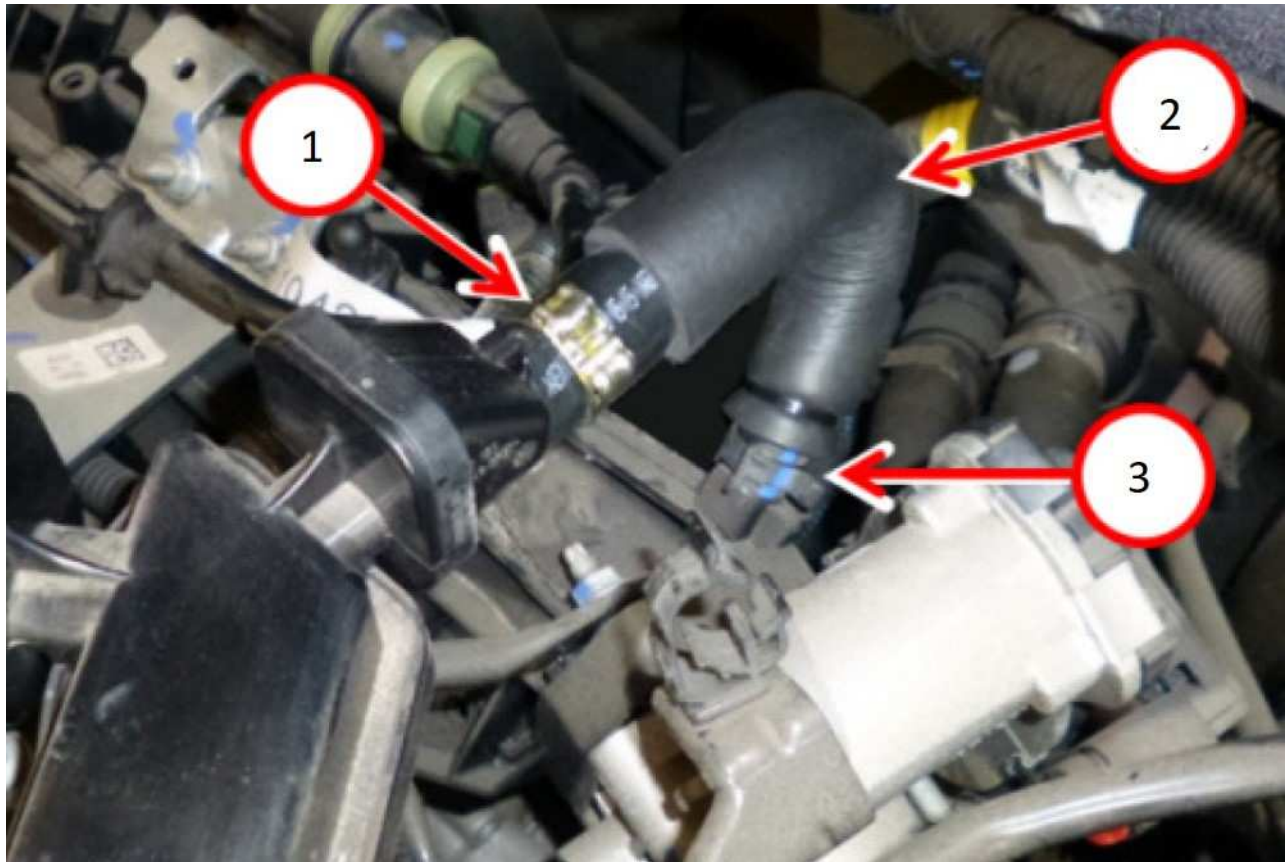
**Fig. 5**  
**Oil Vapor Inlet Tube**

- 1 - New Clamp at the Vapor Separator  
2 - Oil Vapor Inlet Tube  
3 - Clamp to be Reused at the Engine

9. Install the new engine oil vapor inlet tube with restrictor as follows (Fig. 5) :
- Install the tube to the intake air chamber and secure it with the clamp that was previously removed and saved (Fig. 5) .
  - Install the tube to the oil vapor separator and secure it with the new clamp (Fig. 5) .
