# Technical Service Bulletin

## 39 Four-wheel drive malfunction message, DTC C05ED00 is stored in the all-wheel drive control module

39 20 35 2051558/4 August 21, 2020. Supersedes Technical Service Bulletin Group 39 number 20-32 dated June 17, 2020 for reasons listed below.

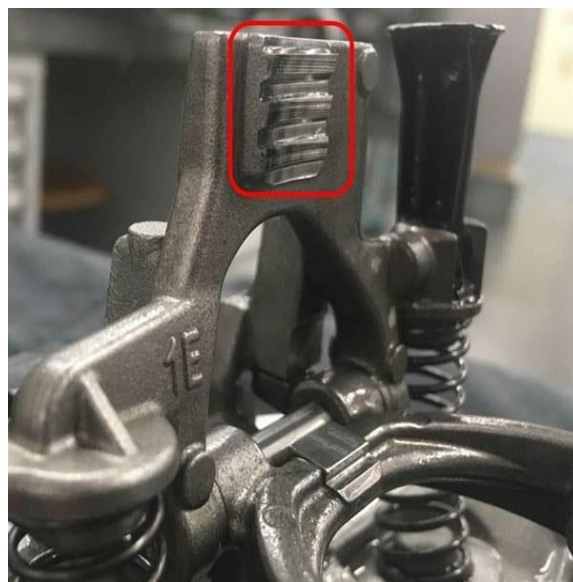
Quattro Ultra shift fork inside the rear differential is worn/faulty (Figure 1).

**Figure 1.** Worn/faulty shift fork.

Improved material in production
