# Service Bulletin

Bulletin No.: 19-NA-068

**Subject:** Malfunction Indicator Lamp (MIL) Illuminated, Intermittent Service Messages, Gauges May Be Erratic - DTCs U0073, U0121, U0100 and/or U0101 Set, G103 Inspection

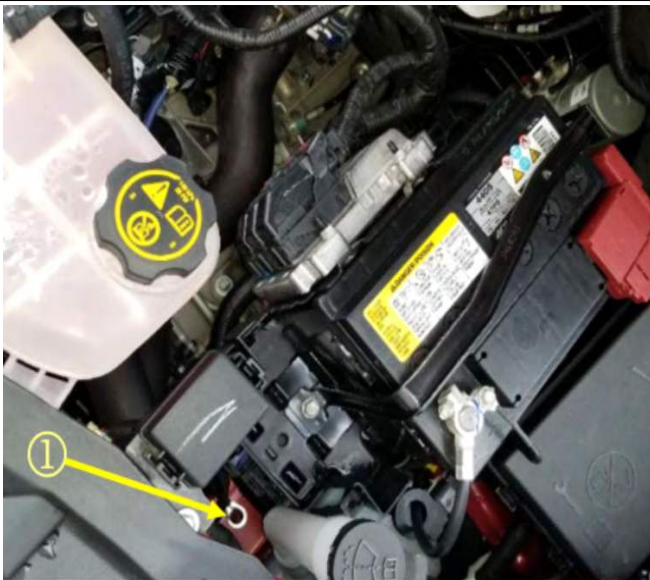
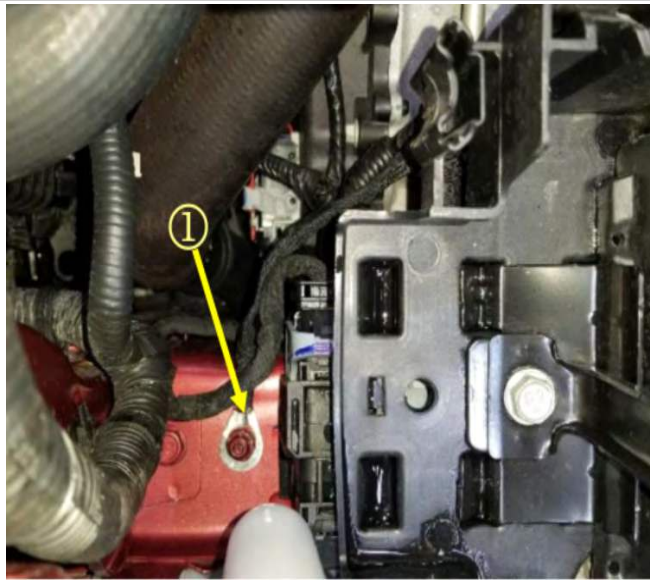
5300152

The cause of the condition may be a poor ground connection at G103 (1), located at the left front frame rail in front of the battery.

Perform inspection on ground G103; clean and/or remove paint from the grounds contact points and torque fastener to specification.
