# Service Bulletin

Bulletin No.: 20-NA-021  
Date: August, 2020

Subject: Intermittent Service Steering Column Lock message displayed with U0155 Set

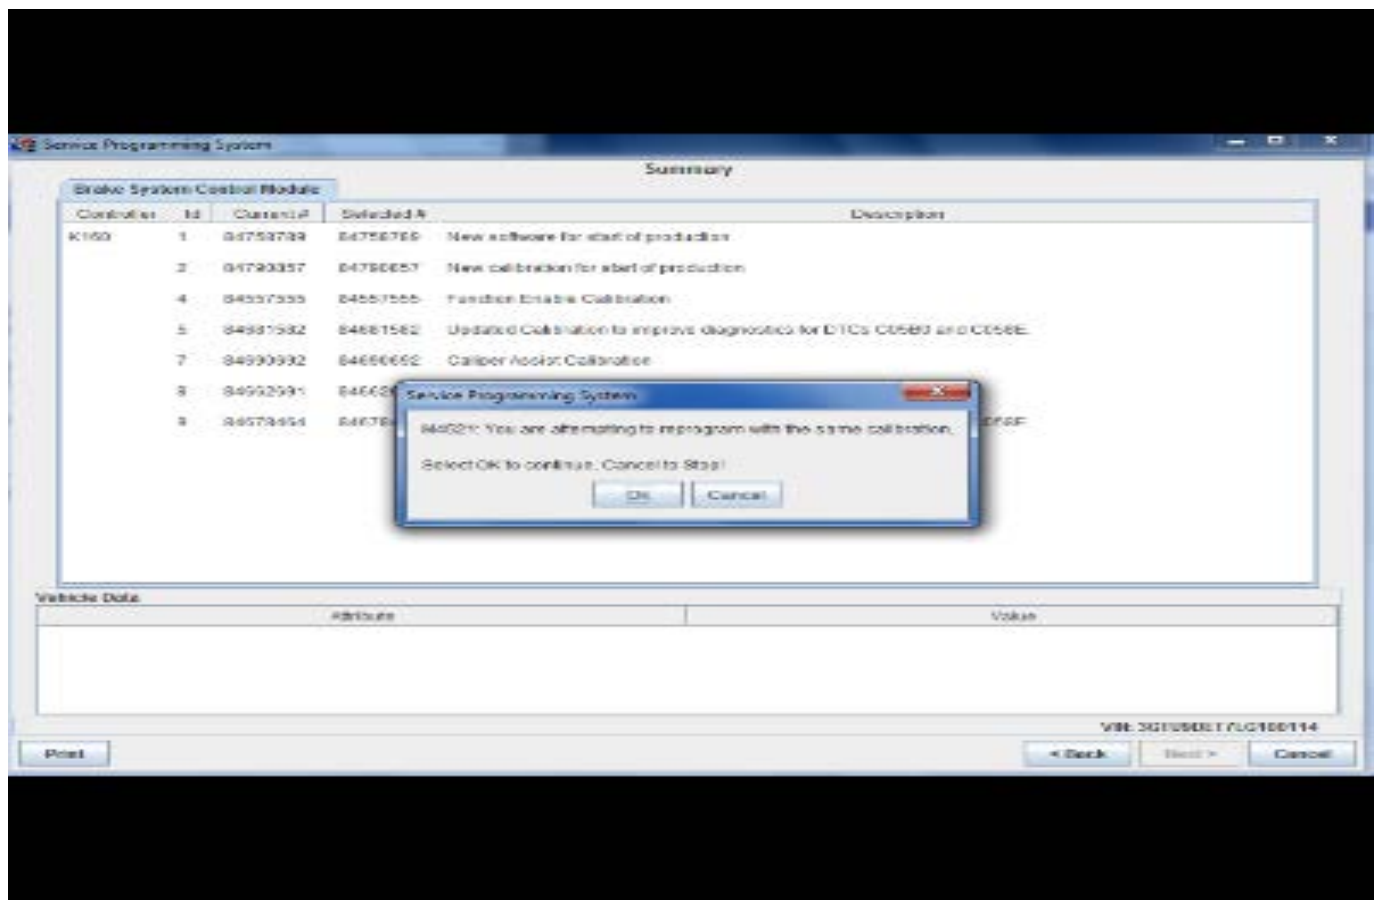
5431207

Important: If the Same Calibration/Software Warning is noted on the SPS screen, select OK and follow screen instructions. After a successful programming event, the WCC is located in the Service Programming System dialogue box of the SPS Summary screen. No further action is required. Refer to the Warranty section of the bulletin.

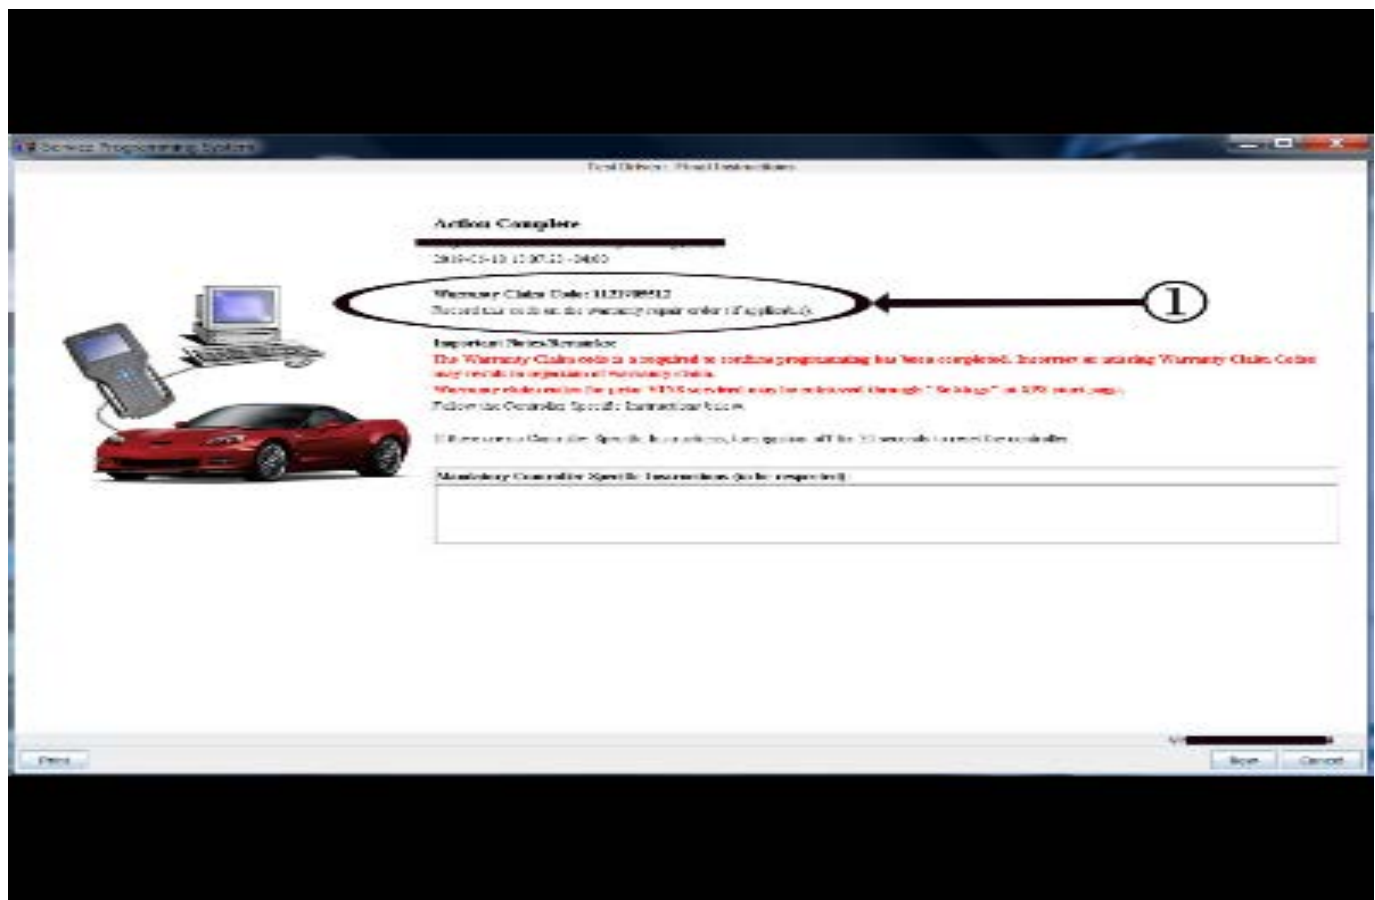
5431209

Important: To avoid warranty transaction rejections, you MUST record the warranty claim code provided on the SPS Warranty Claim Code (WCC) screen on the job card. Refer to callout 1 above for the location of the WCC on the SPS screen

2. Record SPS Warranty Claim Code on job card for warranty transaction submission.
