# Service Bulletin

Bulletin No.: 20-NA-135

**Subject:** Power Liftgate and/or Instrument Panel Cluster (IPC) Inoperative, No Audio, Malfunction Indicator Lamp (MIL) Illuminated - DTC P159F-00, U0184-00, U0198-00 and/or U1501-00 Set

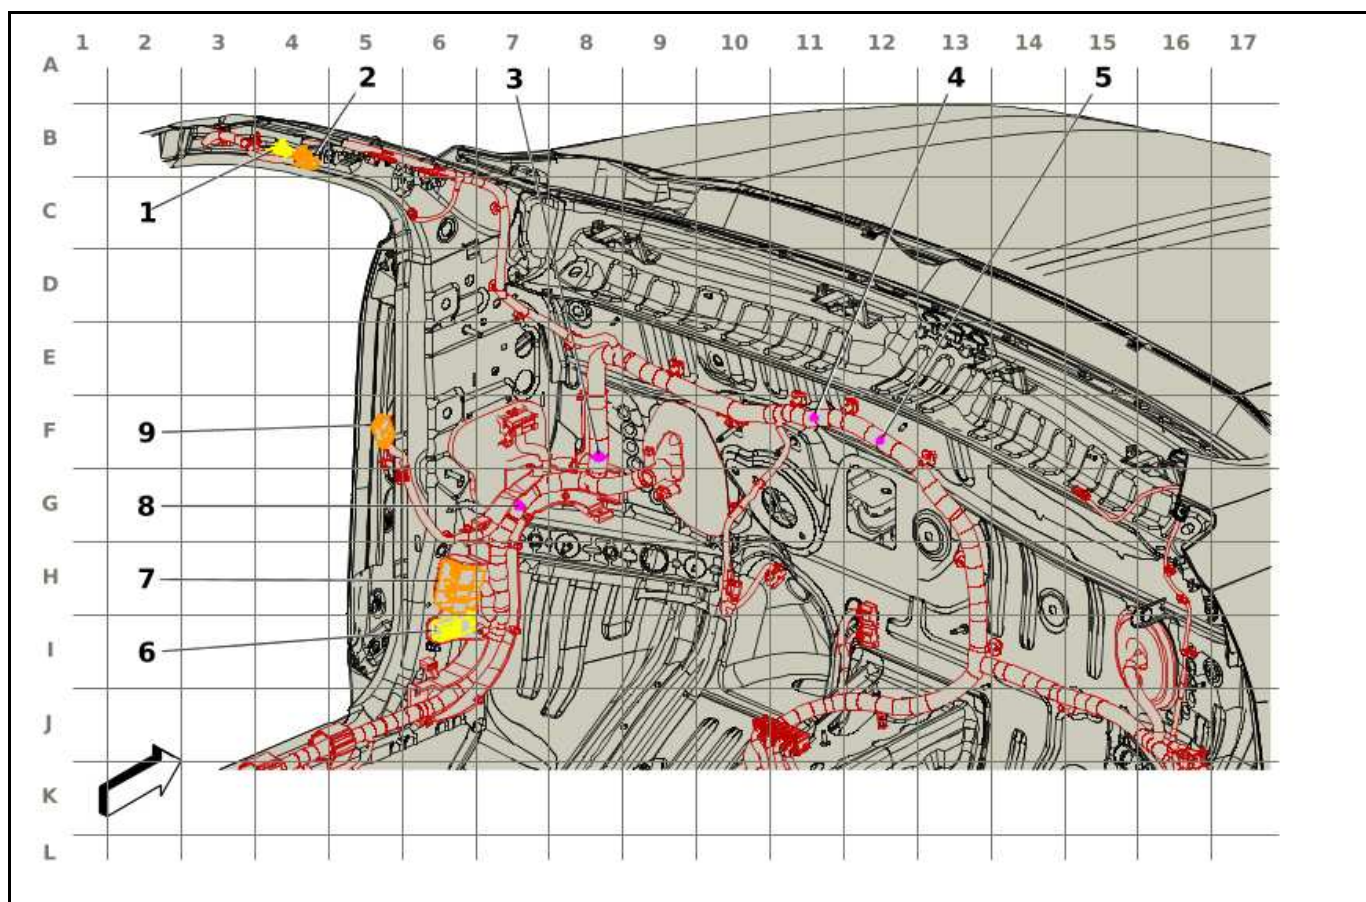
5437484

| Cause | The cause of the condition may be that the X200 connector was not fully connected and locked, resulting in an open circuit. |

Note: First inspect the X200 connection BEFORE disconnecting.

2. Inspect the X200 IP harness to Body harness connector (7), located at the lower Left A-Pillar, for possibly not being seated correctly.
3. Ensure that the wires are not twisted, not too taut, and the routing is correct.
4. Also ensure that the connection is correctly seated on all 4 sides.
5. Verify that the condition has been eliminated.
