# TECHNICAL SERVICE BULLETIN

## Illuminated MIL With DTC P203B - Urea Sensor Reprogramming

### Tool- Built On Or Before 04-Aug-2017

**20-  
2270**  
17 August  
2020

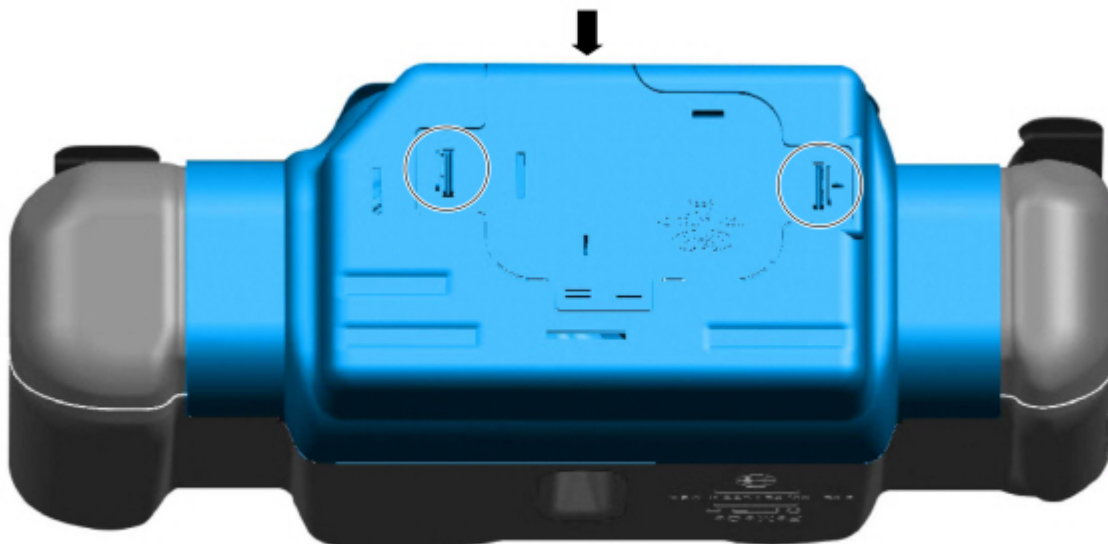
E341813

Figure 2 - Arrow indicates pushpin location, circles are the pinch tab locations

4. For chassis cab vehicles, remove the pushpin and pinch the tabs to open the access cover in the reductant tank cover to access the reductant level sensor/quality module. (Figure 2)

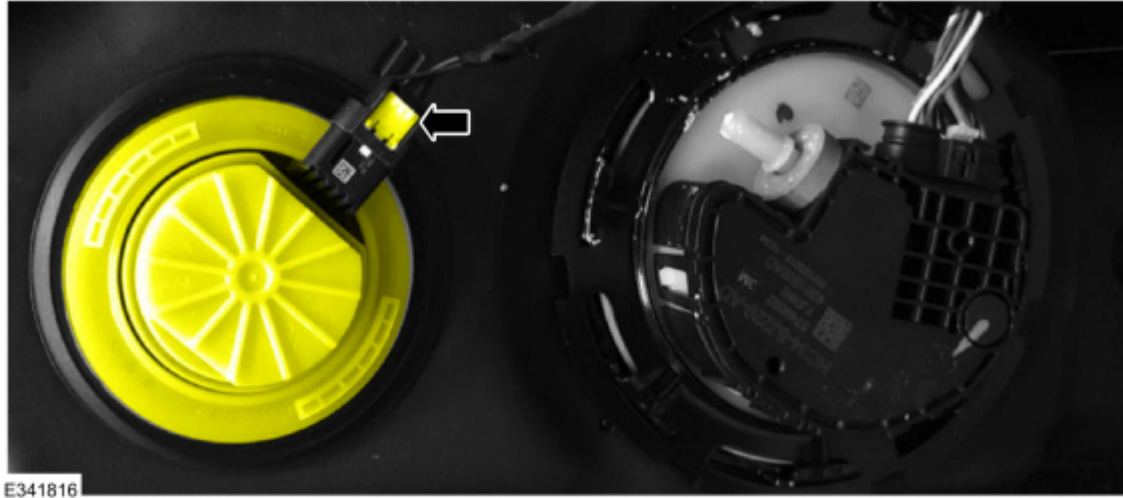
Figure 3 - Chassis cab shown, pickup similar - reductant level sensor/quality module highlighted with arrow pointing to white secondary lock tab

5. Locate the reductant level sensor/quality module. Carefully unlatch the white secondary lock, press the tab and disconnect the electrical connector from the reductant level sensor/quality module.

**NOTE: Use of a metal pick tool can allow for access to unlatch the white secondary lock and then press the tab by hand. (Figure 3)**

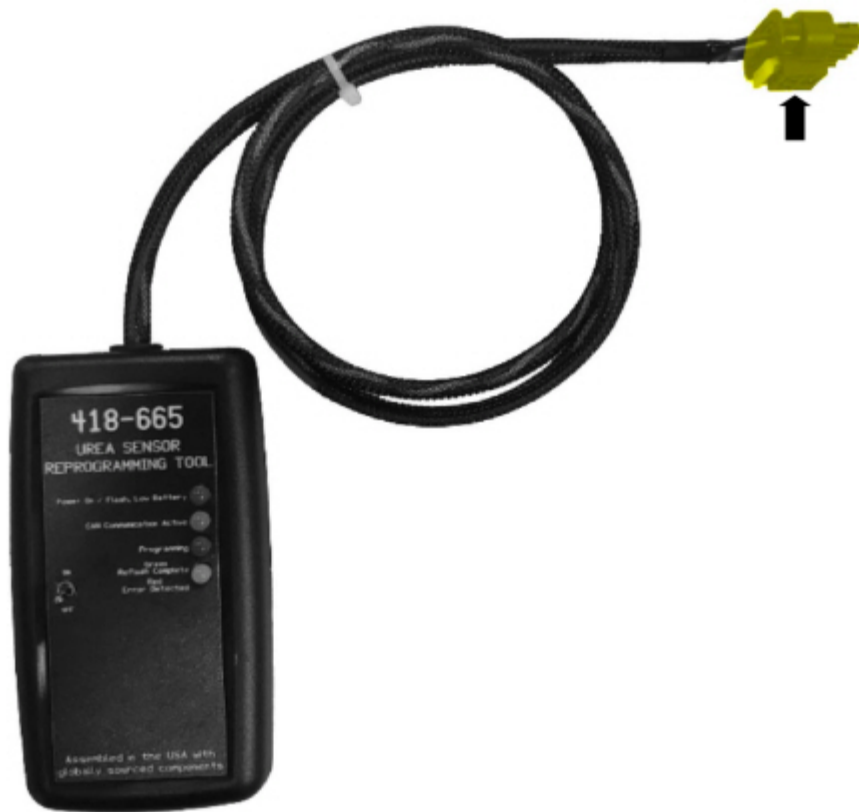
E341817

Figure 4 - Urea Sensor Reprogramming tool connector that goes to reductant level sensor/quality module

7. Connect the Urea Sensor Reprogramming tool (Rotunda tool number 418-665) into the reductant level sensor/quality module on the reductant tank.

**NOTE: When using the Urea Sensor Reprogramming tool for the first time, remove the plastic tab from the battery compartment to power the tool. (Figures 4-5)**

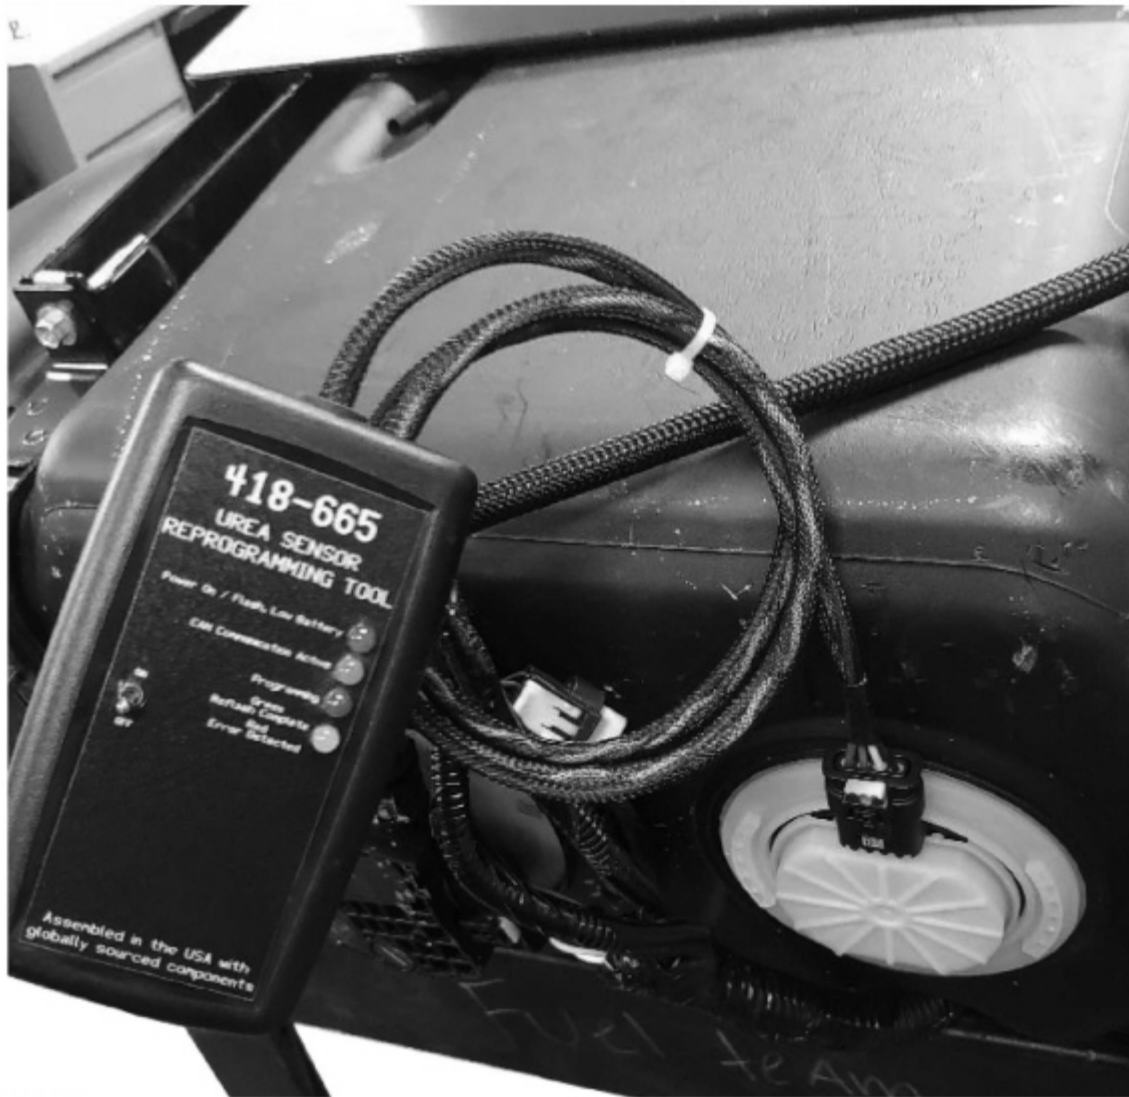
E341818

Figure 5 - Urea Sensor Reprogramming tool connected to reductant level sensor/quality module

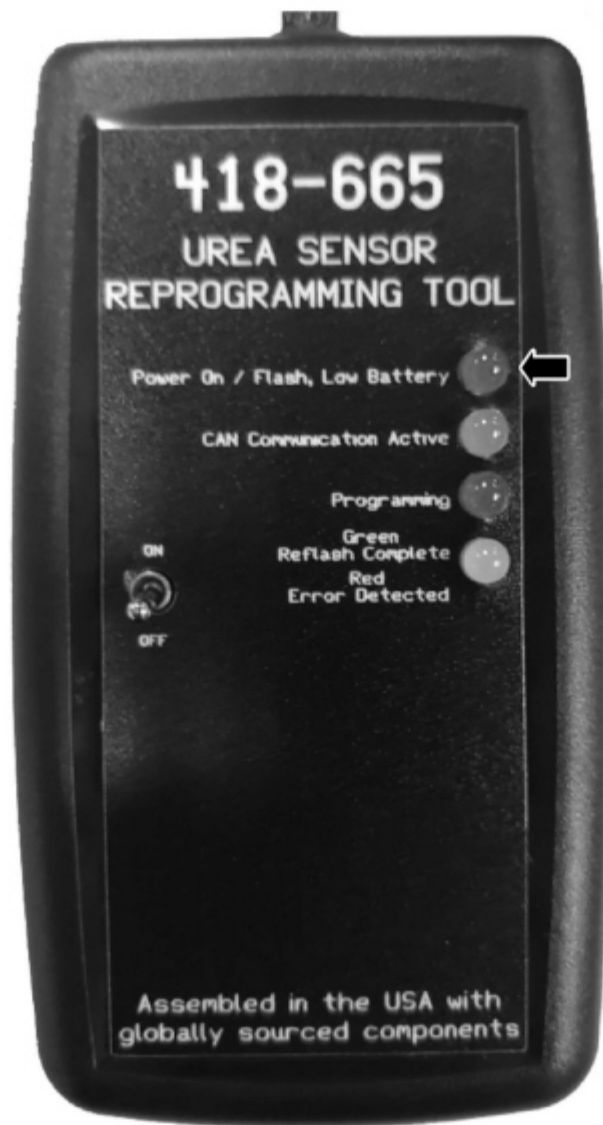
E341819

Figure 6 - Arrow indicates top green LED

8. Once the Urea Sensor Reprogramming tool is connected, move the toggle switch to the ON position. The top green LED light will illuminate and the software reprogramming process for the reductant level sensor/quality module will begin automatically. (Figure 6)

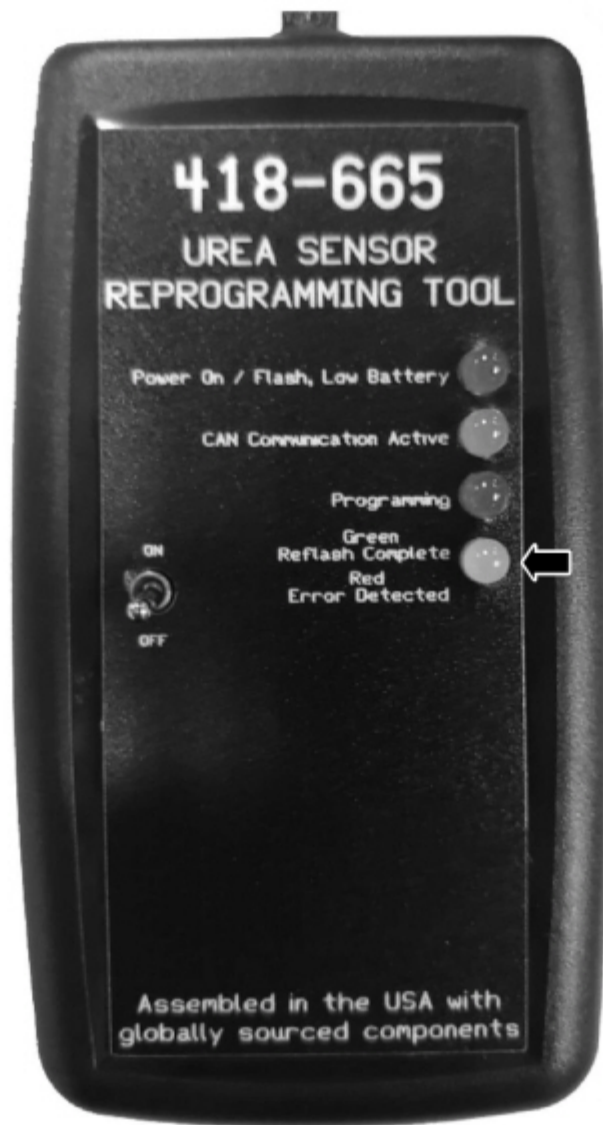
E341820

Figure 7 - Arrow indicates bottom LED

9. Allow up to 60 seconds for the tool to complete reprogramming the reductant level sensor/quality module.
10. Does the bottom LED on the Urea Sensor Reprogramming tool illuminate green? (Figure 7)
  - (1). Yes - the reductant level sensor/quality module has been successfully reflashed. Disconnect the Urea Sensor Reprogramming tool and reconnect the reductant level sensor/quality module wire harness. Install the reductant tank cover or reductant tank access cover onto the reductant tank. Repair is complete.
  - (2). No - proceed to Step 11.
