| | GROUP<br><b>FUE</b> | MODEL<br><b>2019-2020MY<br/>Forte (BDm)</b> |
| | NUMBER<br><b>047</b> | DATE<br><b>August 2020</b> |
| <b>TECHNICAL SERVICE BULLETIN</b> | | |
| <b>SUBJECT: NU 2.0L MPI MIL ON DTC P010100 AND/OR P010600<br/>AND/OR P006800 LOGIC IMPROVEMENT</b> | | |

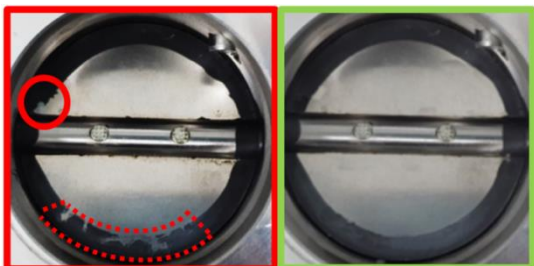
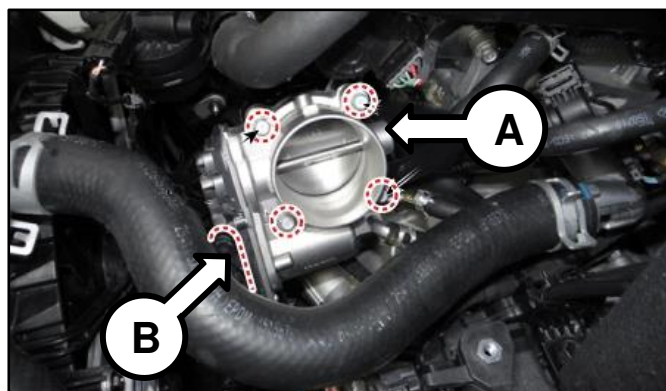
The ETC throttle plate features a special coating (D) around the outside diameter of the plate. **DO NOT** use a wire brush and attempt to remove the coating.

**DO NOT** wipe off the throttle plate coating (D), doing so (as shown below) may cause an idle performance issue.

1. Remove the ETC (A) assembly by referring to the “Engine Control/Fuel System → Engine Control System → ETC (Electronic Throttle Control) System → Repair procedures” chapter in the applicable Shop Manual on KGIS.

Using a clamp tool, clamp the ETC coolant hose (B) to reduce coolant loss.

2. Using UM040 CH010 (or equivalent) cleaner, spray onto a lint free towel, then wipe the inside wall (C) of the ETC inlet to remove any carbon deposits.
