MODEL  
2021MY  
K5 (DL3a)

NUMBER  
048

SUBJECT: **SERVICE ACTION: LOW PRESSURE FUEL LINE ROUTING  
INSPECTION AND/OR ADJUSTMENT (SA432)**

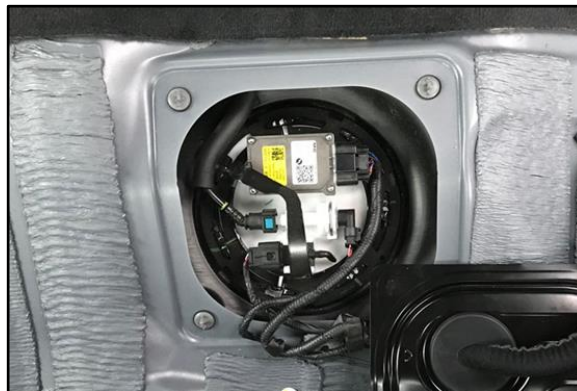
This bulletin provides information to inspect and if necessary, adjust the low pressure fuel line routing on some 2021MY K5 (DL3a) vehicles with GAMMA 1.6L T-GDI engine, produced from March 27, 2020 through July 23, 2020 which may NOT have been properly routed during assembly. The incorrectly routed fuel line may cause a Malfunction Indicator Lamp (MIL) with DTC P0087 and the vehicle may exhibit poor acceleration and/or hesitation during low speed operation. Kia is requesting the completion of this service action on all affected vehicles, including dealer stock, prior to delivery. Before conducting the procedure, verify the vehicle is included in the list of affected VINs.

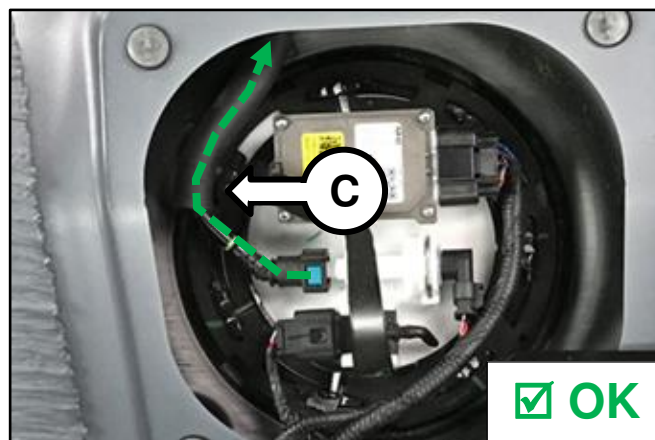
- 3a. Locate the low pressure fuel line (C) coming from the fuel pump module. The fuel line should be routed alongside the fuel pump module retaining ring and NOT crossed over the Fuel Pump Control Module (FPCM), towards the front of the vehicle.

Fuel line **is** routed properly (OK).

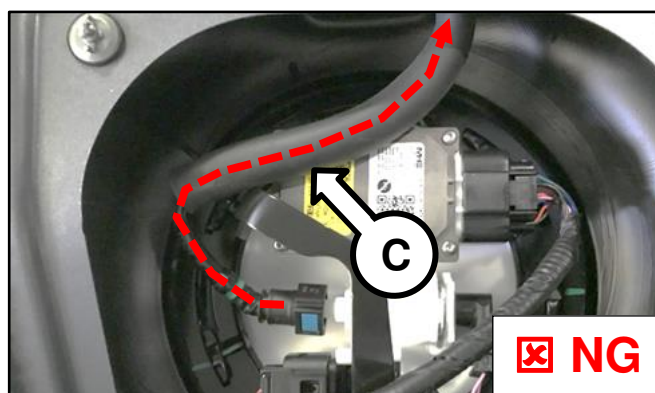
Fuel line **is not** routed properly No Good (NG).

- If the fuel line **is not** routed properly and/or a kink is found, **(NG)**, then proceed to the 'Repair Procedure' outlined below to correct the routing of the fuel line.
- If the fuel line **is** routed properly and no kink is present, **(OK)**, then this service action is complete.

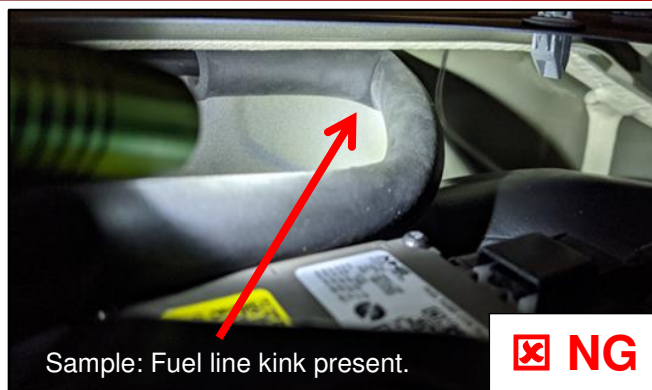
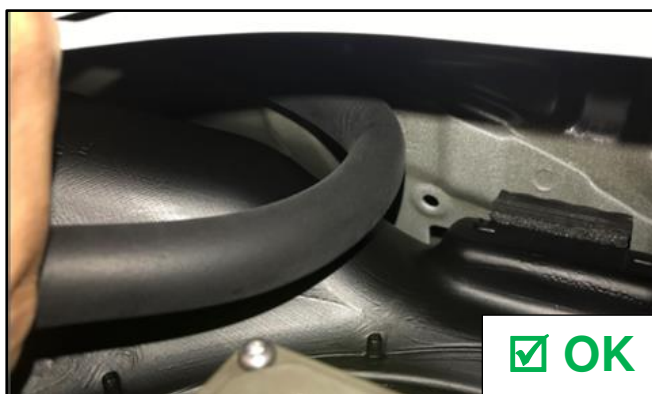
3b. Inspect the low pressure fuel line for kink(s) between the fuel tank and the floor pan.
