Preliminary Information

PIP5498M SES Lamp P050D P0300 Setting On A Cold Start And/Or a Run Rough Warm with No codes

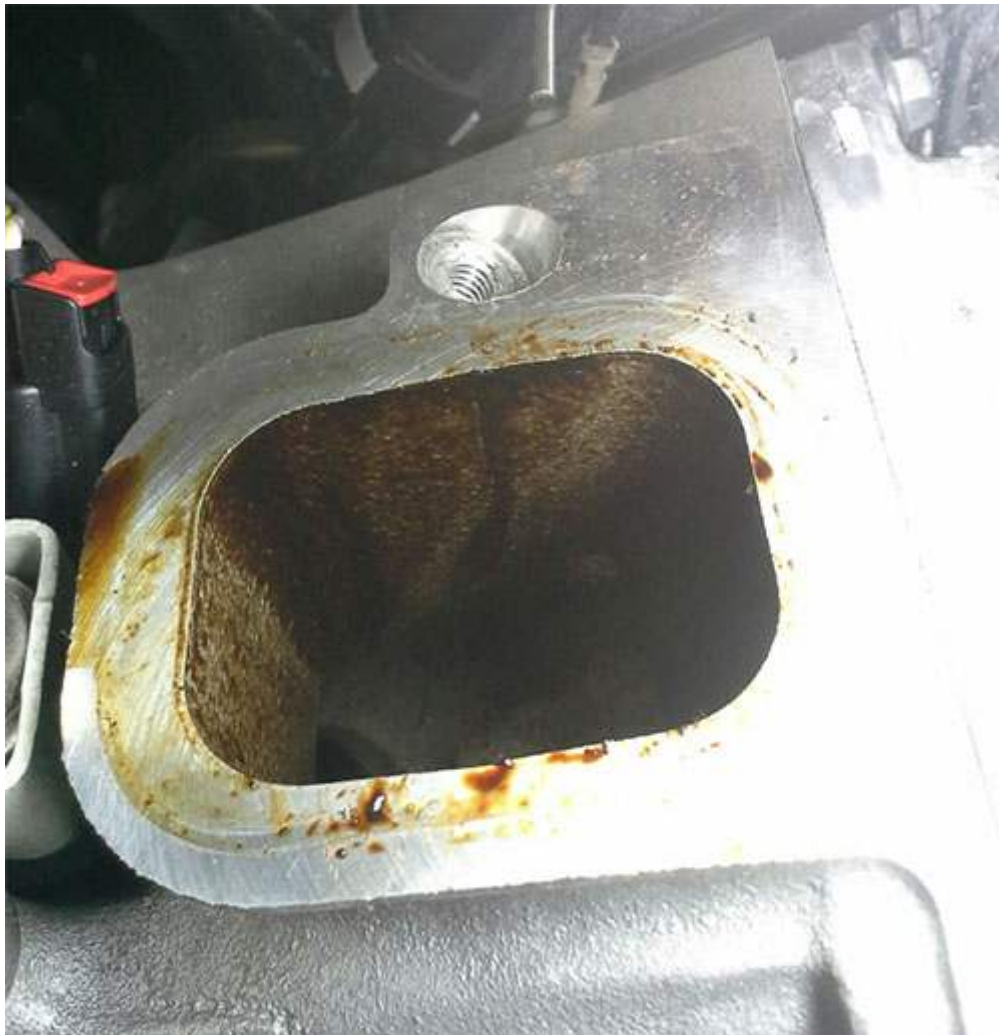
If the head casting line is the concern the intake port will be wet with a coolant oil mix.

This could be the cause of a running rough warm concern with or without codes.

The location of where the coolant is running down in the port will also look washed down.

If this is found the cylinder head will need to be replaced.
