# Service Alert

**DTC U2050:55 STORED AFTER REPLACING OR REPROGRAMMING BCM**

**Service Alert No.:** SA-003/20

2019-2020 Mazda3  
2020 CX-30

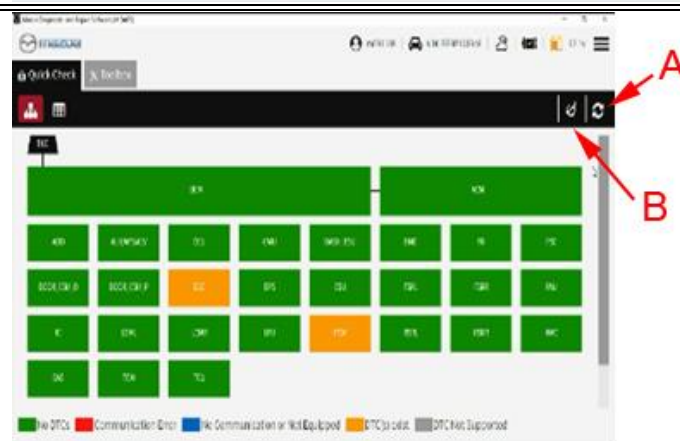
**CAUTION:** If the engine is not started, DTC P2610 is stored and cannot be erased.

6. Select Quick Check (A), then start the engine and select the DTC Clear icon (B).
