# Service Alert

| <b>Subject:</b><br><br>"IN-VEHICLE NETWORK MALFUNCTION" INSTRUMENT CLUSTER<br>WARNING MESSAGE | <b>Service Alert No.:</b> SA-029/20 |
| | <b>Last Issued:</b> 09/10/2020 |

2019-2020 Mazda3  
2020 CX-30

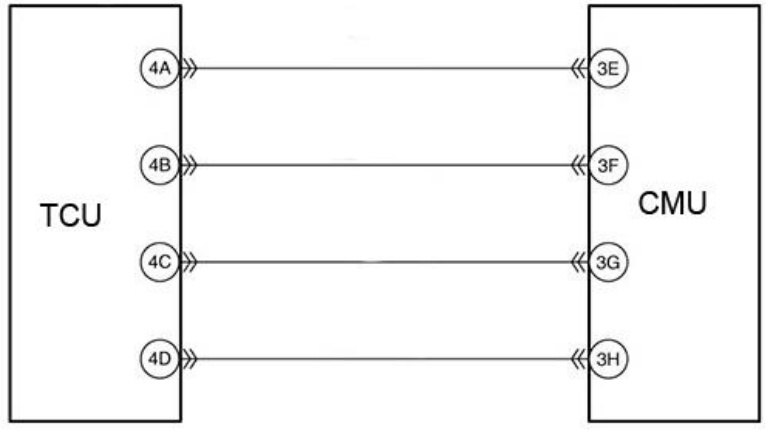
| DTC | Action |
|---|---|
| B1252:87 | Check USB cable connections between TCU and CMU. |

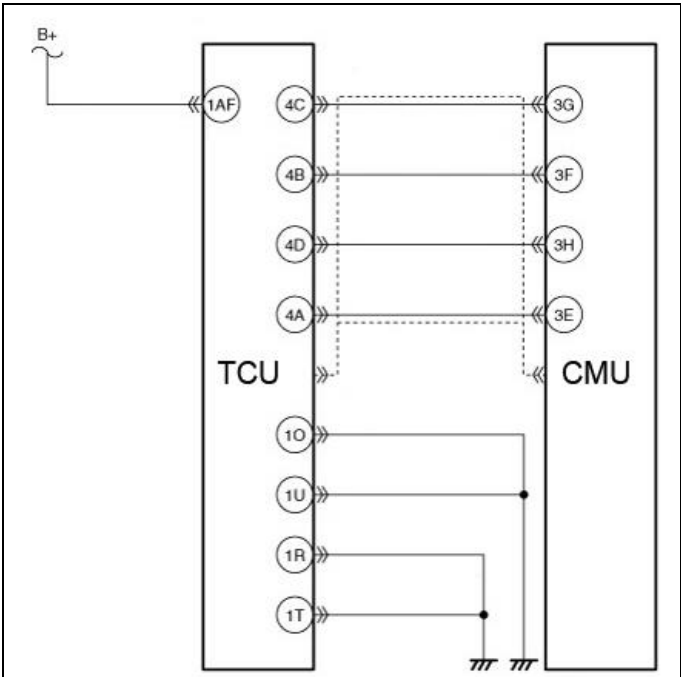
| U0198:00 | <p>Check USB cable connections between TCU and CMU.</p> |

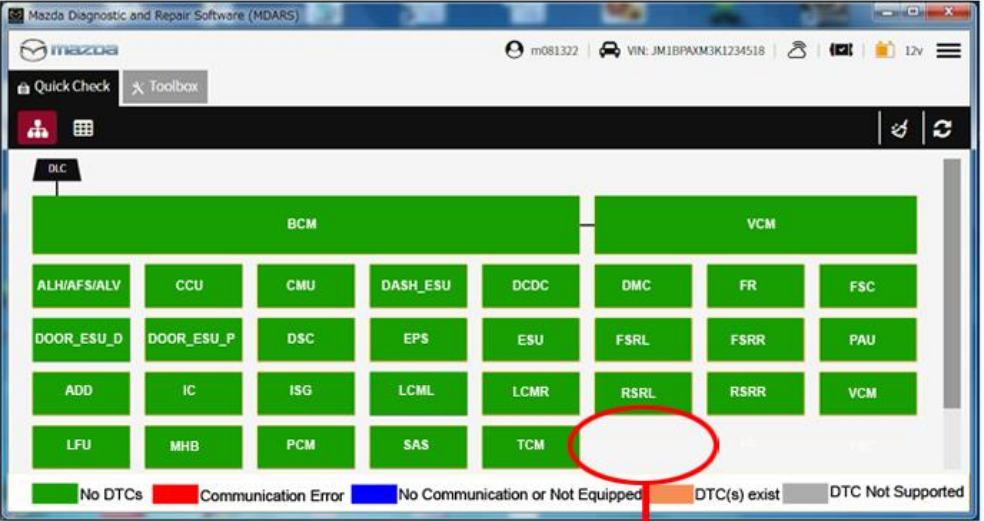
| d. | IG ON while refreshing DTC. | |

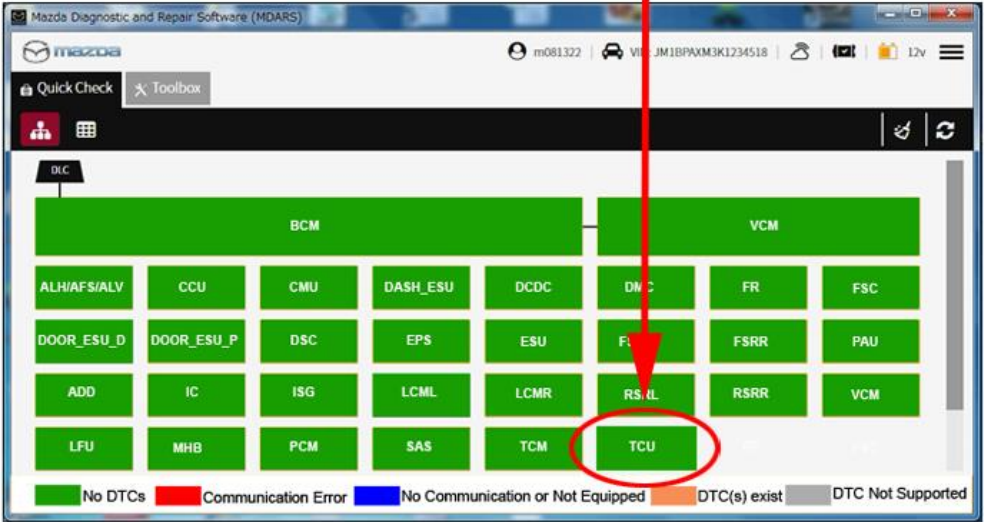
| e. | TCU now appears. Go to step 3. | <p style="text-align: center;">TCU appears</p> |
