# Service Alert

**ENGINE NO START WITH DTC B13D3:97 STORED DUE TO  
ACTIVATION OF PACEMAKER FUNCTION**

**Service Alert No.:** SA-048/20

**Last Issued:** 09/21/2020

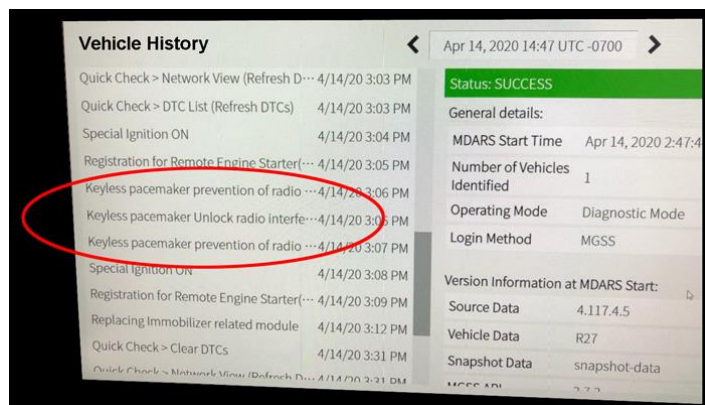
Some customers may experience an engine no start condition where the engine will only start by holding the key transmitter over the Start/Stop button. This may be caused by an accidental activation of the keyless pacemaker function.

Example of Keyless Pacemaker Function activated:

- YES: Deactivate the Keyless Pacemaker Function.
- NO: This service information does not apply. Go to MGSS [DTC B13D3:97 \[BODY CONTROL MODULE \(BCM\)\]](#).
