# Technical Service Bulletin

| <b>Topic</b> | Bentayga W12 - Bentley dynamic ride system fault displayed in Driver Instrument Panel |
| <b>Transaction No.</b> | 2051553/2 |
| <b>Release date</b> | Sep 28, 2020 |

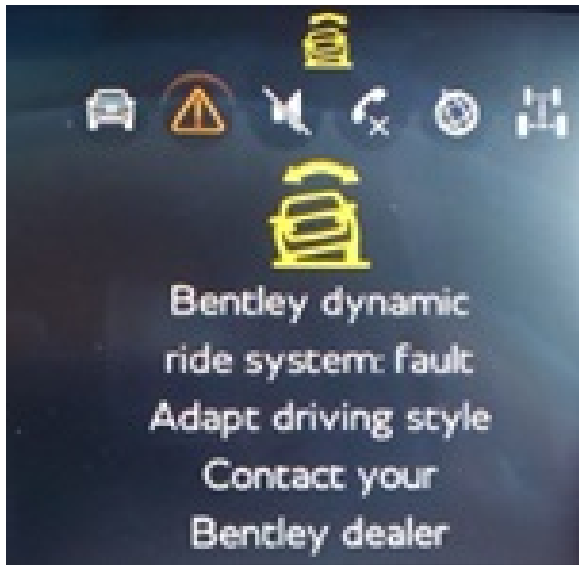
Bentley dynamic ride system fault displayed in the Driver Instrument Panel.

Diagnostic Trouble Code/s (DTC's) stored in the Battery Energy Control Module 2 (Super capacitor) The following DTC's relating to Hybrid EV Battery Temp Sensor system faults can be logged either individually or combined - P0A1F00 - P0A9E00 – P0AC800 - P0ECA00

The Super capacitor part number must be checked, should the part numbers be as shown below and the symptoms/DTC's are as previously described please carry out the instructions within the Measure section of this TPI

Following a successful update, the part number will change to 4M0.915.169.F with Software version 114
