## Technical product information

| <b>Topic</b> | New Continental GT, GTC and Flying Spur - Suspension Warning Lamp |
| <b>Transaction No.</b> | 2059172/4 |

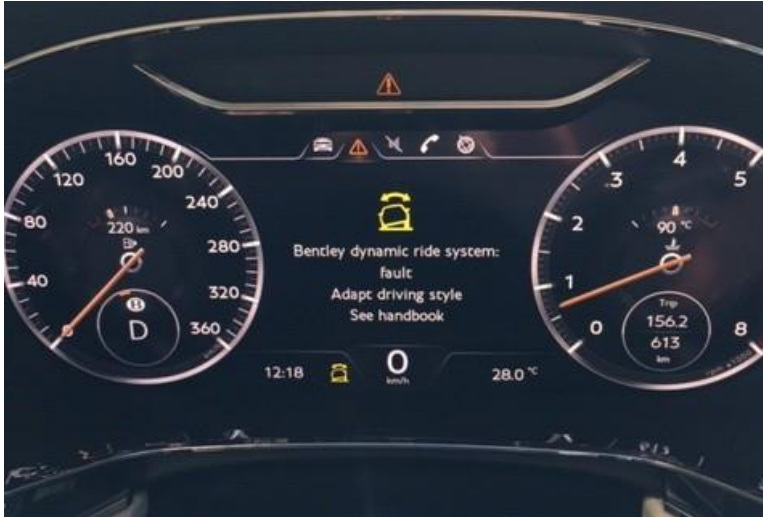
Suspension warning lamp illuminated on Driver Instrument Panel (DIP).

"Bentley dynamic ride system: *fault - Adapt driving style - See handbook*" displayed on DIP.

Red or yellow Suspension warning lamp illuminated on DIP.

Diagnostic Trouble Code (DTC) *U005600: Vehicle communication BUS D performance, Symptoms 12689537, 12689541 or 12689542* stored within address's *0074 - Chassis Control, 00D4 – Roll Control System 1 or 00D5 – Roll Control System 2*.

Various Suspension related DTC's stored within address's *0074 - Chassis Control, 00D4 – Roll Control System 1 and 00D5 – Roll Control System 2*.
