ITB17-042c

September 14, 2020

## INFINITI; DTC P0456 CAUSED BY EVAP LEAK AT VENT CONTROL VALVE O-RING

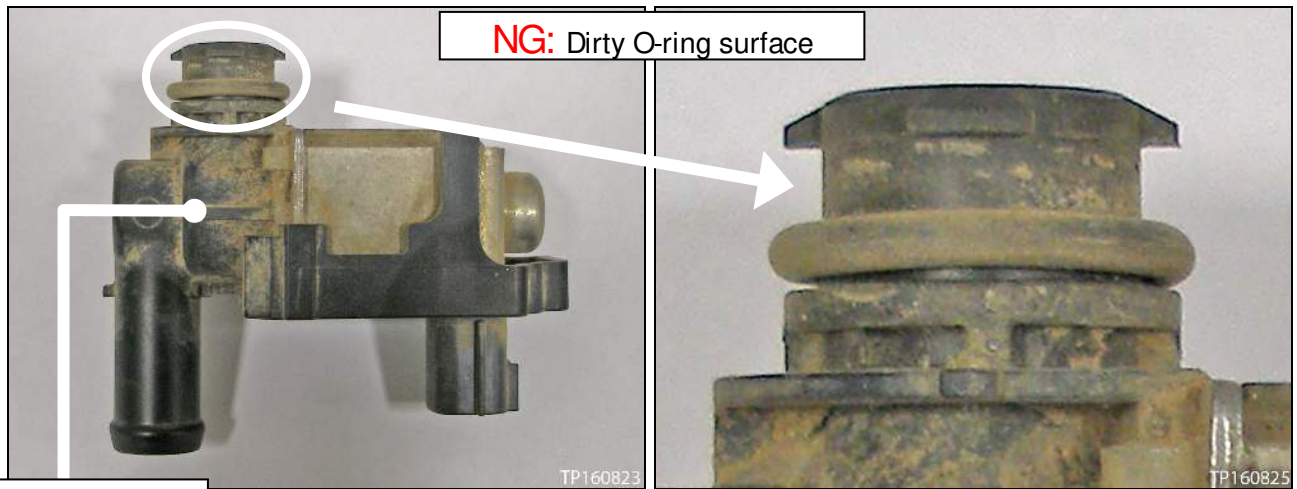
Figure 1

Vent control  
valve

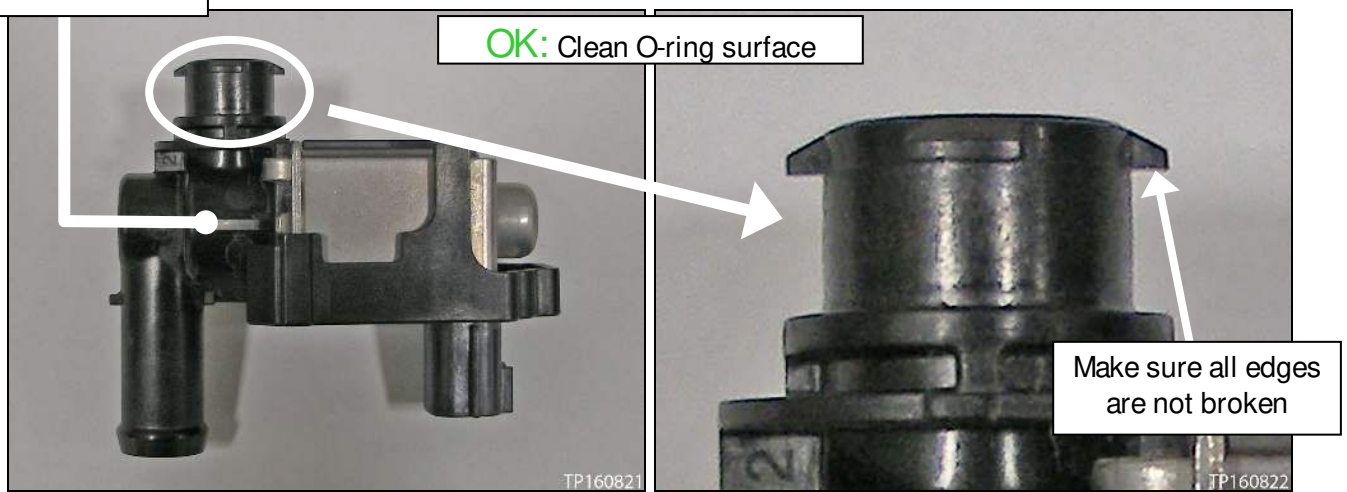
Figure 3

Where vent control valve  
mounts in canister

Canister

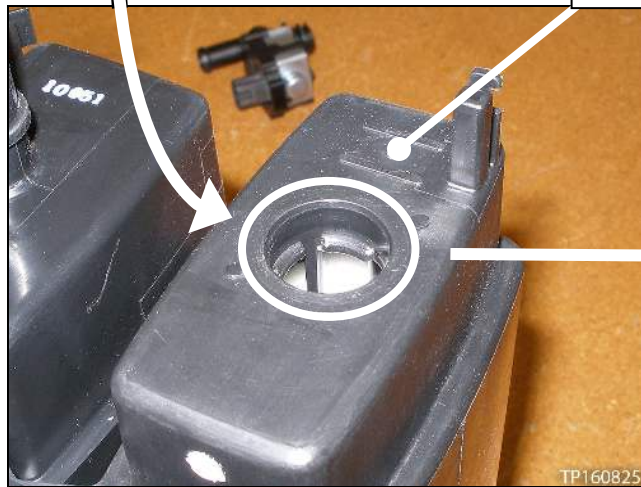
Figure 5

This surface must  
be clean all around
