# SERVICE BULLETIN

EC20-022

NTB20-062

## 2020 TITAN/TITAN XD; MIL ON WITH P2096, P2097, P2098 OR P2099 STORED

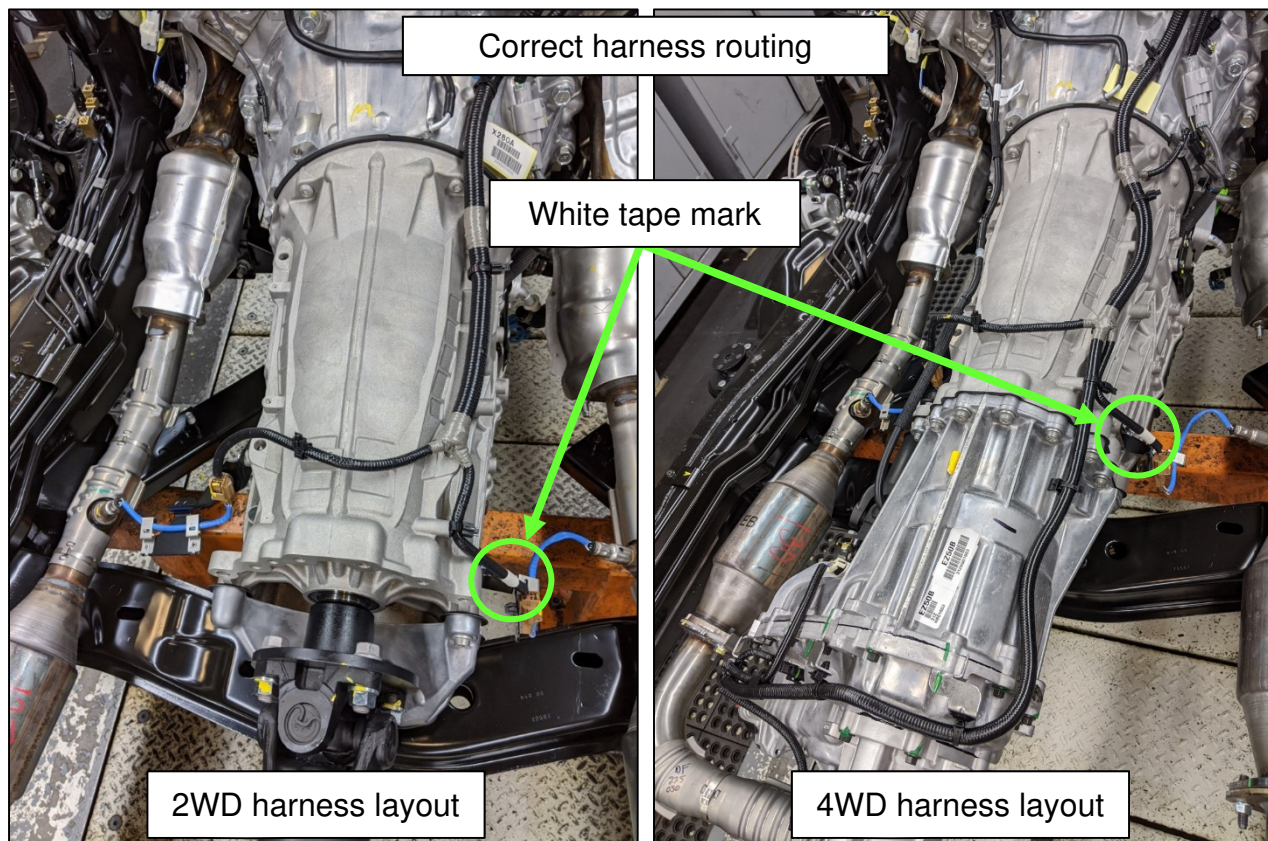
If the following DTCs are stored together, it is possible that the O2 sensor harness routing at the transmission has been unintentionally swapped between bank 1 and bank 2.

**NOTE:** The correct wiring harness routing, shown below, should run along the right side of the transmission, with the white tape mark of the rear O2 sensor on the passenger side as shown in Figure 1 for 2WD and Figure 2 for 4WD.

Refer to Figure 1 for 2WD and Figure 2 for 4WD on page 2, for the correct routing of the related wiring harness.
