Preliminary Information

PIT5759E Service Safety Restraints System With DTC B14DC SYM 1B and/or 13

| Brand: | Model: | Model Years: | VIN: | | Engine: | Transmissions: |
|---|---|---|---|---|---|---|
| Chevrolet | Tahoe | 2021 | All | All | All | All |

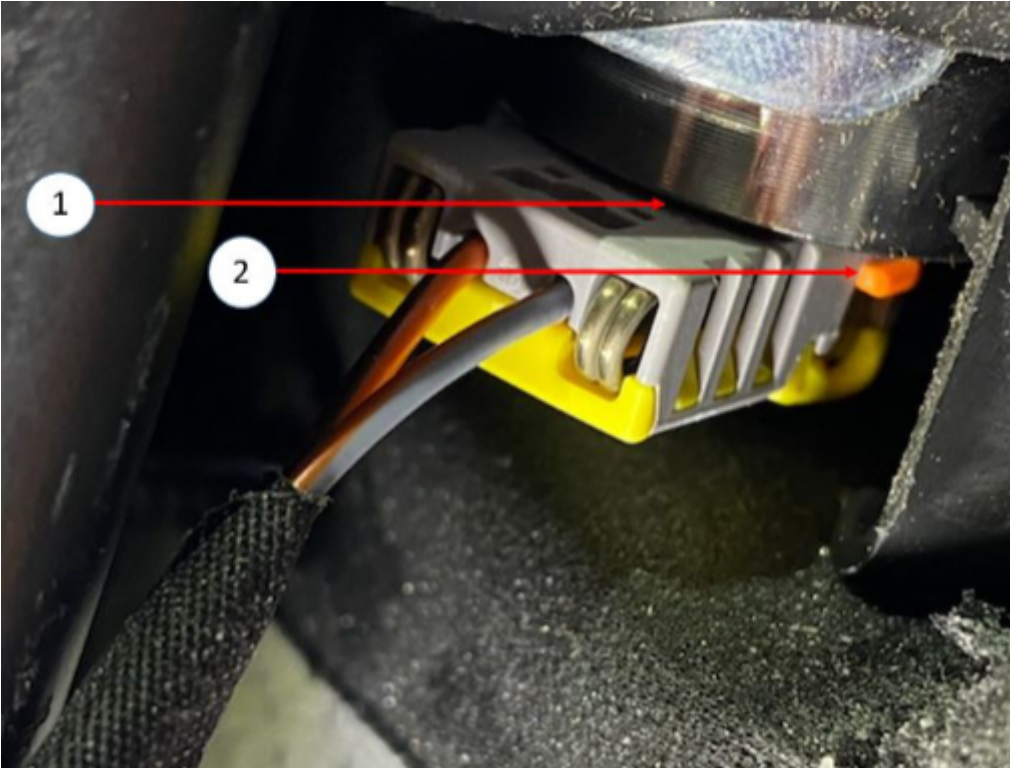
| Condition | Some customers may comment on a "Service Safety Restraints System" message displayed on the DIC. When checking for DTCs, a B14DC symptom 1B and/or 13 will be set in the K36 Restraints Control Module. This DTC is for an open or high resistance in the F106DA Driver's front seat inboard airbag deployment loop. |
| Cause | High resistance at the F106DA Driver's front seat inboard air bag connector. |

- Cut off the old air bag connector and splice in the new pigtail connector using two DuraSeal splice sleeves per the Wire-to-Wire Repair located in SI, Document ID 5214974.
- Reconnect the F106DA Driver's front seat inboard air bag connector (shown below) and make sure it is fully seated tight up against the airbag (1). Also, make sure the orange CPA is fully seated (2), as shown below.
- Reinstall the driver's inboard air bag and torque the fasteners to 7 Nm (62 lb in).
- Reassemble the seat and use GDS2 to monitor the deployment loop 13 resistance. Verify the resistance is within the normal range and the DTC does not return.
