## STAR ONLINE PUBLICATION

**Case Number:** S2008000137

**Symptom/Vehicle Issue:** Airbag Light Is On Or Power Door Locks Inoperative. DTC's U113D-00, B25AF-2A, B1830-11, B182C-11, And B007F-11 May Be Present.

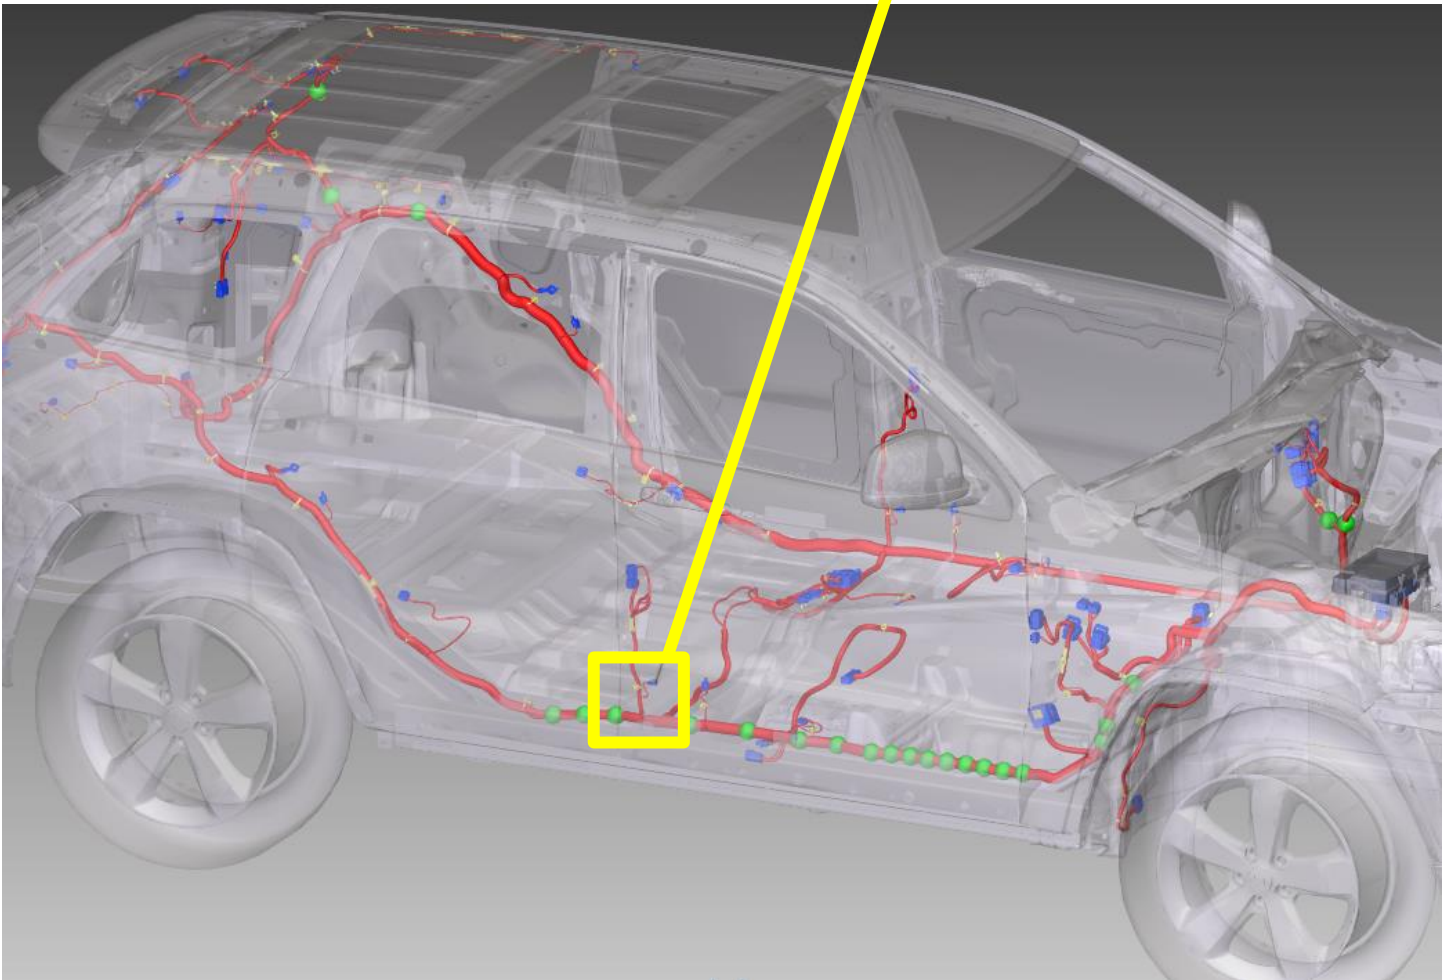
### Passenger B-Pillar Body Cutout Location

**Discussion:** The vehicle body harness may have been pinched at the bottom of the passenger side B-pillar in between the trim retainer and the designated body cut out. The Airbag Light may be on and/or Power Door Locks may be inoperative. Some or all of following DTC's may be present.

**Repair:** If possible, repair the wires using standard procedures. If necessary, replace the body harness. Reroute the harness to avoid the body cutout. The application of felt tape around the cutout can be used to further protect the harness.

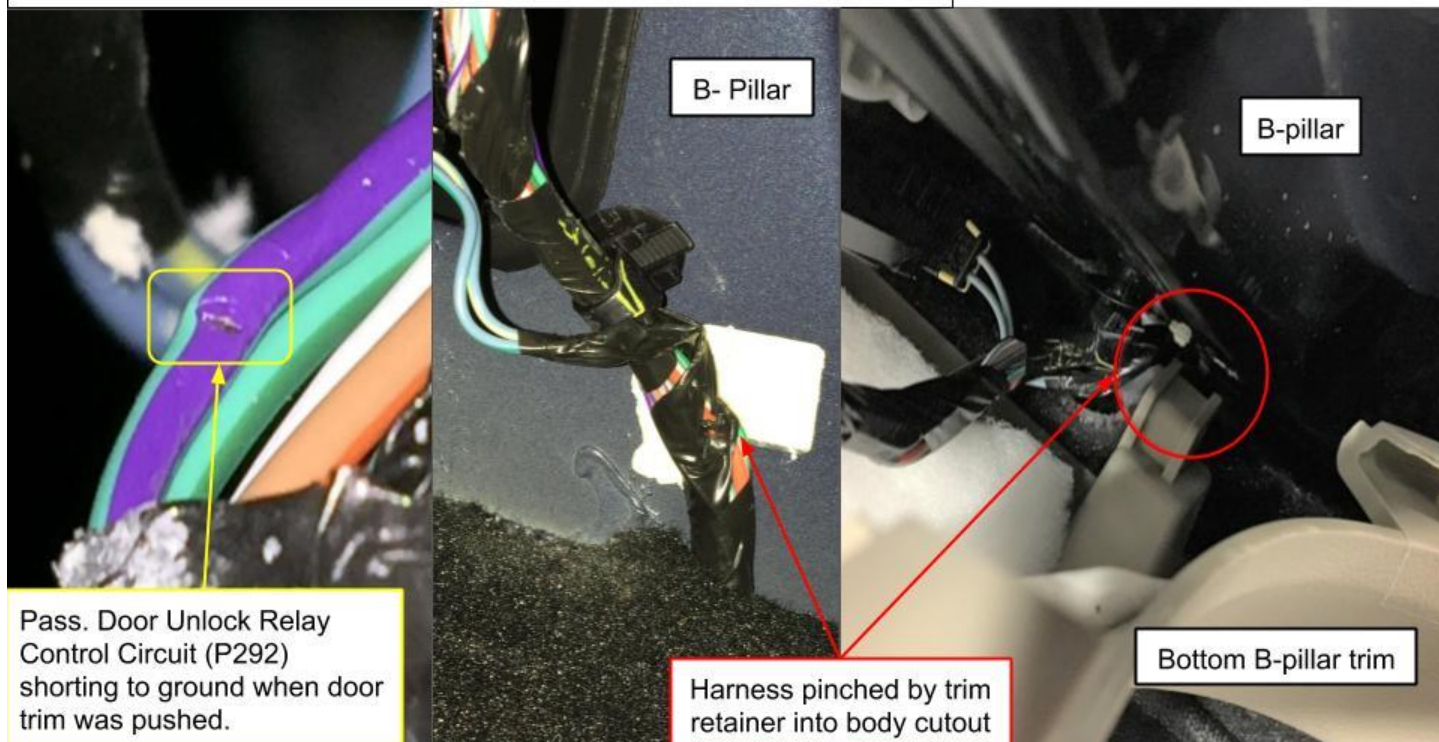
### Customer Concern: Power door locks are in INOP

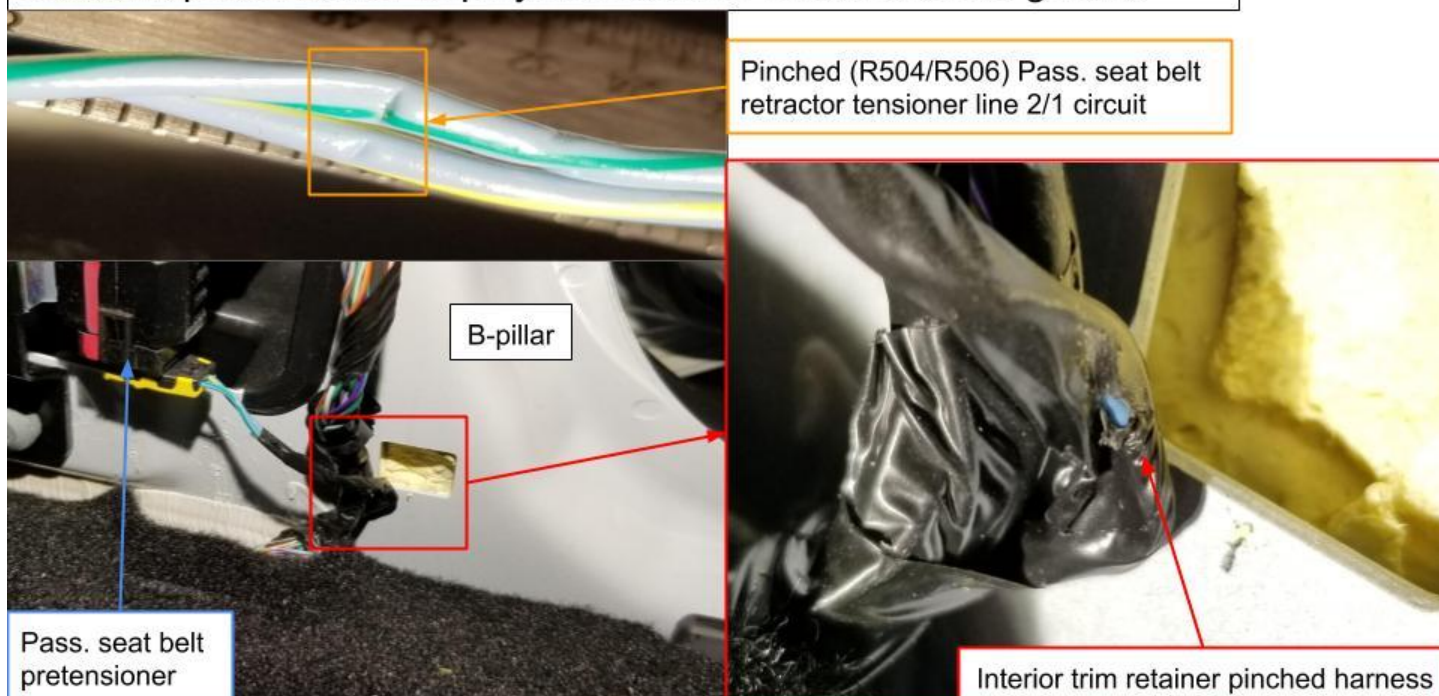
**Customer concern:** Airbag light is on - active B007F-11 passenger seat belt pretensioner deployment control circuit short to ground
