# Service Bulletin

Bulletin No.: 17-NA-305

Subject: Malfunction Indicator Lamp (MIL) Illuminated – DTCs P0615, P0617, P305C, P305D, P305E and/or P3054 Set

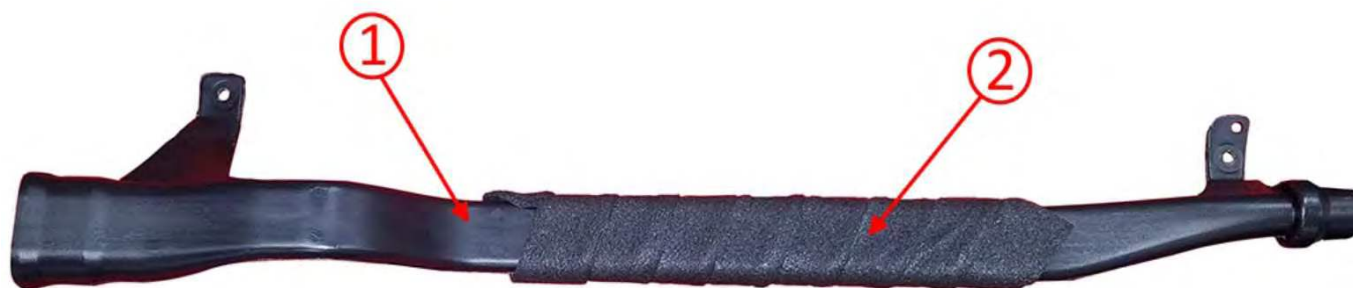
| Cause | This condition may be caused by condensation on the cooling duct, used for the charging pad, dripping water on the DC/DC converter electrical connector. |

3. Wrap the duct (1) with a closed cell adhesive foam (2).
