# Service Bulletin

Bulletin No.: 18-NA-115

Subject: Cold Start Misfire and/or Rough Idle – DTC P0300 May Be Set

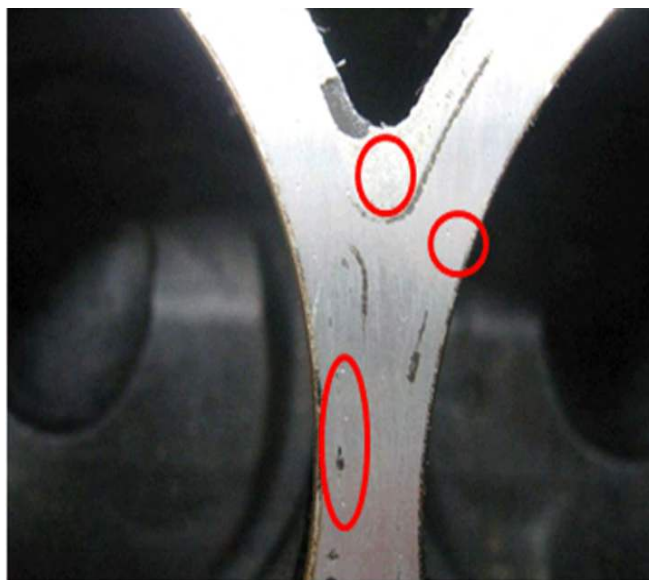
3632858

Notice: Small surface pock marks or pitting appearance on the deck surface is normal and an engine should not be replaced for any such appearance marks as they do not connect to the engine coolant passages and cause a leak path that will generate engine misfires.

6. With the cylinder head removed, perform a visual inspection. Reference the following pictures provided. The first two pictures represent normal examples of deck pitting and are not the cause of the misfire and/or rough idle condition.

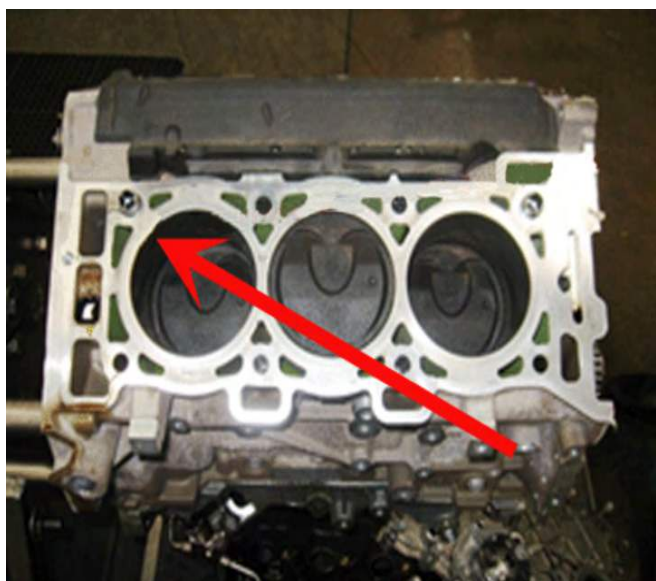
3632865

7. The two following pictures represent an example and the location of how actual engine cylinder block porosity appears. This would be a cause of the condition.

Notice: This porosity condition is rare, therefore the technician should inspect the suspect cylinder(s) and look for a break/pinhole in the carbon ring area.

Shown at the deck face to cylinder liner interface location is an area of engine cylinder block porosity that has caused an engine coolant leak path into the cylinder, causing medium to high misfire counts when the engine is cold.

⇒ If this condition is verified, the engine must be replaced.
