# Service Bulletin

Bulletin No.: 18-NA-225

**Subject:** No Propulsion – MIL Illuminated with One or More of the Following DTCs Set: P0ABC, P0AFA, P1AE6, P0D26, P0C78, P0ABB

| Brand: | Model: | Model Year: | | Build Date Breakpoint: | | Engine: | Transmission: |
|---|---|---|---|---|---|---|---|
| Chevrolet | Bolt EV | 2017 | 2019 | — | | — | — |

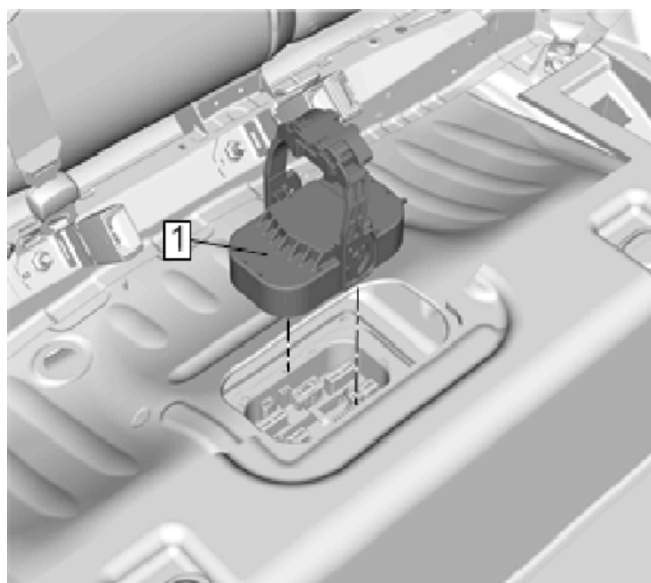
5087054

6. Verify that the S15 Manual Service Disconnect is installed completely, the lever is fully seated and the CPA is secure. Refer to Drive Motor Battery High Voltage Manual Disconnect Lever Replacement in SI.

- ⇒ If the S15 Manual Service Disconnect is installed properly, Go to Step 7.
  - ⇒ If the S15 Manual Service Disconnect is not installed properly, correct the condition as needed.

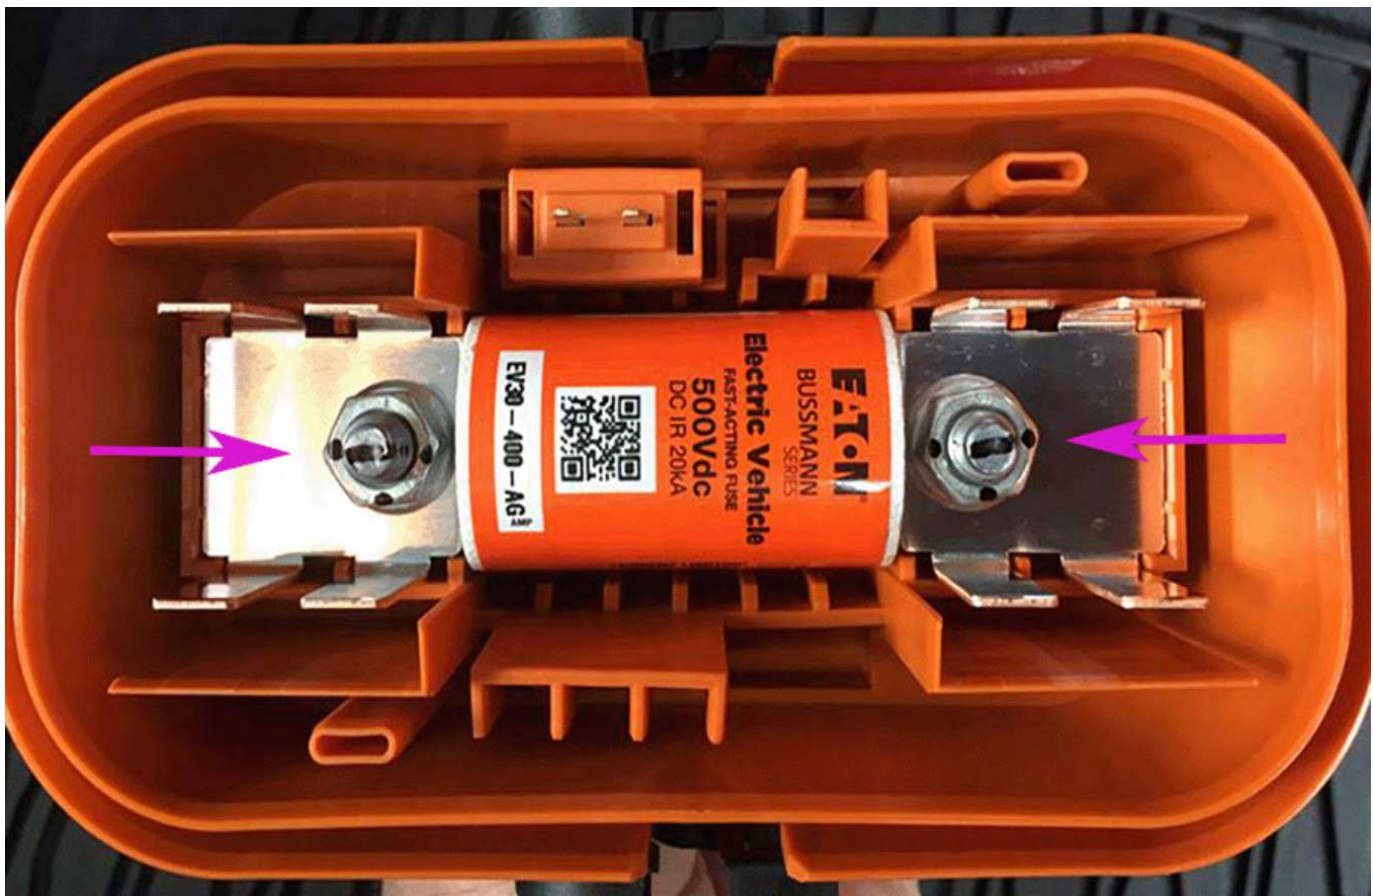
5087244

7. Remove the S15 Manual Service Disconnect (1).

8. Test for less than 10 & across the S15 Manual Service Disconnect fuse terminals (the flat blades at each end). Refer to Testing for Continuity in SI.

⇒ If the resistance measurement is 10 & or greater, replace the S15 Manual Service Disconnect.
