# Service Bulletin

Bulletin No.: 20-NA-135

**Subject:** Power Liftgate and/or Instrument Panel Cluster (IPC) Inoperative, No Audio, AWD/ 2WD Light Toggles Randomly, Malfunction Indicator Lamp (MIL) Illuminated - DTC P0650, P15A1, P159F-00, U0184-00, U0198-00 and/or U1501-00 Set

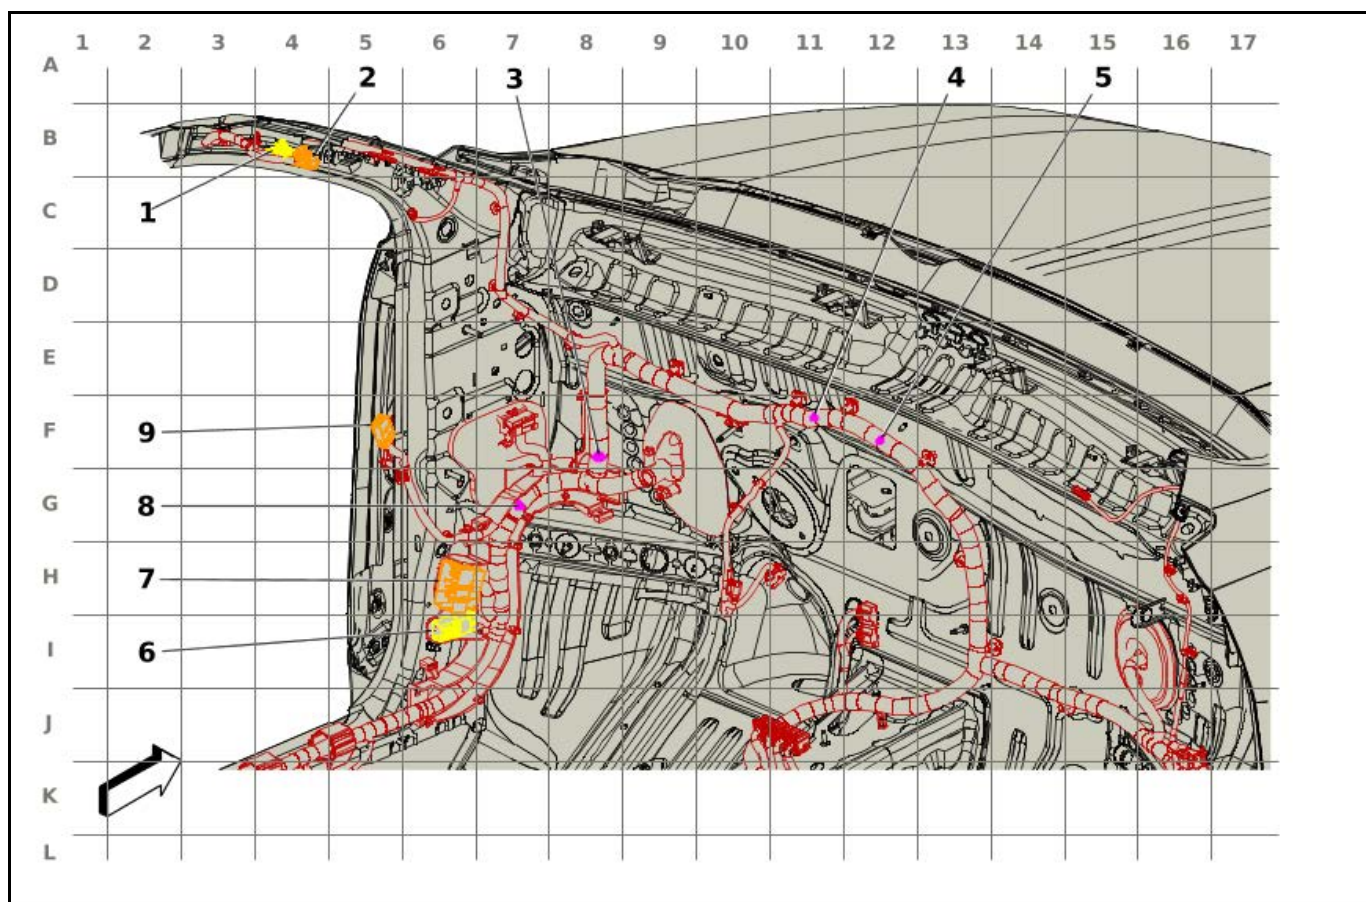
5437484

| Cause | The cause of the condition may be that the X200 connector was not fully connected and locked or poor terminal tension, resulting in an open circuit. |

Note: First inspect the X200 connection BEFORE disconnecting.

2. Inspect the X200 IP harness to Body harness connector (7), located at the lower Left A-Pillar, for possibly not being seated correctly.
3. Ensure that the wires are not twisted, not too taut, and the routing is correct.
4. Also ensure that the connection is correctly seated on all 4 sides.
  - ⇒ If the connector is seated correctly but the condition still exists inspect the terminals for proper terminal tension or backed out terminals.
5. Verify that the condition has been eliminated.
