## TECHNICAL SERVICE BULLETIN

### 6.2L/7.3L - Illuminated MIL With DTCs P0132, P0135, P0138, P0141, P0152, P0155, P0158 And/Or P0161 - Built On Or Before 05-Jun-2020

**20-2380**

29 October  
2020

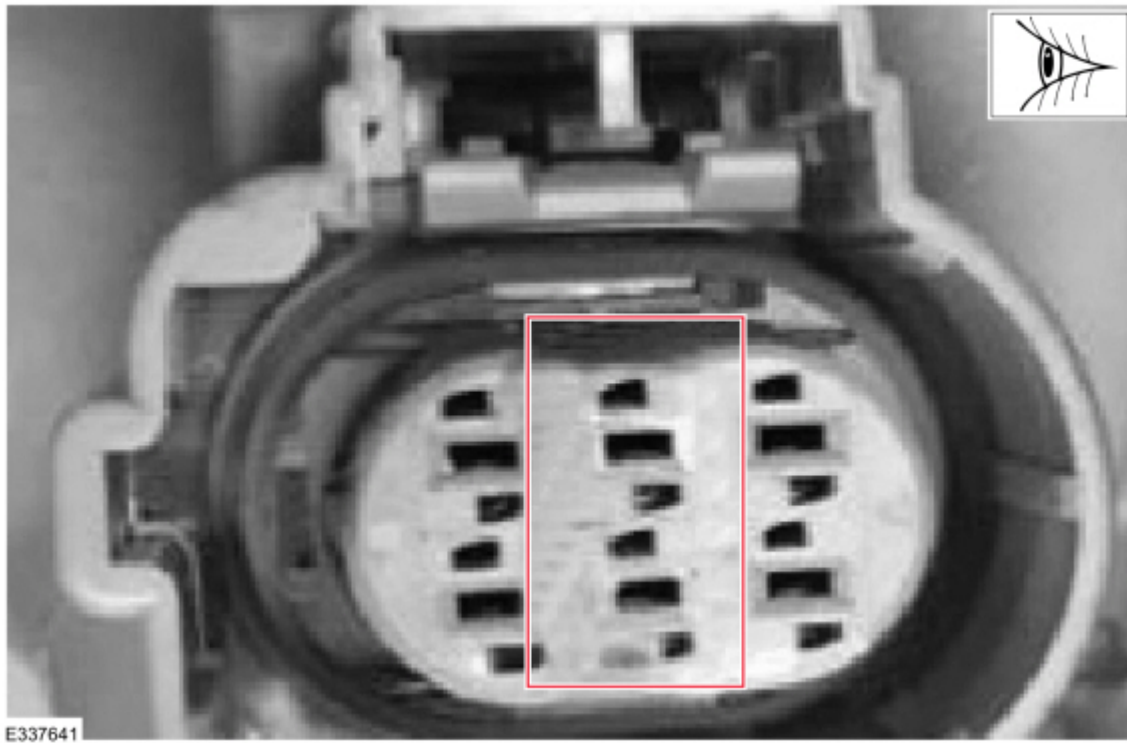
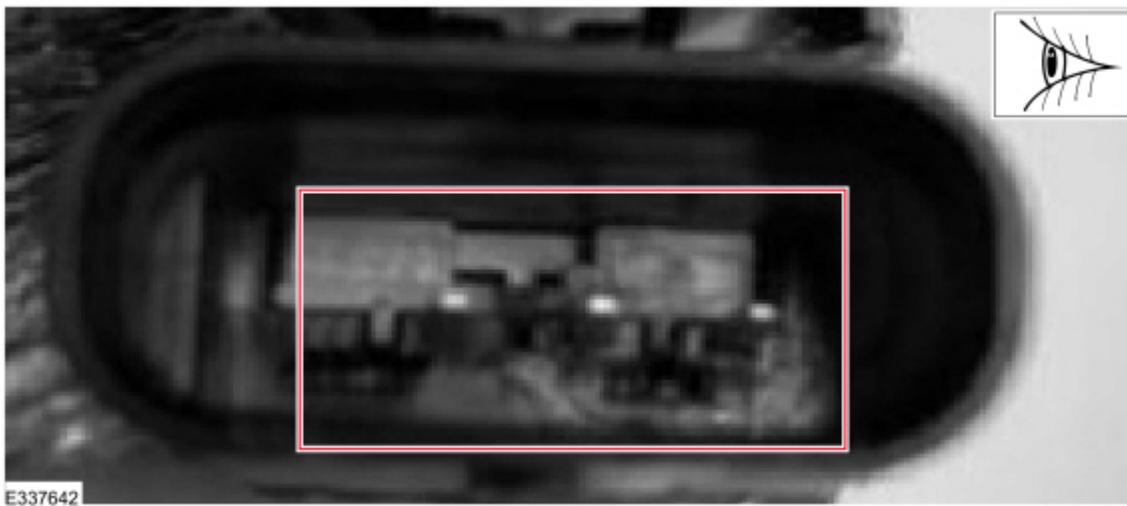
1. Disconnect the appropriate HO2S and/or the catalyst monitor sensor based on the DTC(s) received and inspect for moisture and/or corrosion on the pins of the sensor or the wiring harness. Are there any signs of moisture and/or corrosion present? (Figures 1-2)
  - (1). Yes - replace the affected HO2S and/or the catalyst monitor sensor. Refer to Workshop Manual (WSM), Section 303-14. Proceed to Step 2.
  - (2). No - this article does not apply. Refer to the Powertrain Control and Emissions Diagnosis (PC/ED) Manual for normal diagnostics.
