| | GROUP<br><b>ELE</b> | MODEL<br><b>2021MY<br/>K5 (DL3a)</b> |
| | NUMBER<br><b>216</b> | DATE<br><b>October 2020</b> |
| <b>TECHNICAL SERVICE BULLETIN</b> | | |
| <b>SUBJECT: SERVICE ACTION: MULTIFUNCTION CAMERA (MFC)<br/>REPLACEMENT (SA442)</b> | | |

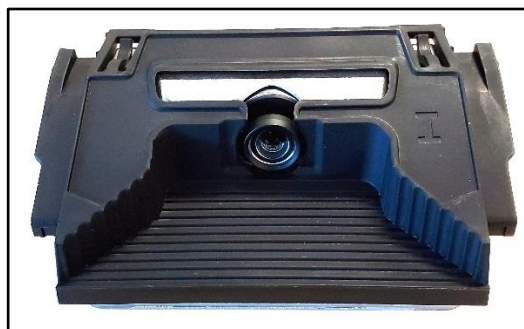
This bulletin provides the procedure to replace the multifunction camera (MFC) on some 2021MY K5 (DL3a) vehicles produced between September 1, 2020 through September 16, 2020 due to an internal control chip concern inside of the camera which may illuminate warning lights in the instrument cluster and/or MIL ON with DTC C160449. Before conducting the procedure, verify the vehicle is included in the list of affected VINs.

**DTC Description: C160449 - ECU Hardware Error**
