## Technical product information

| <b>Topic</b> | TPMS Warning light - DTC U012700 evident |
| <b>Brand</b> | Bentley |
| <b>Transaction No.</b> | 2057947/3 |

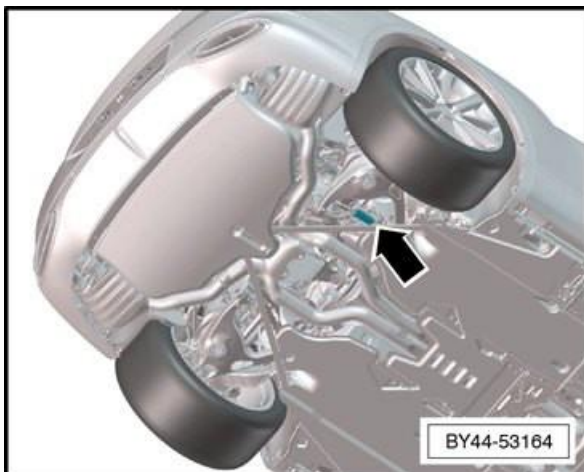
NOTE: For clarity Figure 1 shows the fitting location for the New Continental GT, New Continental GTC and New Flying Spur, Figure 2 shows the fitting location for Bentleyga

1) Replace the Tyre pressure control module and bracket (Figure 1) - Refer to Rep.Gr 44

The control module and bracket should be returned back to Bentley Motors Crewe as a complete assembly using the normal parts return procedure
