# Technical Service Bulletin

**DTC U2050:55 STORED AFTER REPLACING OR REPROGRAMMING  
TCU**

**Bulletin No.:** 09-013/20

**Last Issued:** 10/06/2020

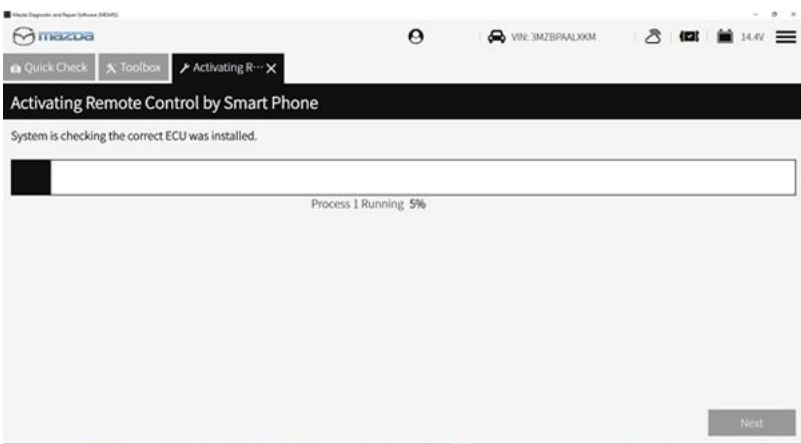
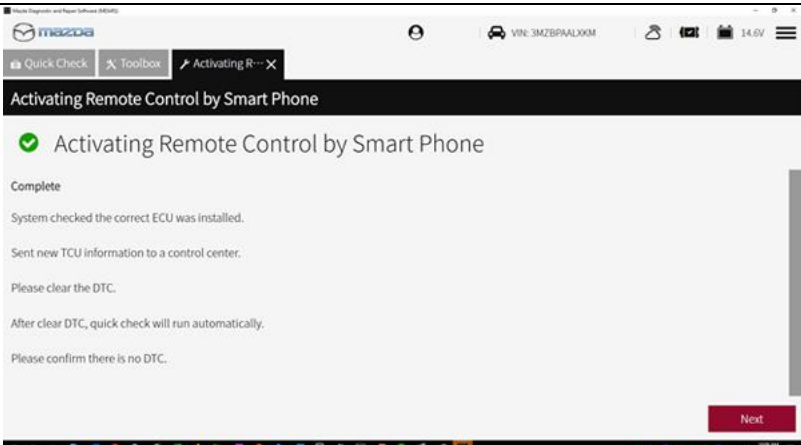
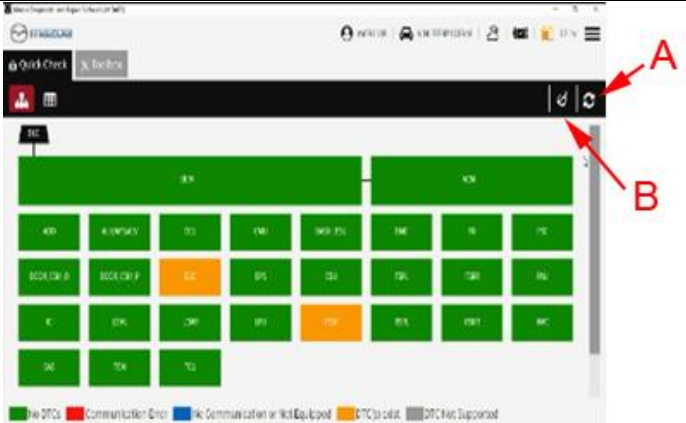
**CAUTION:** If the engine is not started, DTC P2610 is stored and cannot be erased.

3d. Select Quick Check (A), then start the engine and select the DTC Clear icon (B).
