# SERVICE BULLETIN

EC20-015

NTB20-071

## 2016-2019 TITAN XD DIESEL; MIL ON WITH DTC P226C STORED

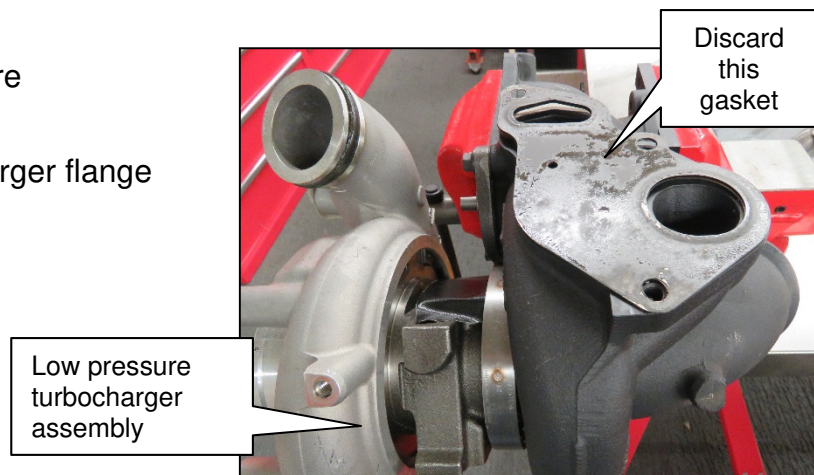
Figure 8

**HINT:** The rotary turbine control valve linkage is not reusable once it is removed from the rotary turbine control valve shaft. A new linkage must be used on the new low pressure turbocharger.

11. Replace the low pressure turbocharger assembly.
- Discard the turbocharger flange gasket.
