# Preliminary Information

## PIP5748B Particulate Matter Sensor Protection Tube Performance Diagnostic May Set A False DTC P1488

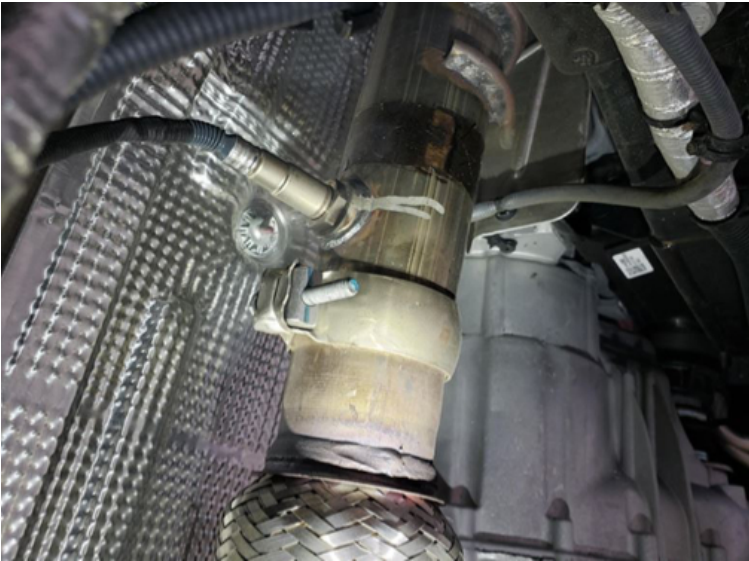
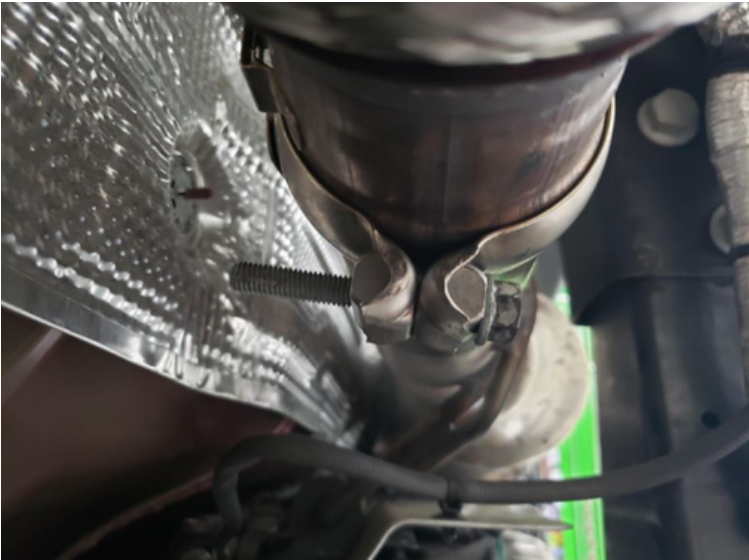
If the sensor is properly torqued and the P1488 has requested the MIL, test the exhaust for leaks using the power smoke diagnostic leak detector (GE-52250 - refer to the latest version of [PIP5684](#)). Because of the location of the exhaust cooler, the sealing bladder can't be used effectively. The pressure necessary to find the leak is minimal, so using two wraps of duct tape around the pipe will seal the cooler holes sufficiently for testing. Repair any leaks as necessary but pay particular attention to the joint illustrated in the pictures below. If the joint is leaking the clamp may have bottomed out before applying sufficient clamp load to the joint. If this condition exists, replace the clamp.

Also replace the particulate matter sensor.
