# Preliminary Information

## PIT5759G Service Safety Restraints System With DTC B14DC SYM 1B and/or 13

Product Investigation Review Required

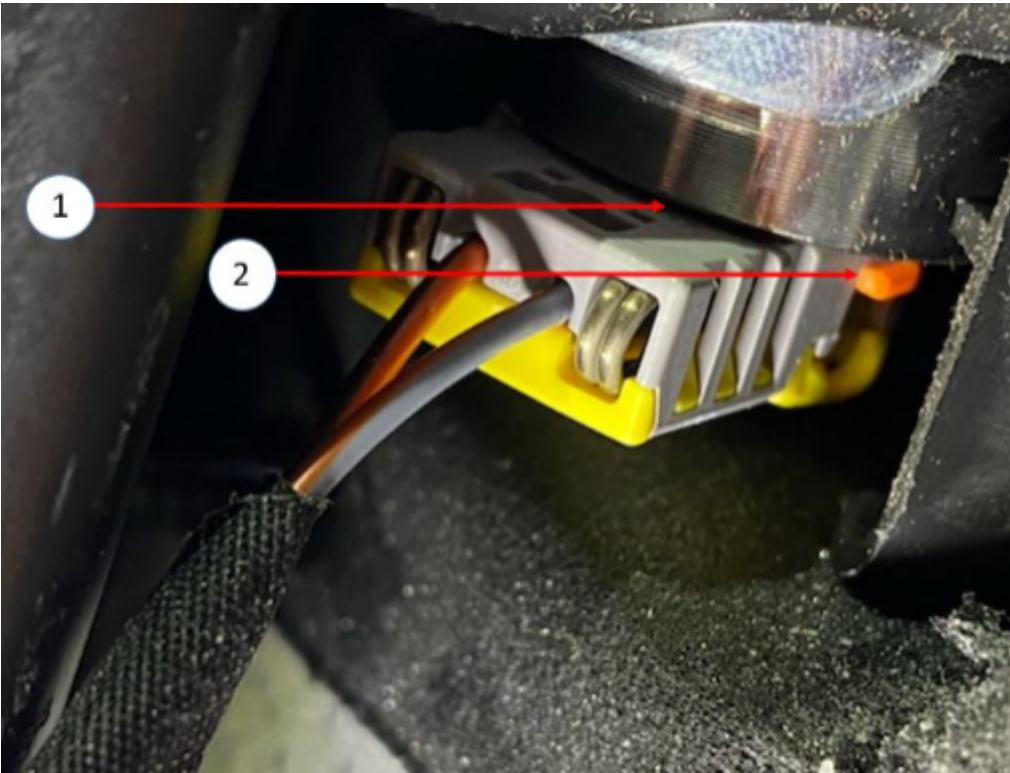
| Cause | High resistance at the F106DA Driver's front seat inboard air bag connector. |

- Cut off the old air bag connector and splice in the new pigtail connector using two DuraSeal splice sleeves per the Wire-to-Wire Repair located in SI, Document ID 5214974.
- Reconnect the F106DA Driver's front seat inboard air bag connector (shown below) and make sure it is fully seated tight up against the airbag (1). Also, make sure the orange CPA is fully seated (2), as shown below.
- Reinstall the driver's inboard air bag and torque the fasteners to 7 Nm (62 lb in).
- Reassemble the seat following SI service procedure.
