Preliminary Information

PIT5759H Service Safety Restraints System With DTC B14DC SYM 1B and/or 13

Product Investigation Review Required

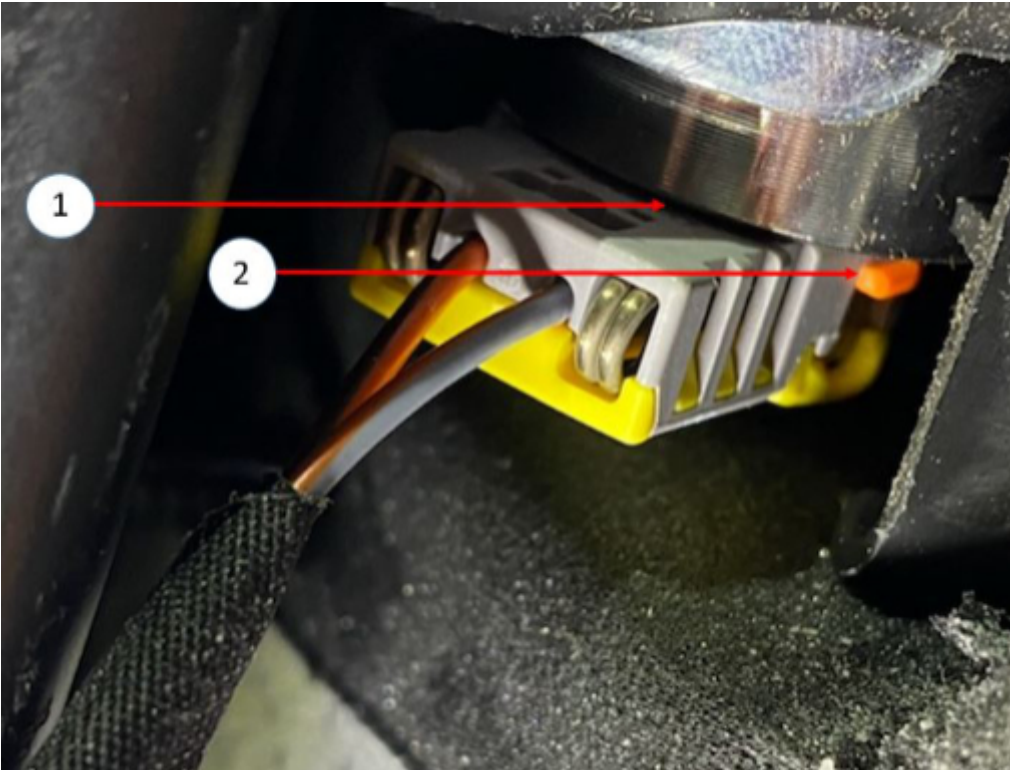
| Condition | Some customers may comment on a "Service Safety Restraints System" message displayed on the DIC. When checking for DTCs, a B14DC symptom 1B and/or 13 will be set in the K36 Restraints Control Module. This DTC is for an open or high resistance in the F106DA Driver's front seat inboard airbag deployment loop. |
| Cause | High resistance at the F106DA Driver's front seat inboard air bag connector. |

- Reconnect the F106DA Driver's front seat inboard air bag connector (shown below) and make sure it is fully seated tight up against the airbag (1). Also, make sure the orange CPA is fully seated (2), as shown below.
- Reinstall the driver's inboard air bag and torque the fasteners to 7 Nm (62 lb in).
- Reassemble the seat following SI service procedure.

- If it is found that the F106DA Driver's front seat inboard air bag connector is the cause of the high resistance then replace it with a new updated pigtail connector part number 13530533 obtained from CCA parts.

- Cut off the old air bag connector and splice in the new pigtail connector using two DuraSeal splice sleeves per

- Use GDS2 to monitor the deployment loop 13 resistance. Verify the resistance is within the normal range and the DTC does not return.
