# Service Bulletin

Bulletin No.: 20-NA-179

Subject: Malfunction Indicator Lamp (MIL) Illuminated – DTCs P0521 and/or P06DD Set

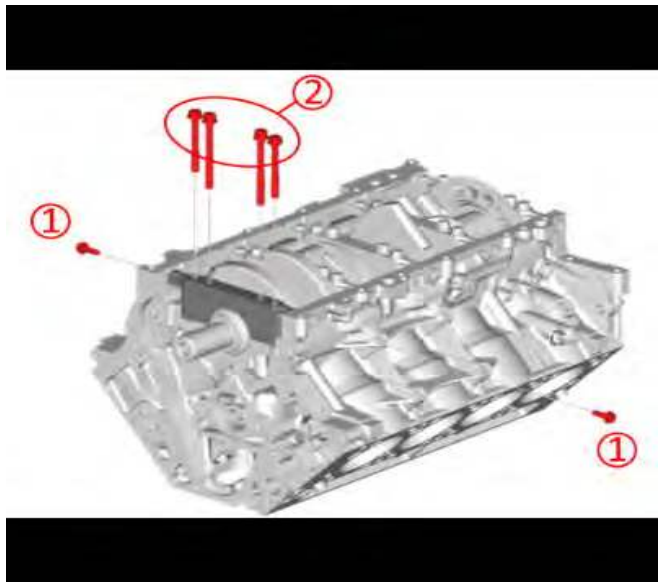
5633412

Note: The generator may need to be repositioned to gain access to the main cap side bolts.

2. Remove the main cap side bolts (1).

Important: When removing the main bearing cap be careful not to damage the main bearing or journal surface of the crankshaft. Please set the main bearing cap in a safe place so no debris or damage could occur.

3. Remove and discard the bolts (2) that secure the #1 main bearing cap.

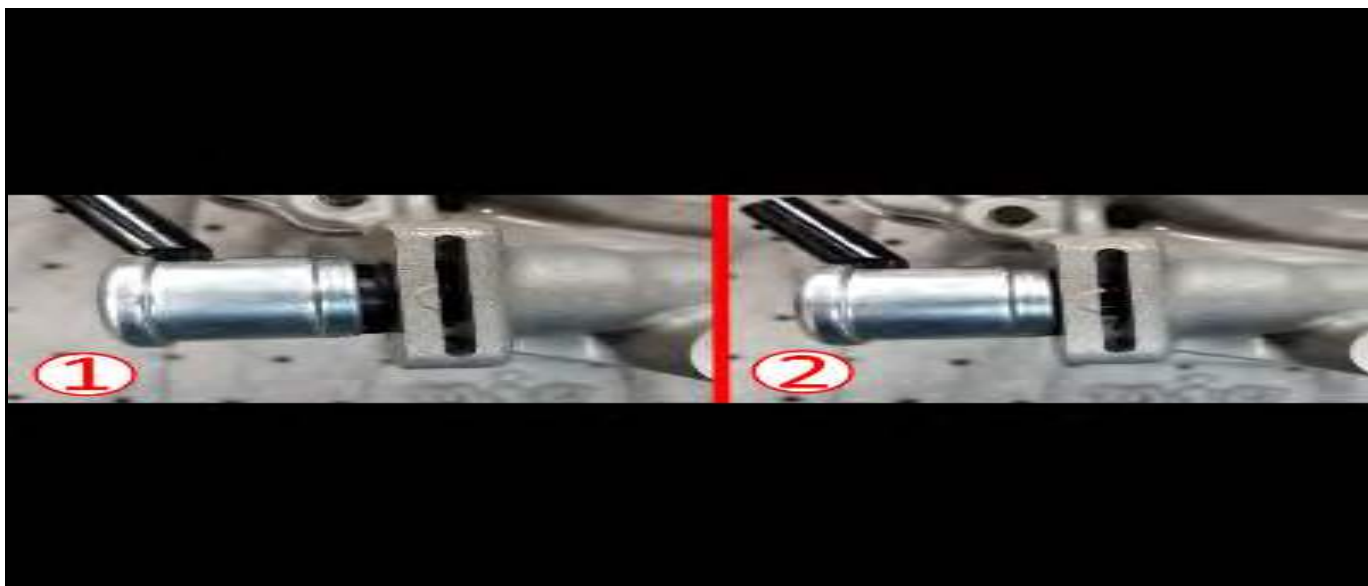
5633444

4. Inspect the OCV:  
" If you find this oil pressure control valve dislodged (1), it will be necessary to install a redesigned oil control valve retainer.
5. Disconnect the oil pressure control valve electrical connector and position aside.

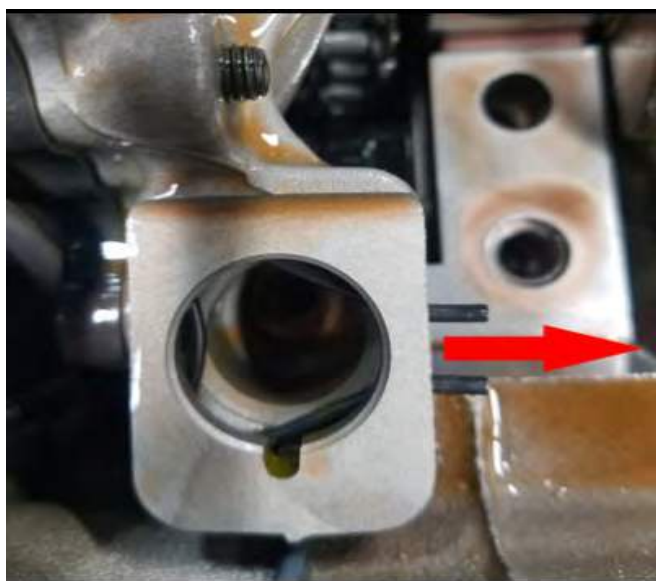
5633443

Note: Remove the existing oil pressure control valve retainer by pulling towards the rear and discard. You will be installing a newly designed retainer during installation.

6. Push in the retainer and remove the oil pressure control valve and set aside.
7. Once the retainer is removed, inspect the oil pressure control valve for any signs of damage and ensure the O-ring is not cut.
  - ⇒ Apply a small amount of clean engine oil to the pressure control valve and reinstall ensuring it is seated correctly.
