# Service Update

## N192287020 Momentary Loss of Park Engagement

**Release Date:** October 2020

| Make | Model | Model Year | | RPO | Description |
|---|---|---|---|---|---|
| Cadillac | CT6 | 2019 | 2020 | MHS<br>or<br>MHW | 10 Speed Automatic Transmission |

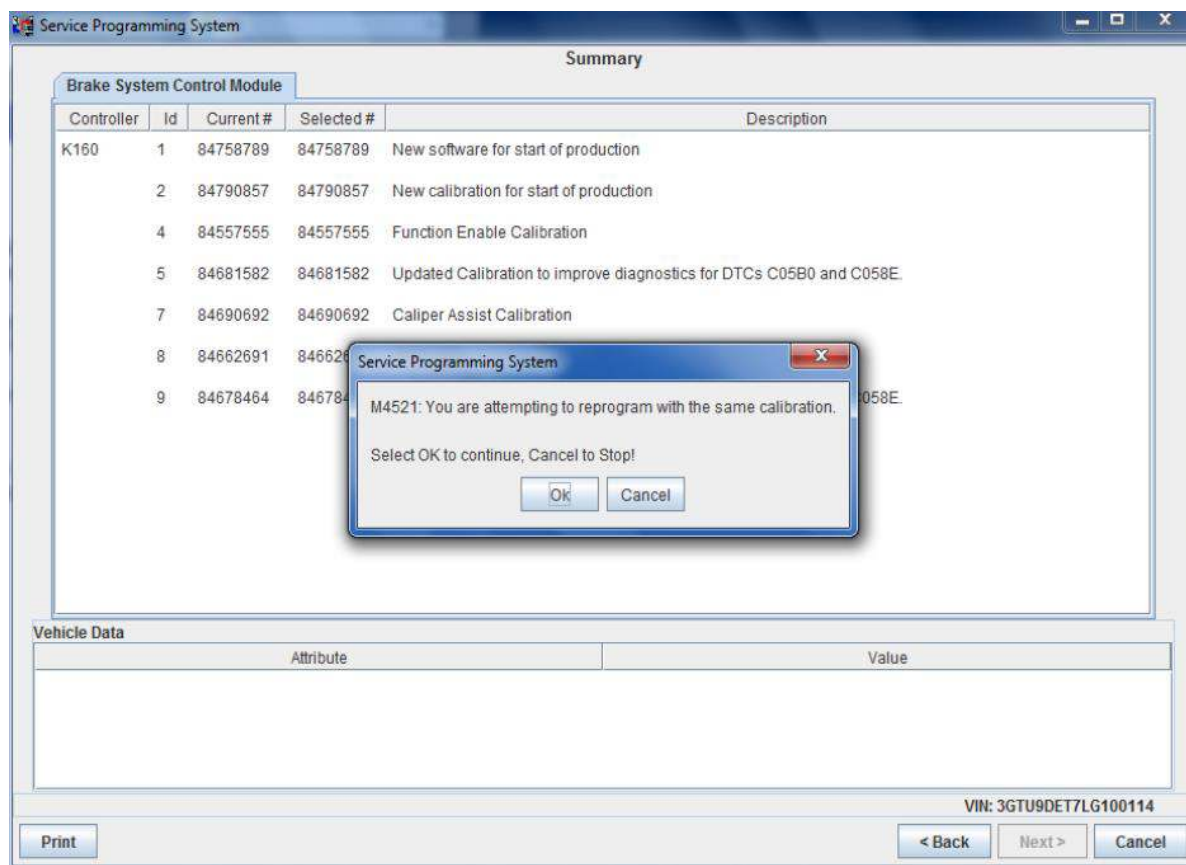
5431207

**Important:** Techline Connect and TIS2WEB screens shown above.

**Important:** If the same calibration/software warning is noted on the TLC or SPS Summary screen, select OK and follow screen instructions. After a successful programming event, the WCC is located in the Service Programming System dialogue box of the SPS Summary screen. No further action is required. Refer to the Warranty section of the bulletin.

1. Reprogram the Engine Control Module. Refer to *K20 Engine Control Module: Programming and Setup* in SI.

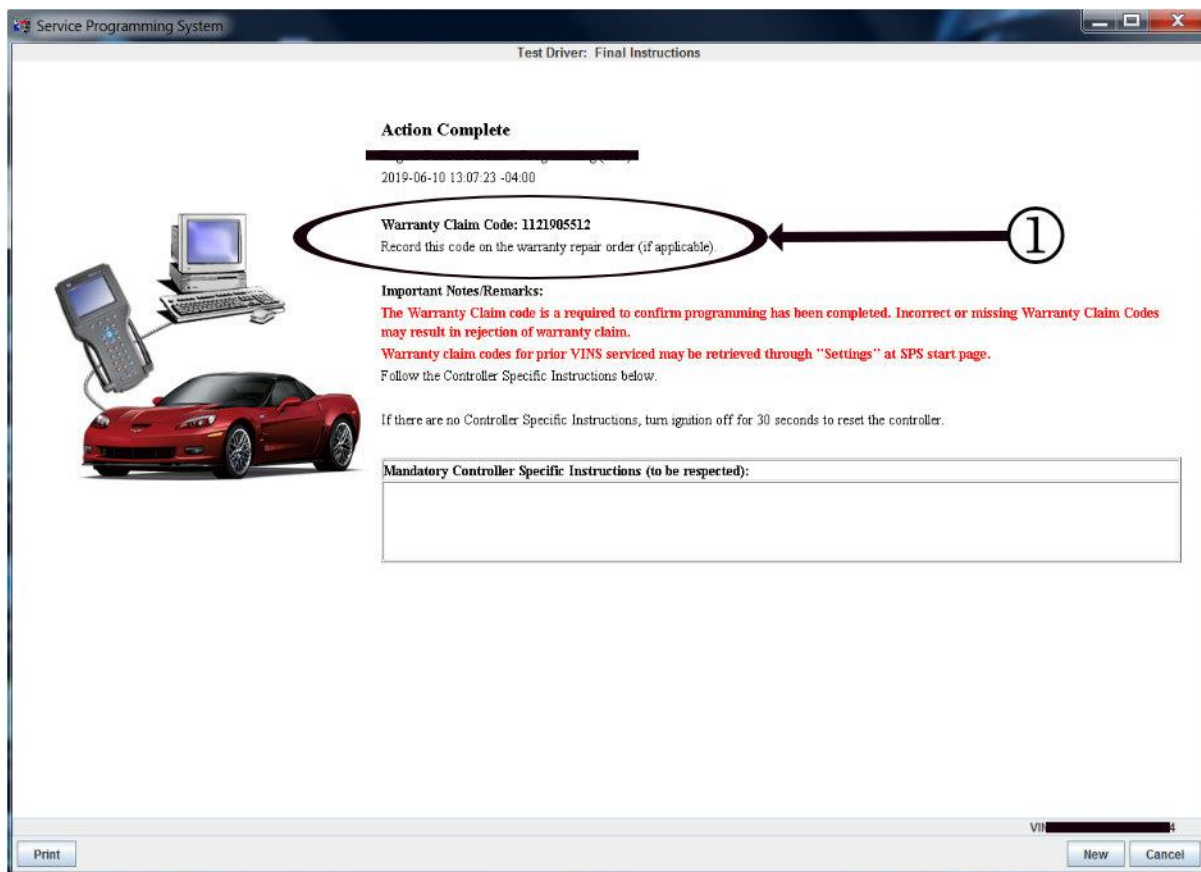
5431209

**Important:** To avoid warranty transaction rejections, you **MUST** record the warranty claim code provided on the Warranty Claim Code (WCC) screen shown above on the job card. Refer to callout 1 above for the location of the WCC on the screen.

2. Record SPS Warranty Claim Code on job card for warranty transaction submission.
