### N202293610 Electronic Transmission Range Select Mode Valve Stuck

**Release Date:** October 2020

| Make | Model | Model Year | | RPO | Description |
|---|---|---|---|---|---|
| Cadillac | CT6 | 2019 | 2019 | LGW or LGX | 3.0L or 3.6L V6 Gas Engine |

| <b>Condition</b> | Certain 2019 model year Cadillac CT6 vehicles may have a condition which can cause the transmission auxiliary pump to stay on when DTC P18AA is set at engine off. |

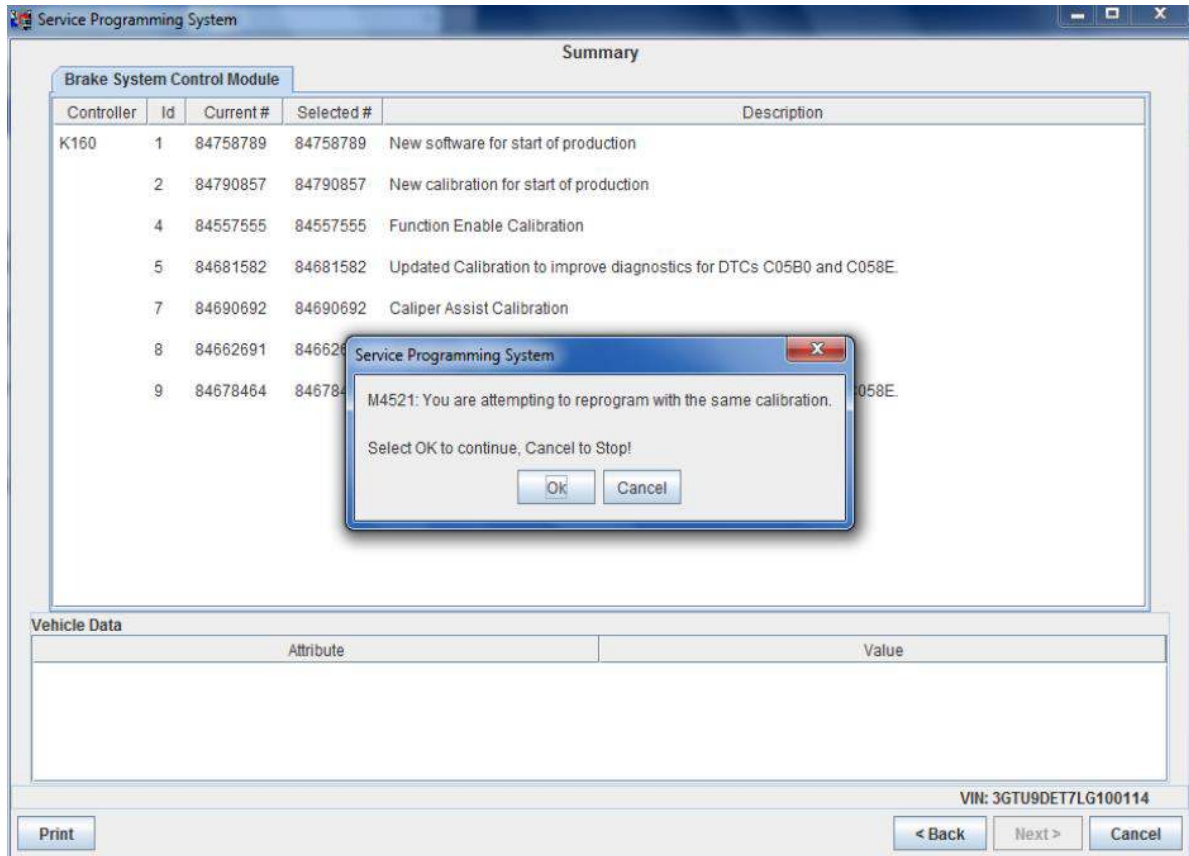
5431207

**Important:** TIS2WEB screen shown. Techline Connect screen is similar and will be included in the near future.

**Important:** If the Same Calibration/Software Warning is noted on the SPS screen, select OK and follow screen instructions. After a successful programming event, the WCC is located in the Service Programming System dialogue box of the SPS Summary screen. No further action is required. Refer to the Warranty section of the bulletin.

1. Reprogram the Transmission Control Module. Refer to *K71 Transmission Control Module: Programming and Setup* in SI.
  - Select "Refresh Characterization Data" when prompted to select a programming type.

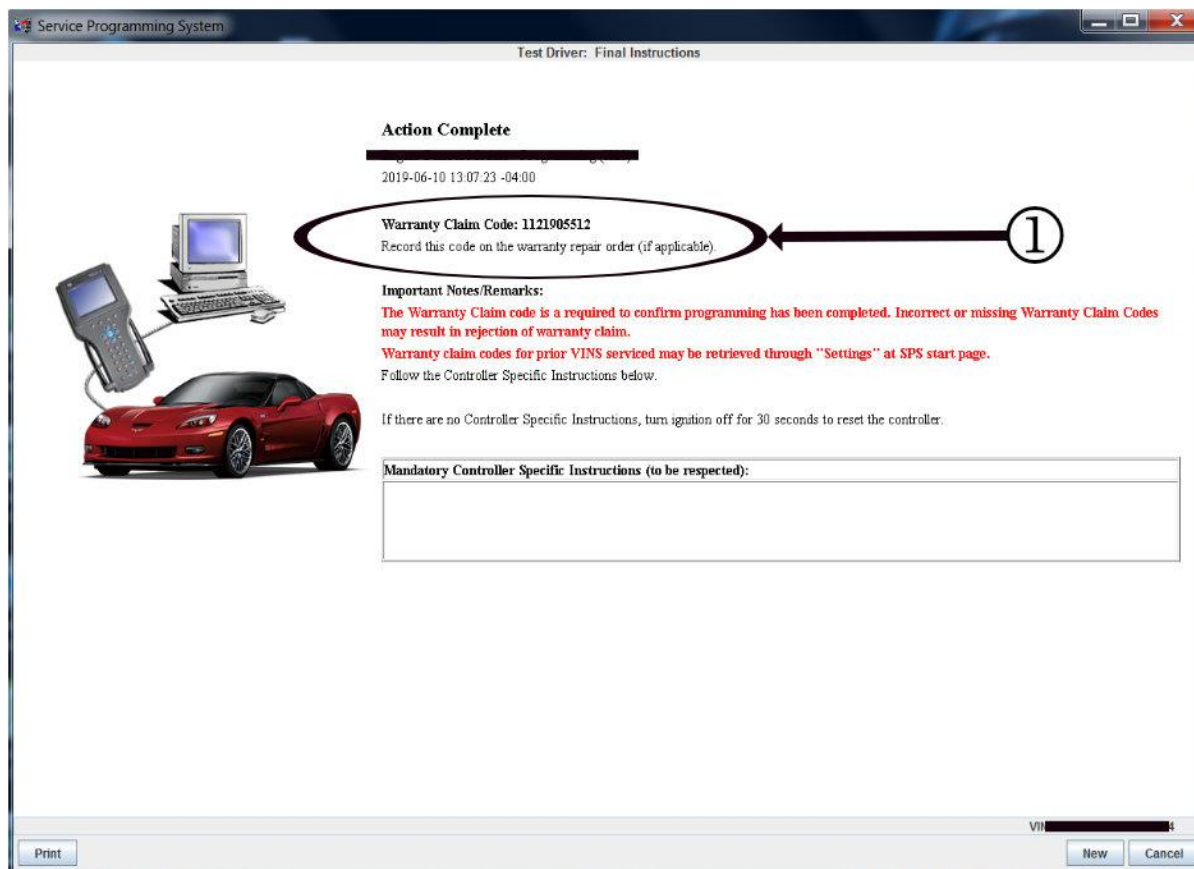
5431209

**Important:** TIS2WEB screen shown. Techline Connect screen is similar and will be included soon.

**Important:** To avoid warranty transaction rejections, you **MUST** record the warranty claim code provided on the SPS Warranty Claim Code (WCC) screen on the job card. Refer to callout 1 above for the location of the WCC on the SPS screen.

- Record SPS Warranty Claim Code on job card for warranty transaction submission.
