| MIL on P0AA649 / P1C8049 - Corrosion on MGR Cable | | USA |
| Engine/Hybrid System | Hybrid/Battery Control System | |
| 2019-2020 RAV4 HV | | |

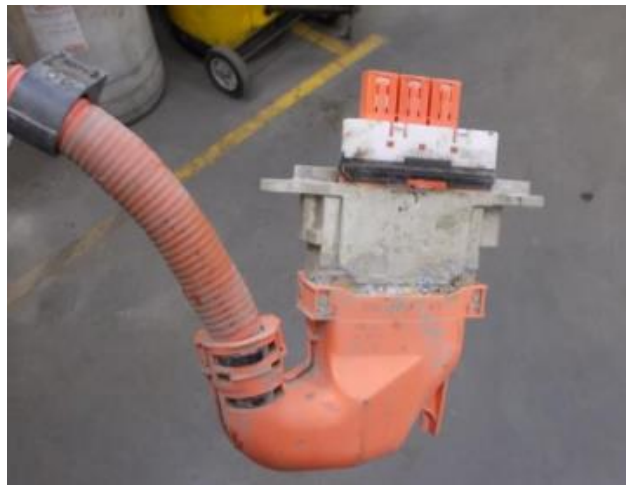
Vehicles exhibiting this condition have been experiencing a short in MGR connector due to corrosion.

Raise the vehicle to visually inspect the high voltage wire harness that connects to the MGR. Unplug and check for corrosion or buildup of dirt and sediment in the connector. See below:

This issue is currently being investigated. Confirm the cable corrosion or dirt build-up at the MGR connector and call TAS for further instruction. If it is a weekend or holiday, continue with diagnosis and repair. Please save all parts and/or details and contact TAS on the next available workday.
