## TECHNICAL SERVICE BULLETIN

### 7.3L - Illuminated MIL With Misfire Or Lack Of Power And DTCs P0300, P0316, And/Or P0301-P0304 - Built On Or Before 28-Sep-2020

**20-2370**

| <b>Ford</b><br>2020 F-53 Motorhome Chassis | Engine: 7.3L |

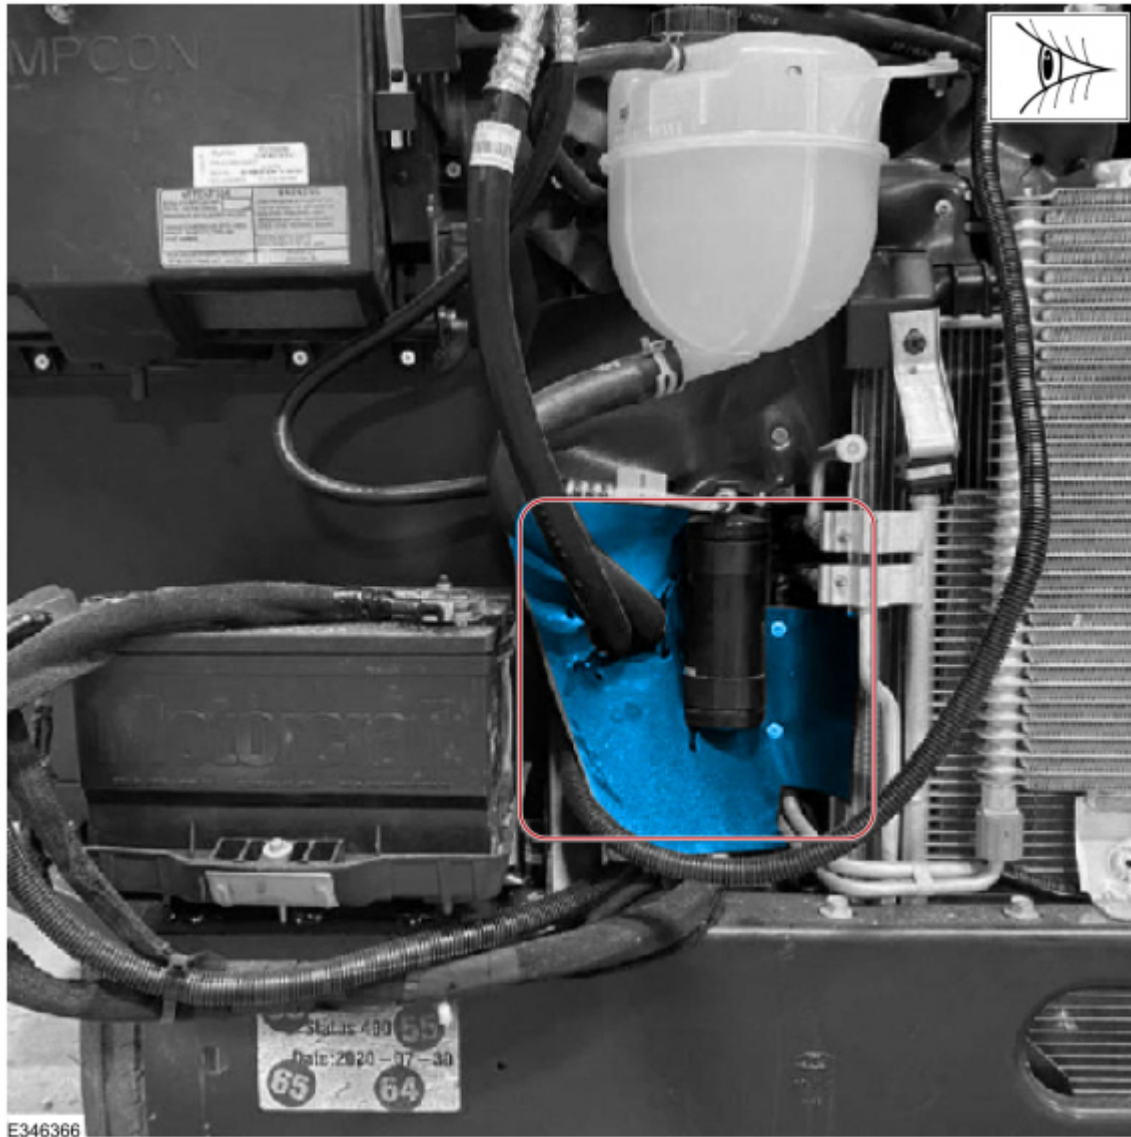
Figure 1

1. Locate the passenger side engine compartment baffle. Does the baffle completely cover the area between the radiator assembly and the battery try as shown in Figure 1?
