## QUALITY ACTION

## CAMPAIGN BULLETIN

### Final All Wheel Drive Clutch Break-In

Reference: P0A33

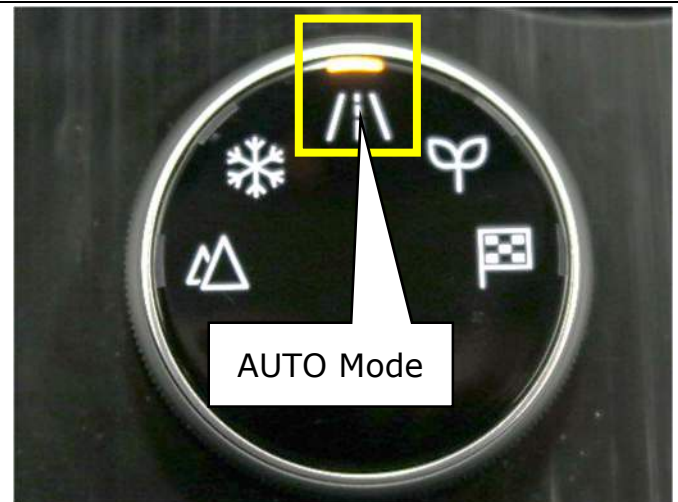
Figure 1

3. Verify the AWD selector is in AUTO mode. (Figure 1)
