# Service Bulletin

Bulletin No.: 20-NA-071

**Subject:** Service Engine Soon Lamp Illuminated and/or Service Power Brake Assist Message Displayed, with DTCs P0557 or P0558 Stored

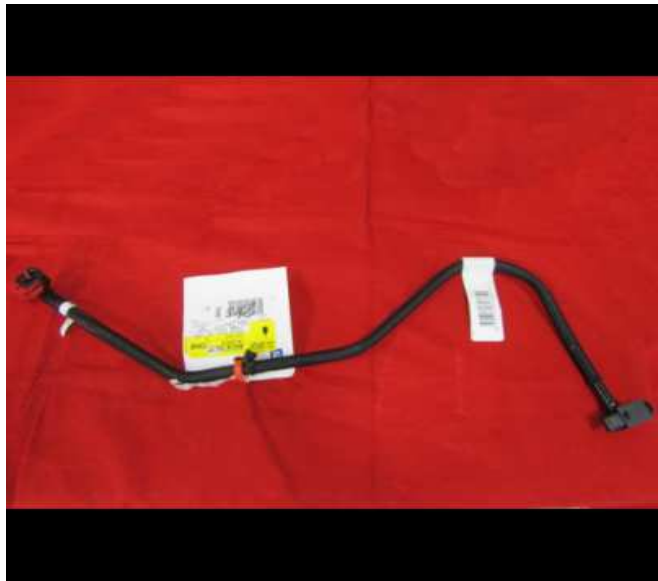
5549611

LFY Hose

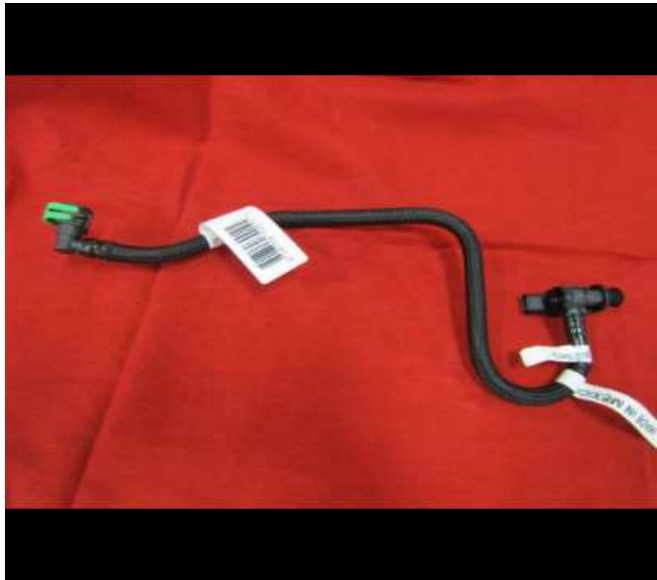
5549615

LGX Hose

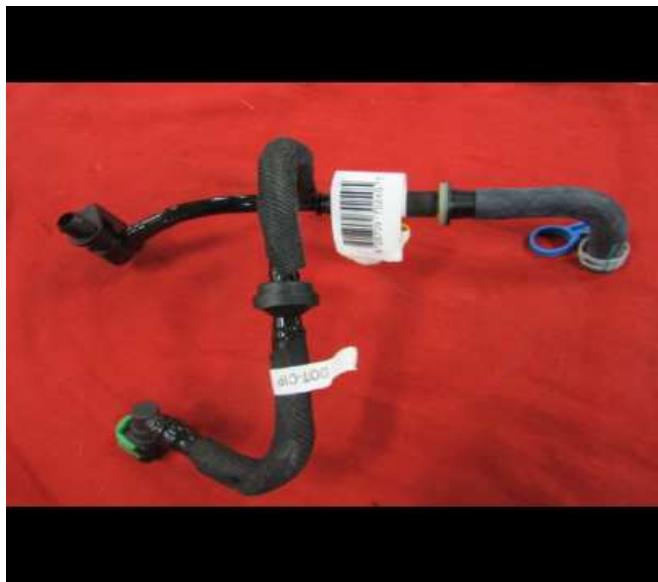
5549612

LCV Hose

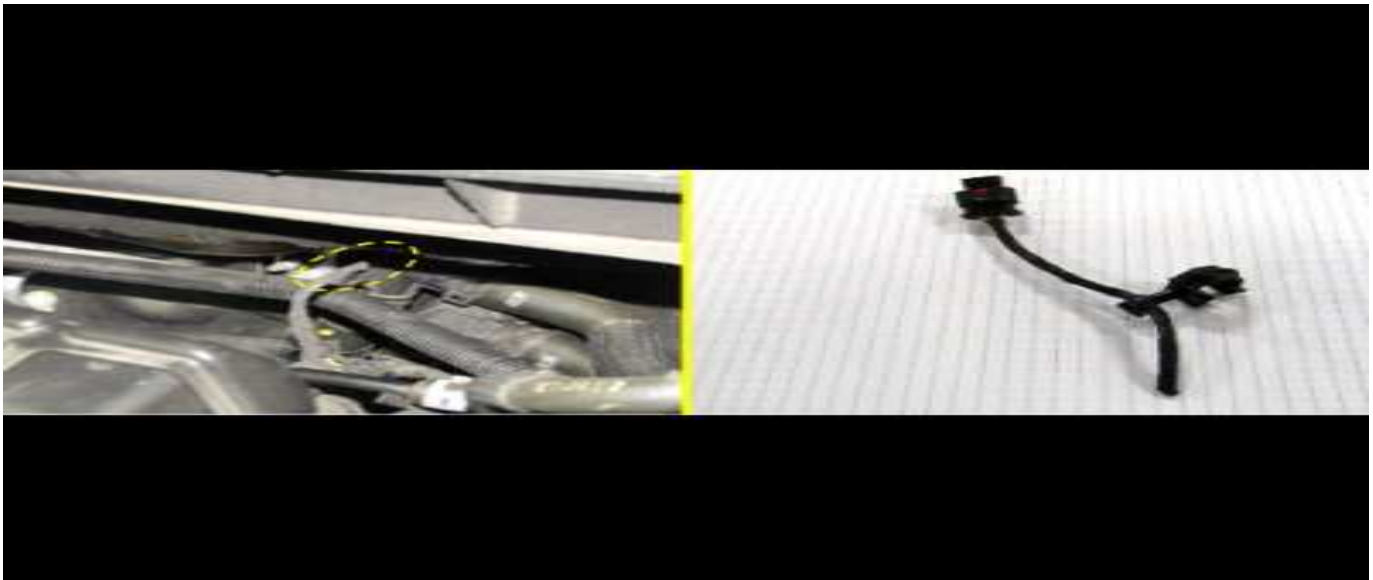
Note: The top graphic shows the LGX connector intact; the bottom one shows the LFY wiring already cut.

2. Locate the power brake booster vacuum sensor electrical connector. Fold conduit back and cut off connector, leaving approximately 5.0 cm (2.0 in) of wiring on the engine harness side.
3. Tape the cut wiring end to the engine harness. These wires will no longer be used.

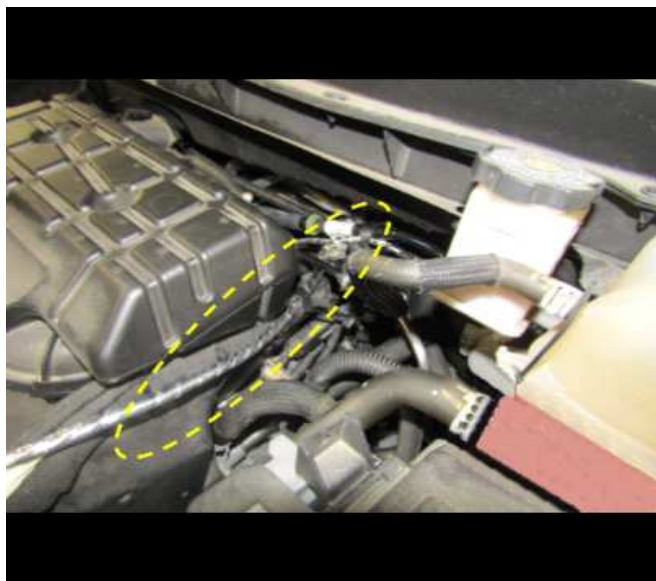
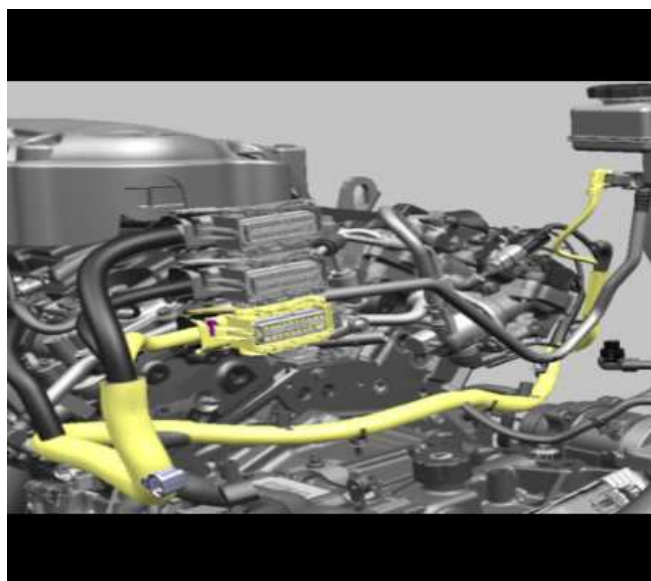
Note: The LFY harness routing is shown in the top graphic, the LGX routing is shown in the bottom math file. The routing for LCV is similar to the routing of the LGX.

10. Start routing the new harness alongside the engine harness.

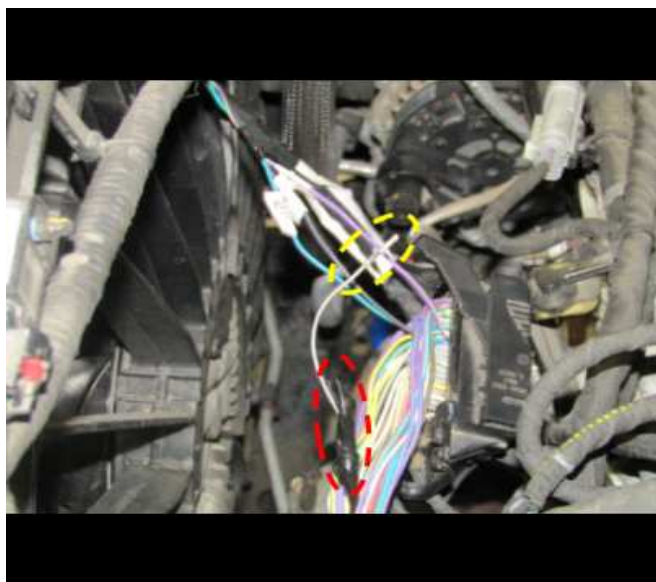
5549629

Note: In this step, do NOT cut the terminal off of circuit #2151 (circled in yellow in the graphic above).

15. Cut off the terminated leads that were in circuits #6030 and #6031 and fold and tape off the ends (circled in red in the graphic above). These circuits will no longer be used.

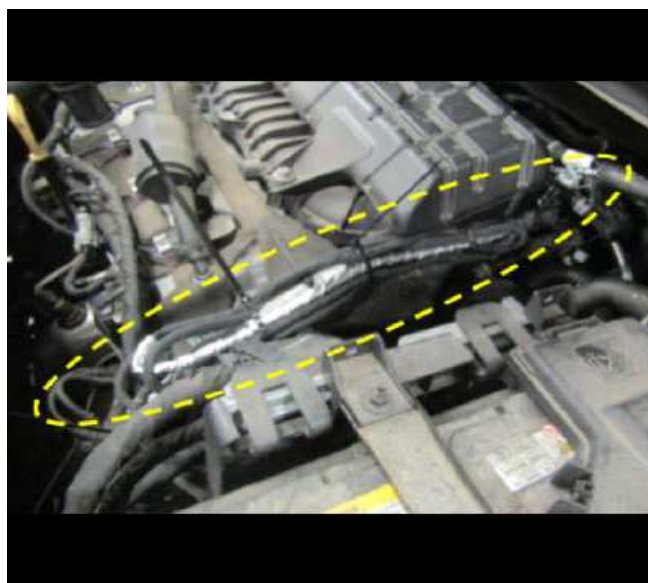
5549633

Note: Graphic shown above is LFY harness routing.

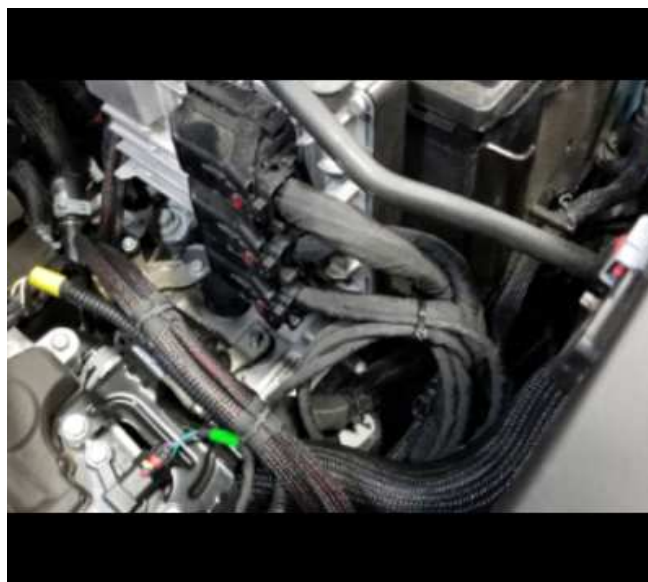
5549634

Note: Graphic shown above is LGX harness routing, with LCV being similar.

Important: It will be necessary to coil the extra wire length. Ensure the wire is tied back away from any sharp edges or moving parts that could cause damage to the harness.
