**December 18, 2020**

**Warranty Extension: 2012-15 Civic Hybrid IMA Motor Power Inverter (MPI)****AFFECTED VEHICLES**

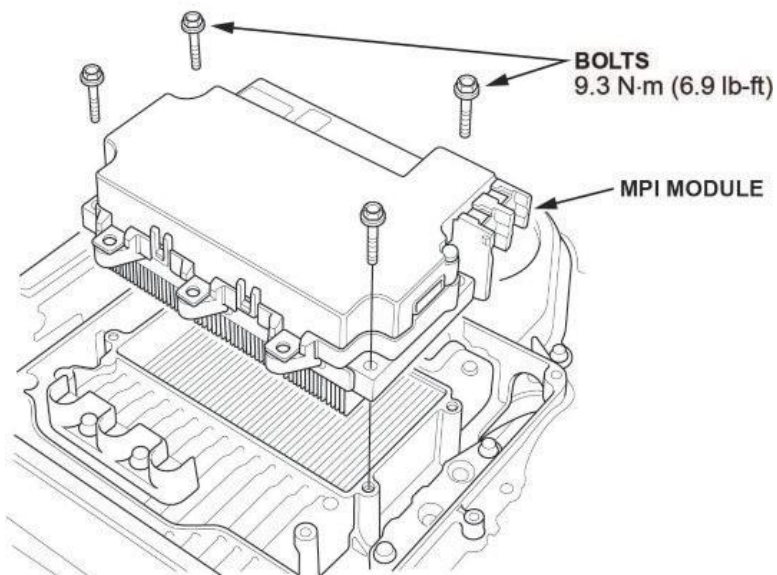
The Motor Power Inverter (MPI), also known as the Intelligent Inverter Unit (IIU), may fail over time due to a defective solder joint. This failure may result in one or more of the following DTC(s):

Do an all-DTC check and replace the MPI if any of the DTC(s) listed under INSPECTION PROCEDURE are stored.

23. Remove the MPI module and install the new MPI module.
