# Technical Service Bulletin

| <b>Subject:</b><br><br><b>WRONG VEHICLE LOCATION IN GPS WITH DTCS B119F:01, B119F:13 AND/OR B119F:2B STORED</b> | <b>Bulletin No.:</b> 09-021/20 |
| | <b>Last Issued:</b> 12/10/2020 |

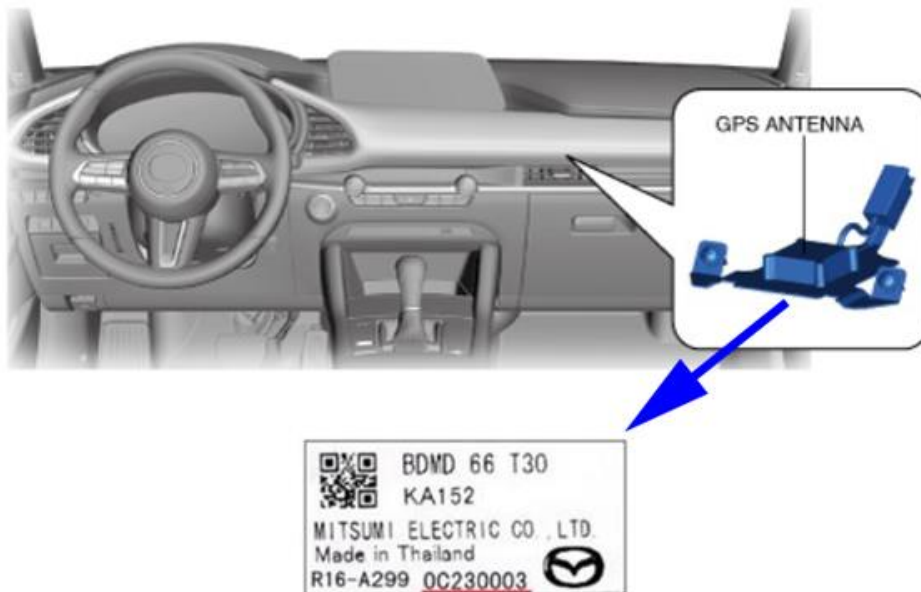
1. Verify customer concern.
2. Confirm if the telephone antenna No.1's lot number is before 0C230003. The lot number is in YMDDnnnn format.

Example:

0C230003: 0→2020 (year), C → March, 23→ 23th (day), 0003→serial number for the day

9H161360: 9→2019 (year), H → August, 16→ 16th (day), 1360→serial number for the day

- If the lot number is 0C230003 or later, the part is already modified.
- If the lot number is before 0C230003, replace the GPS antenna with a modified one by referring to the instructions on MGSS.
  - Mazda3: (GLOBAL POSITIONING SYSTEM (GPS) ANTENNA REMOVAL/INSTALLATION)
  - CX-30: (GLOBAL POSITIONING SYSTEM (GPS) ANTENNA REMOVAL/INSTALLATION)
