# Technical Service Bulletin

## 01 MIL on with hissing noise, DTC P227900 is stored in the ECM

01 21 95 2054795/2 January 12, 2021. Supersedes Technical Service Bulletin Group 01 number 19-15 dated April 23, 2019 for reasons listed below.

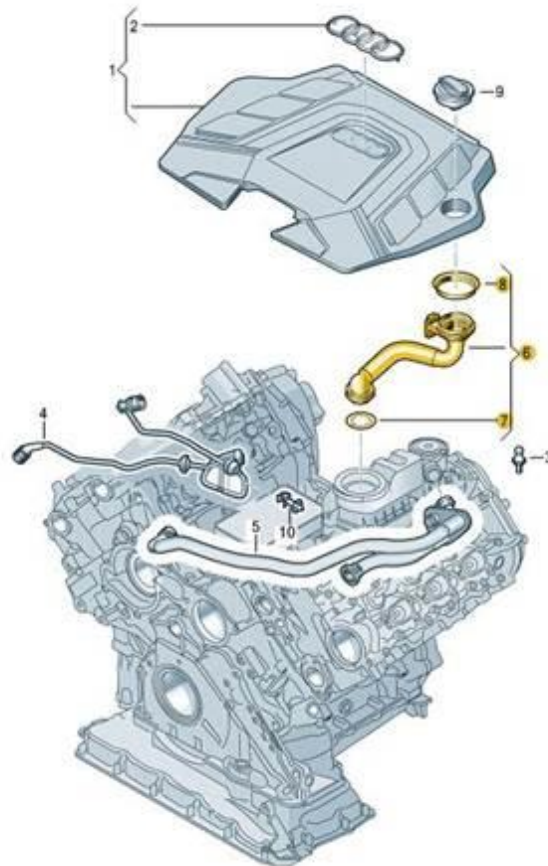
During assembly, the oil fill extension tube (Figure 1) may have been assembled incorrectly. If this extension tube is cross-threaded, an intake/vacuum leak may be generated at the interface between the extension tube and the valve cover (Figure 1, 7).

**Figure 1.** Oil fill extension tube (see possible cross-threading at number 7 on diagram).

If an intake/vacuum leak is suspected, please inspect this component and verify proper sealing. If any components are damaged from cross threading, replace as necessary.
