# Loss of Air Conditioning Cooling With DTC B1423

| YEAR(S) | MODEL(S) | ADDITIONAL INFORMATION |
|---|---|---|
| 2020 | Highlander, Highlander HV | |

Some 2020 model year Highlander and Highlander Hybrid vehicles may experience a sudden loss of air conditioning cooling with Diagnostic Trouble Code (DTC) B1423 (Open in Pressure Sensor Circuit/Abnormal Refrigerant Pressure) present. Follow the Repair Procedure in this bulletin to address these conditions.

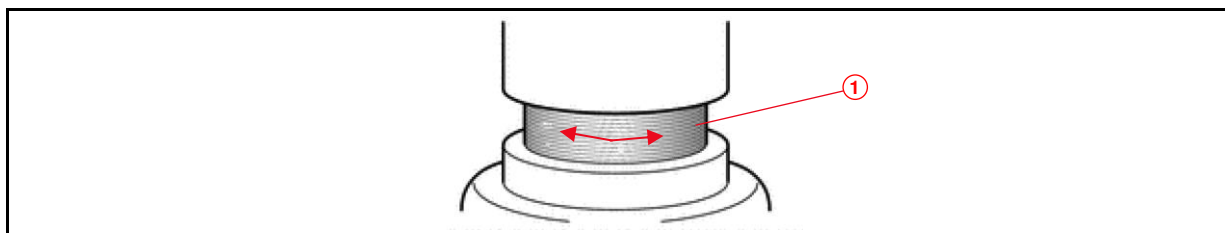
**Figure 1. OK Condition – Pipe Replacement NOT Needed**

Light Scratching Parallel With O-ring Groove Caused by Normal Part Processing

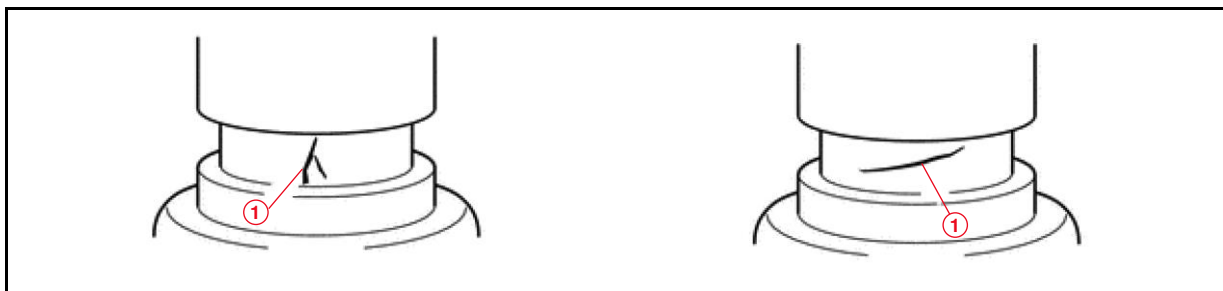
**Figure 2. Damage Condition – Pipe Replacement Recommended**

| <b>1</b> | Damage – Deep Scratching or Gouge of Base Metal |

7. Did the inspection show ANY damage or abnormalities in the O-ring surfaces?
  - **YES** – Proceed as follows:
    - For Highlander vehicles continue to step 8.
    - For Highlander Hybrid vehicles go to step 10.
  - **NO** – Go to step 12.
8. Remove the air conditioning tube assembly (Highlander).

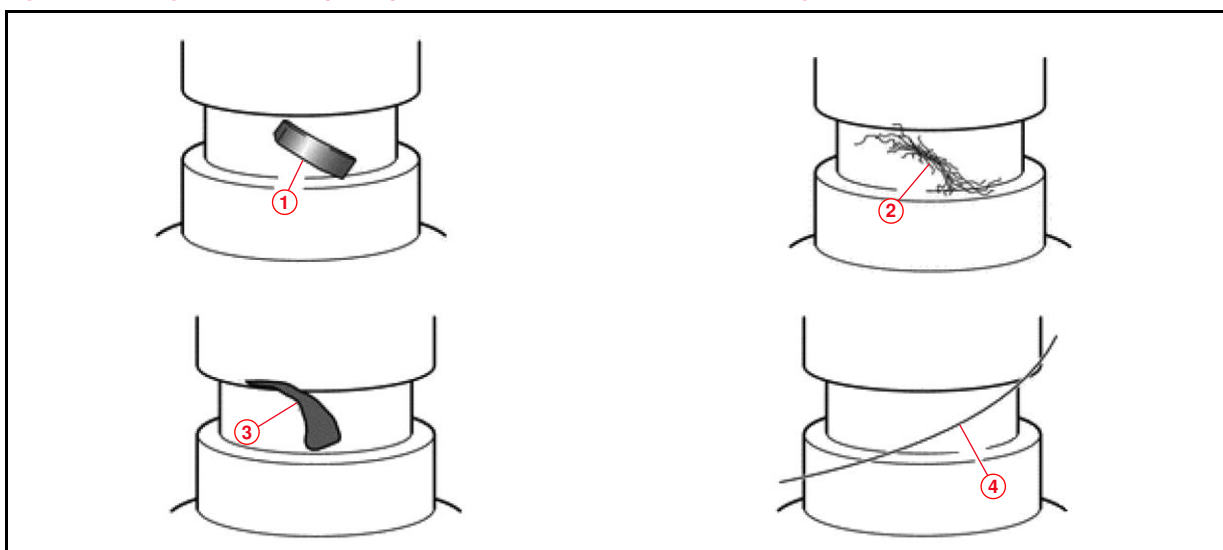
**Figure 3. Foreign Matter – Pipe Replacement NOT Needed (Clean Using Non-metallic Tool)**

| <b>1</b> | Metal Fragment |
| <b>3</b> | Resin Fragment |

| <b>2</b> | Lint |
| <b>4</b> | Hair |

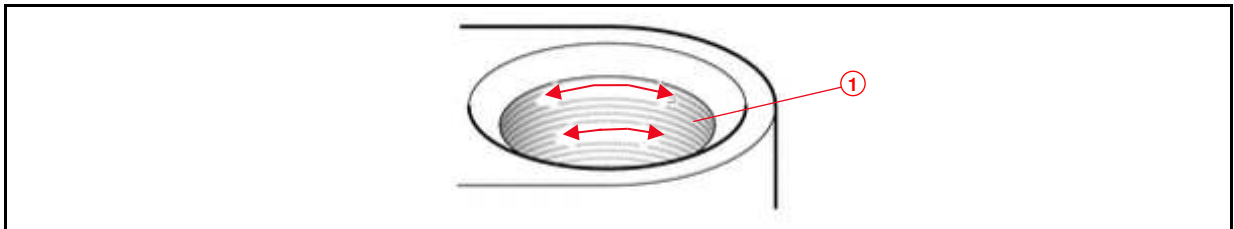
**Figure 23. OK Condition – Condenser Assembly Replacement NOT Needed**

| 1 | Light Scratching Parallel With O-ring Groove (Caused by Normal Part Processing) |

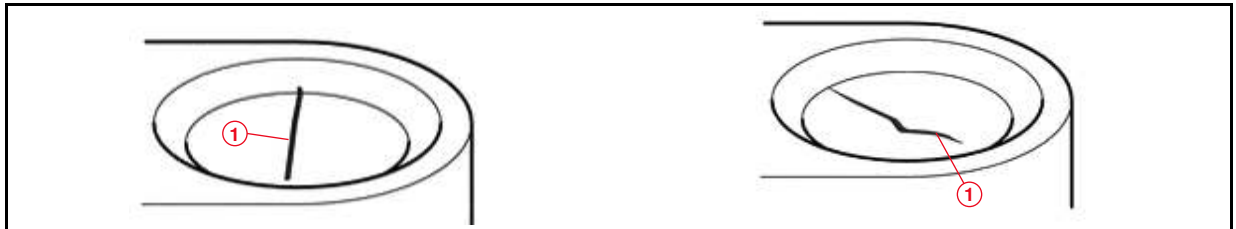
**Figure 24. Damage Condition – Condenser Assembly Replacement Recommended**

| <b>1</b> | Deep Scratching Perpendicular to the O-ring Groove |

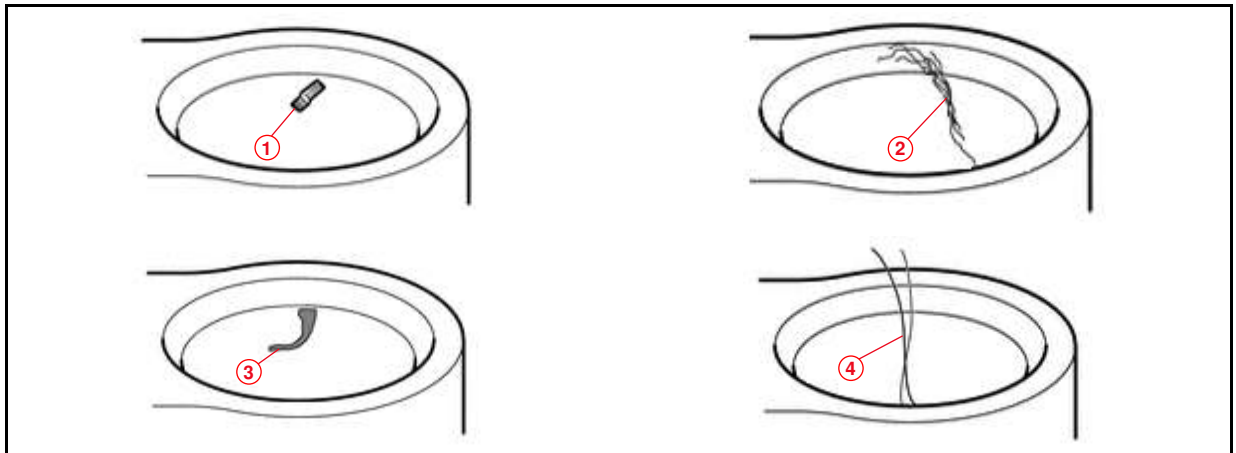
**Figure 25. Foreign Matter – Pipe Replacement NOT Needed (Clean Using Non-metallic Tool)**

| <b>1</b> | Metal Fragment |
| <b>3</b> | Resin Fragment |
