Preliminary Information

PIT5751C SES MIL / Reduced Engine Power / Misfire / IPC Gauges Sweep / IPC Warning Message / Loss Communication / Various DTCs / Blown Fuse (Inspect Engine Harness 3.0L Diesel)

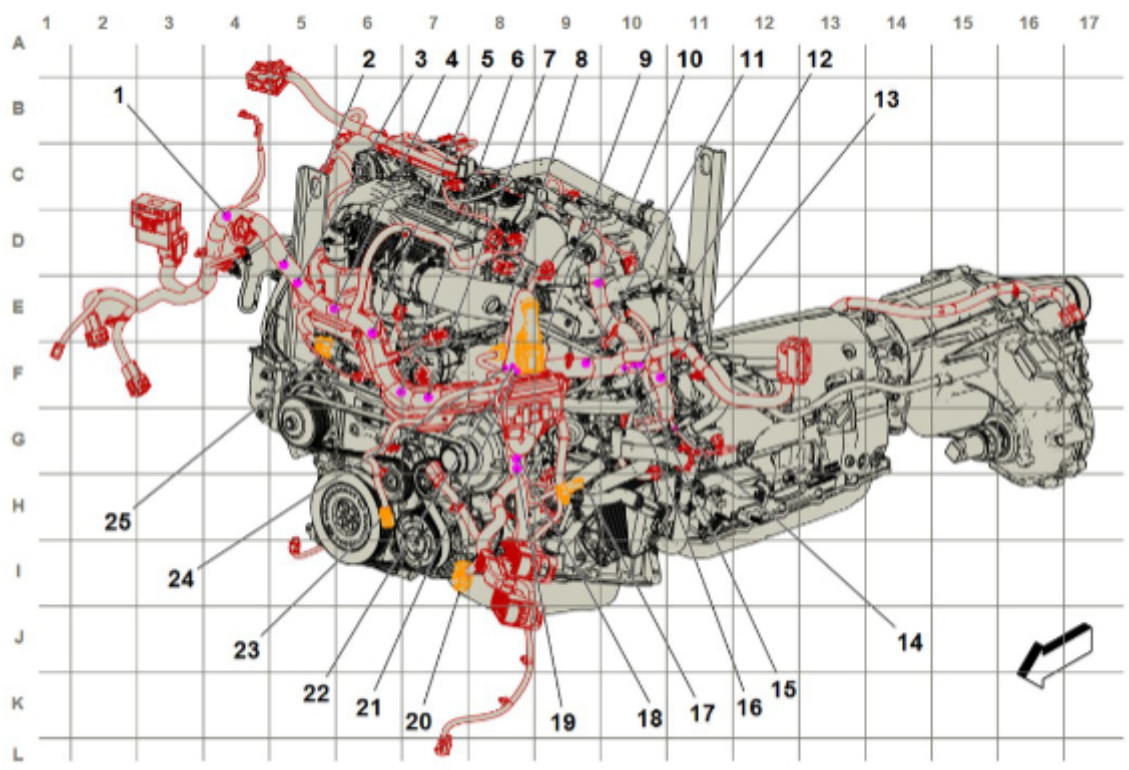
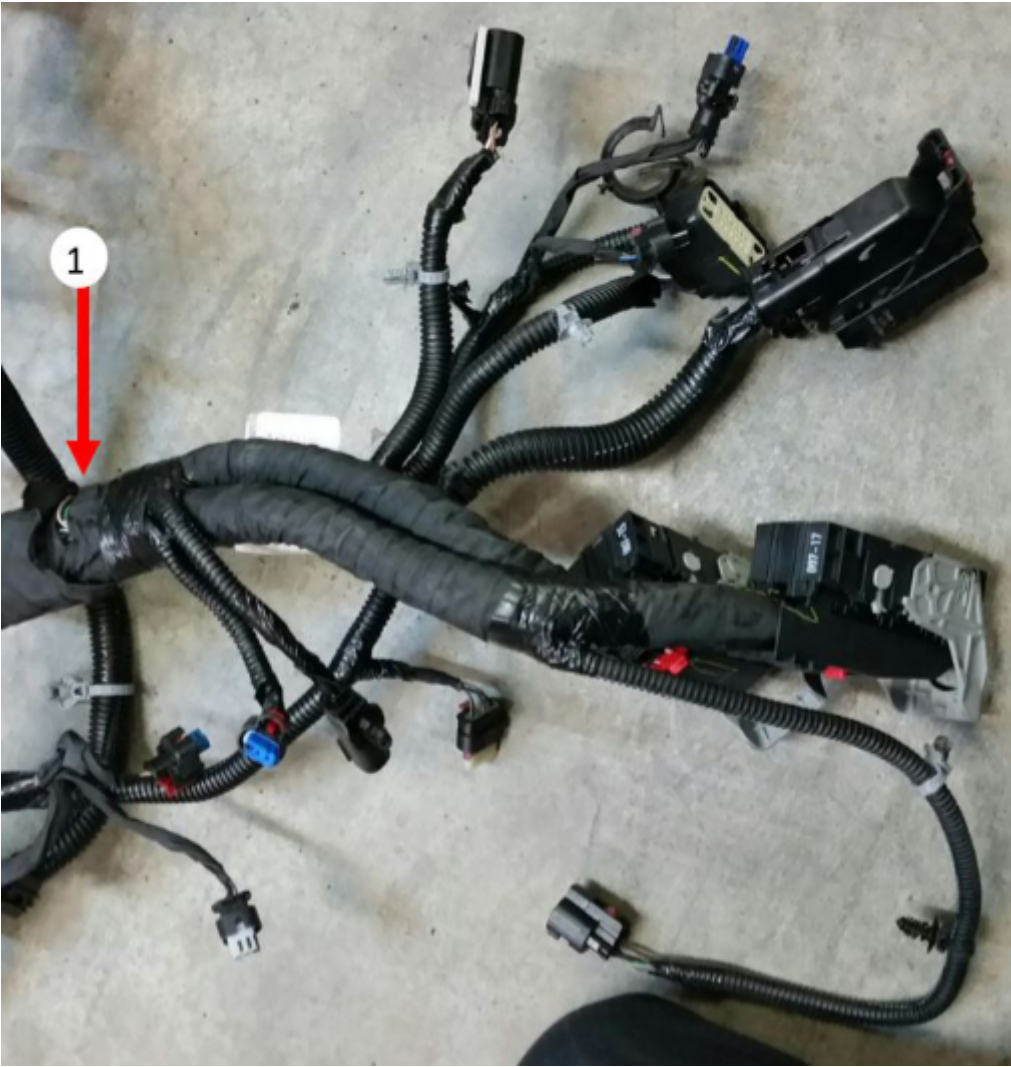
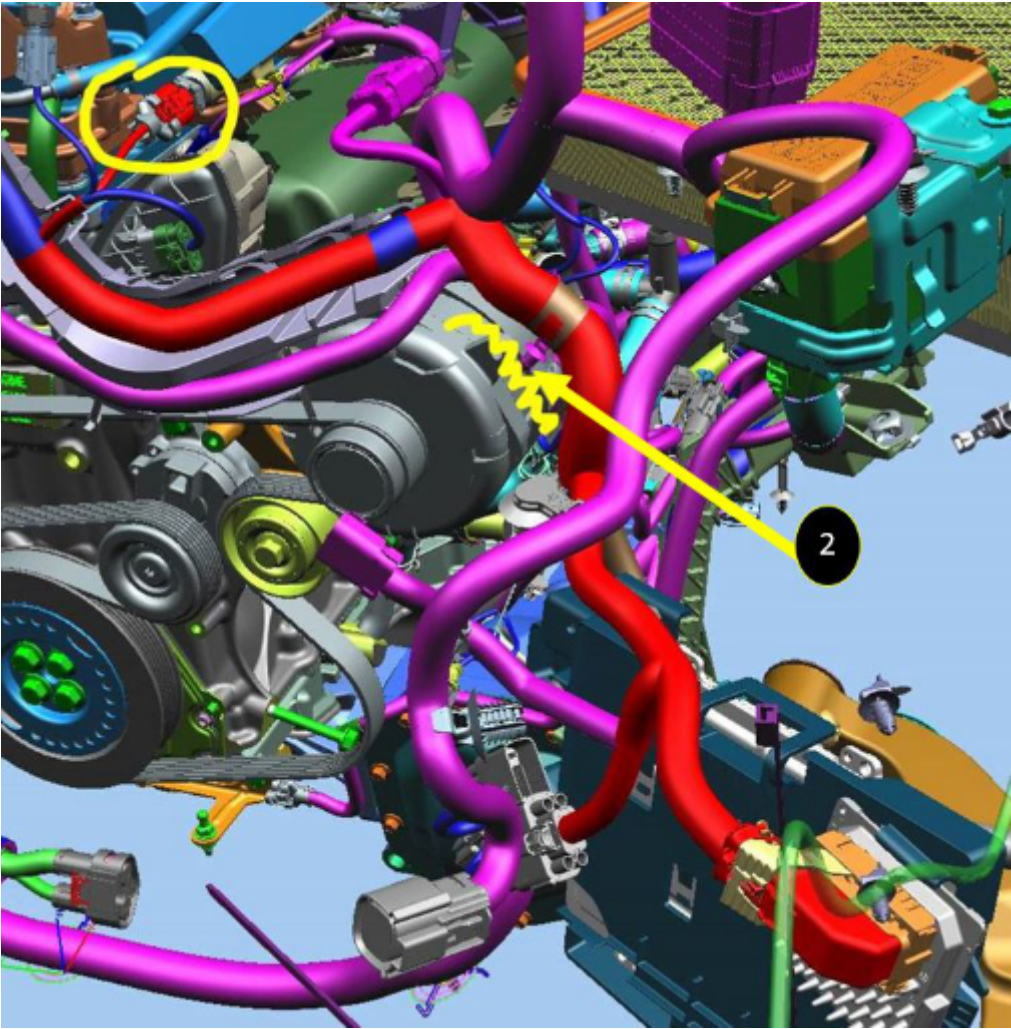
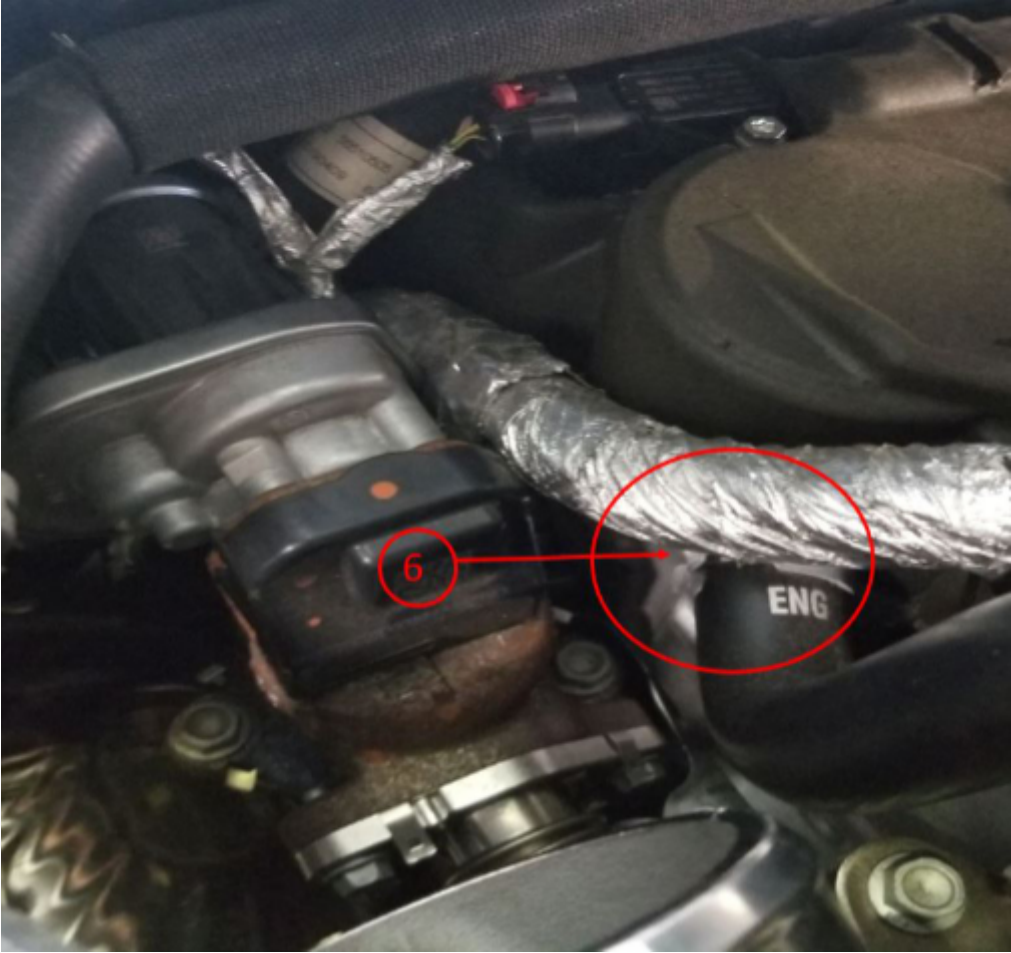
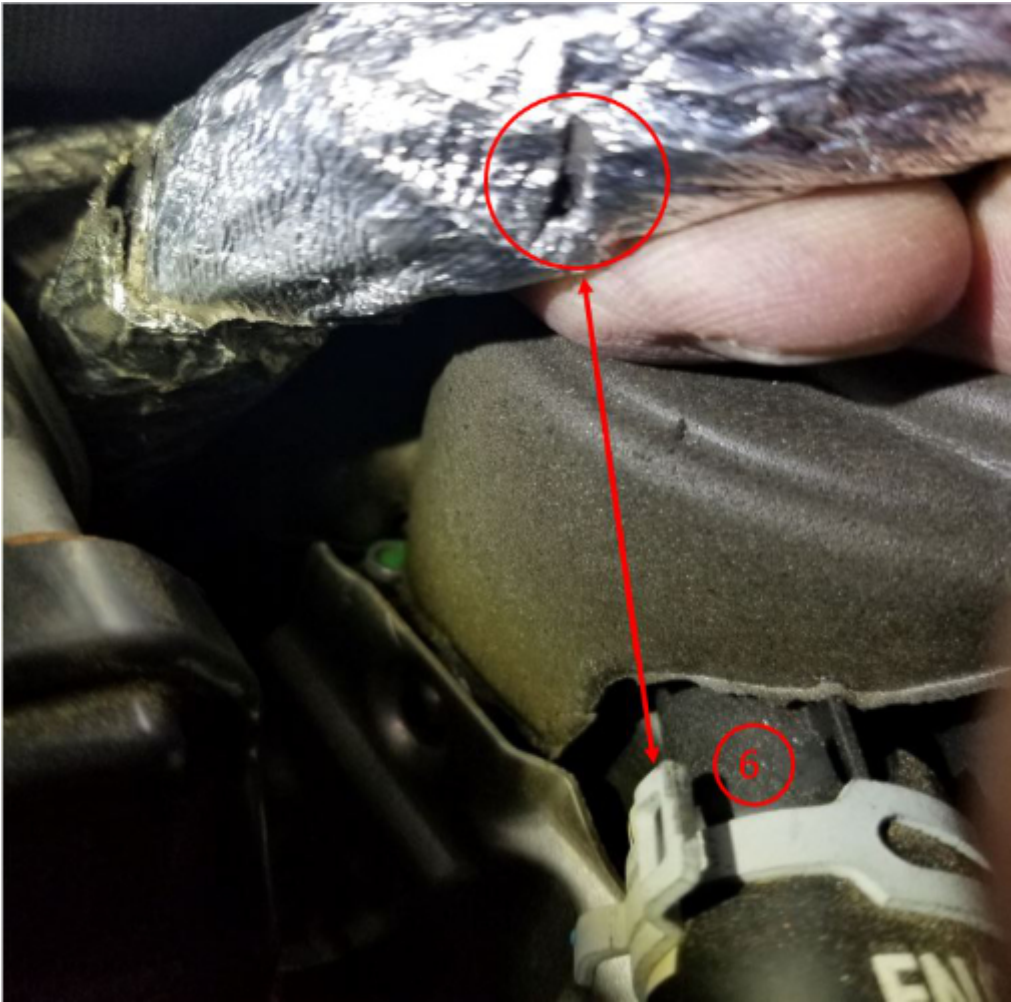
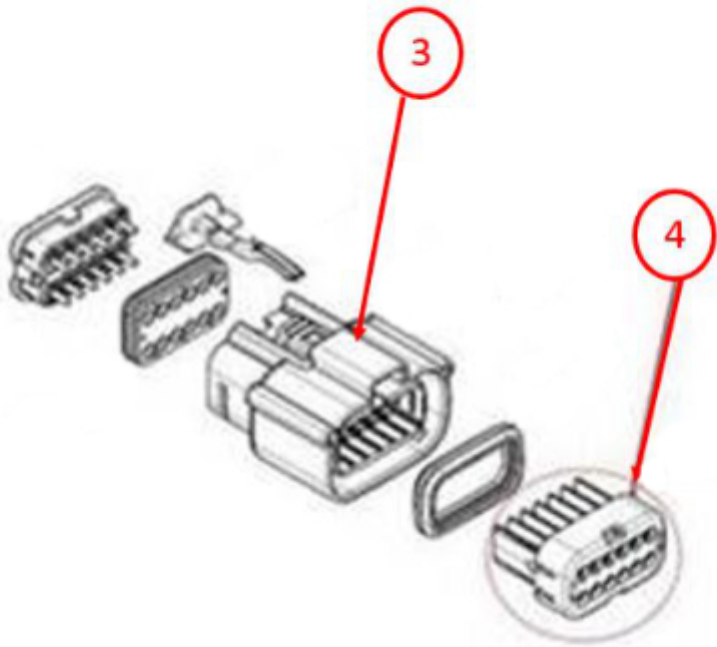
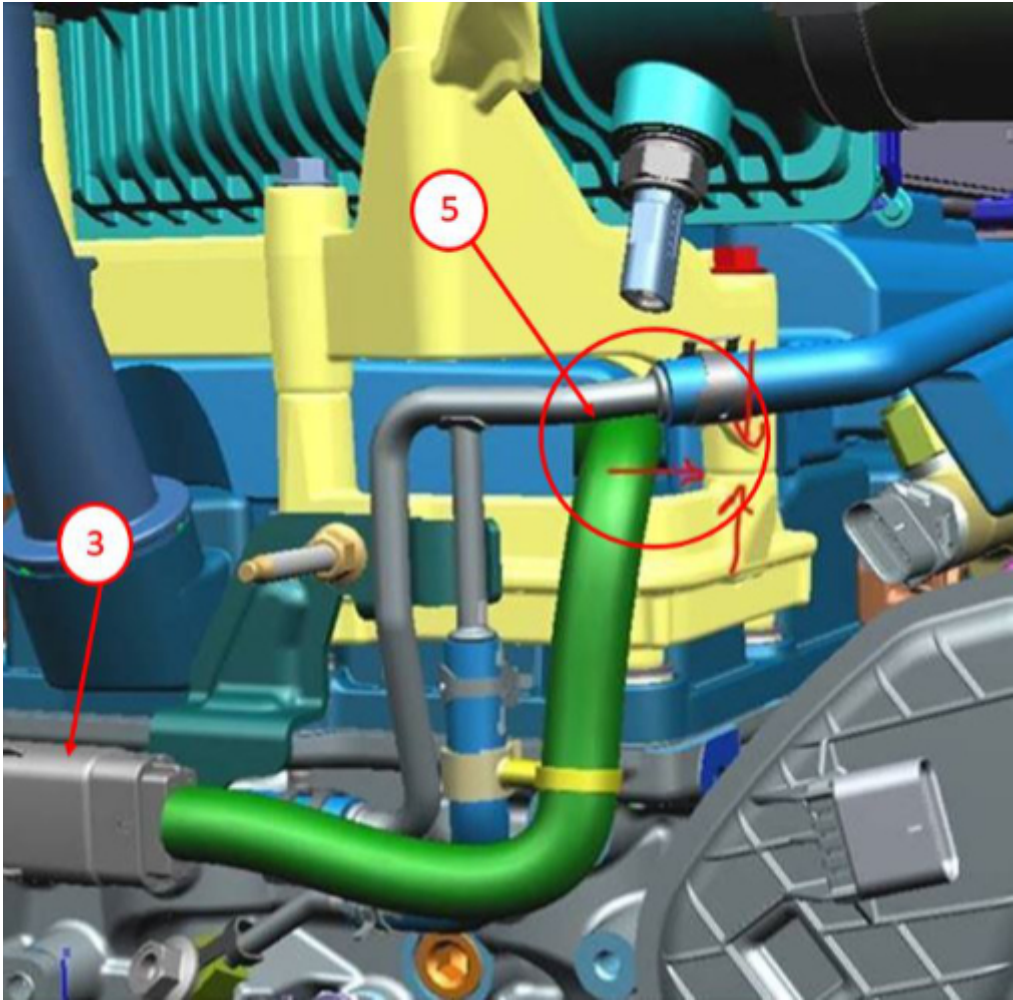
| Cause | <p><u>For any of the DTC's listed above inspect the following areas:</u></p> <p>1. The engine harness pinched/shorted/chaffed at grid coordinates G-8, as shown below. This location is approximately 18 inches from the ECM connectors (1) and on top of the generator (2), as shown below. Due to the number of circuits in the harness, there is a wide variety of different symptoms that could occur, depending on which circuit(s) are damaged.</p> <p>2. The engine harness shorted/chaffed at grid coordinates C-9, as shown below. The engine harness could be shorted out on the PVC hose clamp at the crankcase pressure regulator, as shown below (6). This is located approximately 4 inches from the crankcase sensor connector pigtail harness breakout.</p> <p><u>For DTC's: P0201, P0202, P0203, P0204, P0205, P0206, and/or P0216 inspect these 3 additional areas:</u></p> <p>1. Inspect for poor terminal tension at connector X160, shown below as callout 25. While inspecting X160 make sure the terminal locking feature (4) is not missing.</p> <p>2. Inspect the fuel injector connectors to make sure they are fully connected/seated.</p> <p>3. Inspect the fuel injector wiring harness near the X160 connector (3) for being pinched/shorted/chaffed, as shown below (5).</p> |

In many cases, the ECM has been unnecessarily replaced for these concerns. Please thoroughly inspect the areas shown above and follow published SI diagnostics before any parts are replaced. If any concerns are found, then follow SI Wiring and Connector repair instructions to correct the concern.
