GLOBAL SAFETY FIELD INVESTIGATIONS  
DCS5614  
URGENT - DISTRIBUTE IMMEDIATELY

Subject: N202310850 02 - Customer Satisfaction Program  
Airbag Indicator Light Intermittent  
Revised Service Procedure and Part Ordering Information

Models: 2021 Cadillac Escalade, Escalade ESV  
2021 Chevrolet Suburban, Tahoe  
2021 GMC Yukon, Yukon XL  
Equipped with Restraint System-Seat, Inflatable, Driver & Pass Frt, Frt  
Seat Side, Frt Inboard Seat Side, Roof Side (RPO AYQ)

## N202310850 Airbag Indicator Light Intermittent

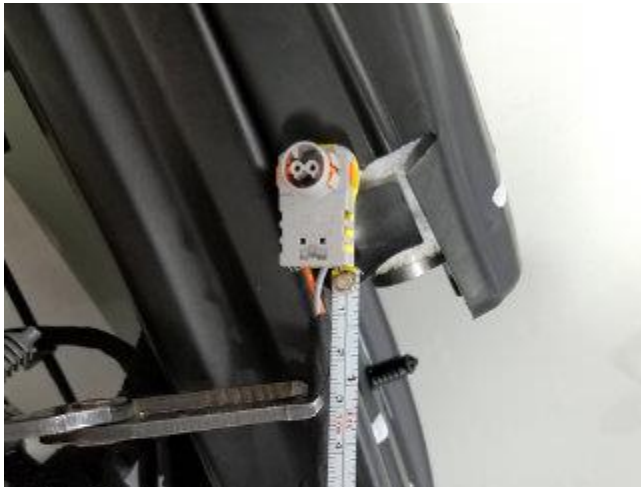
5672141

**Note:** There may be butyl tape over the harness and connector from a previous repair. Remove the butyl tape as necessary. Tape residue can be left on the repair area, it does not need to be completely removed.
