# Technical Service Bulletin

**94 Rear turn signal warning is displayed, DTCs B16D4F4, B16D5F4, B16D6F4, or B16D7F4 are stored in the comfort module**

94 21 35 2062241/1 February 23, 2021.

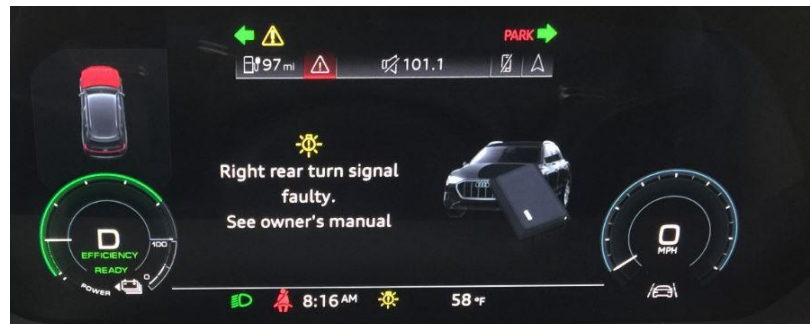
There is a timing issue in the tail lamp software.

1. When actuating the turn signal, a warning is displayed for the rear turn signal that was actuated (Figure 1).

**Figure 1.** Warning displayed for right rear turn signal.

2. If the described condition is present, please proceed to update the software in the tail lamps.

3. Follow all instructions in TSB 2011732: *00 Software Version Management (SVM), operating instructions*.
4. Update the tail lamp software using the SVM action code as listed in the table below, if necessary:
