**NUMBER:** 09-014-20

Transmission Oil Cooler Line Not Fully Connected

2020 - 2021 (DT) RAM 1500 Pickup

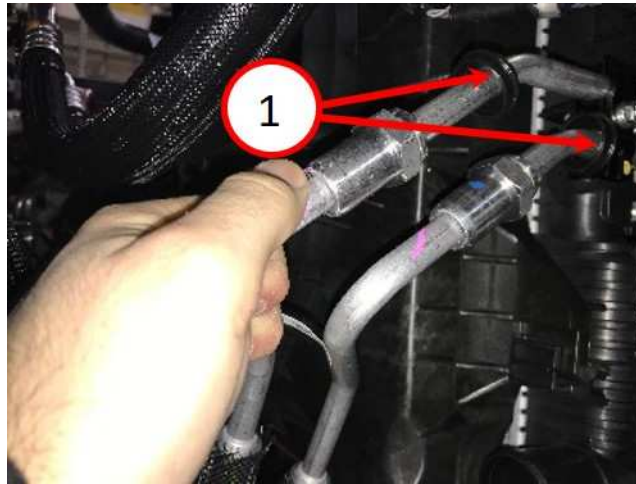
Fig. 2  
Pull On TOC Lines

2. The black assurance caps (Fig. 2) need to be pulled back to inspect for painted area. If yellow paint can be seen on the tube, this is an indication that the tube is not seated completely into the fitting.

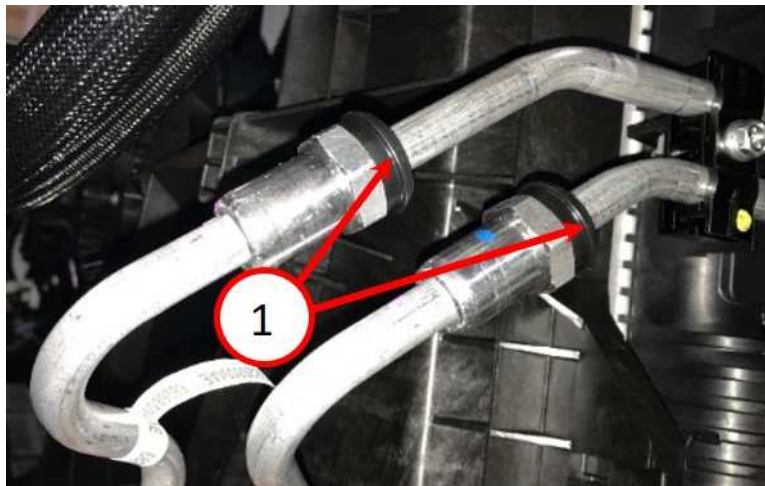
**Fig. 4**  
**Assurance Cap (In Place)**

3. Slide the assurance caps down the tube and snap the cap over the fitting. Listen or feel for a "snap" or "click" as the cap engages with the fitting (Fig. 4) .
