MODEL  
**2019MY**  
**Niro (DE HEV/PHEV)**

NUMBER  
**211**

## TECHNICAL SERVICE BULLETIN

**SUBJECT: AEW P PARTIAL REPLACEMENT FOR DTC P2600/P0C73**

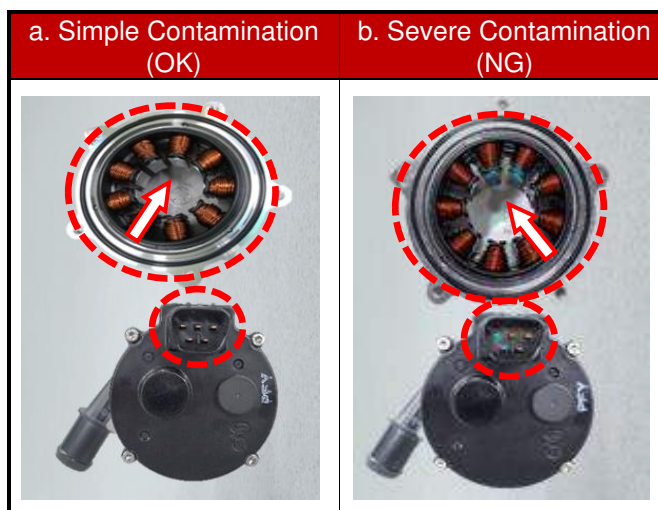
7. Check for coolant intrusion and terminal corrosion in the AEWP housing and take action according to the procedure and example photos.

- a. Simple contamination of the stator coil and power terminal:  
Clean and dry the inside and replace the Kit parts (can case, S-ring, O-ring).
- b. Severe contamination of the stator coil and terminal:  
Replace the AEWP assembly.
